Height Safety Asset Management Report

Site Assessment & Report

Coventry University – Armstrong Siddeley Building, Coventry, West Midlands, CV1 5PY.

Surveyed on behalf of Coventry University

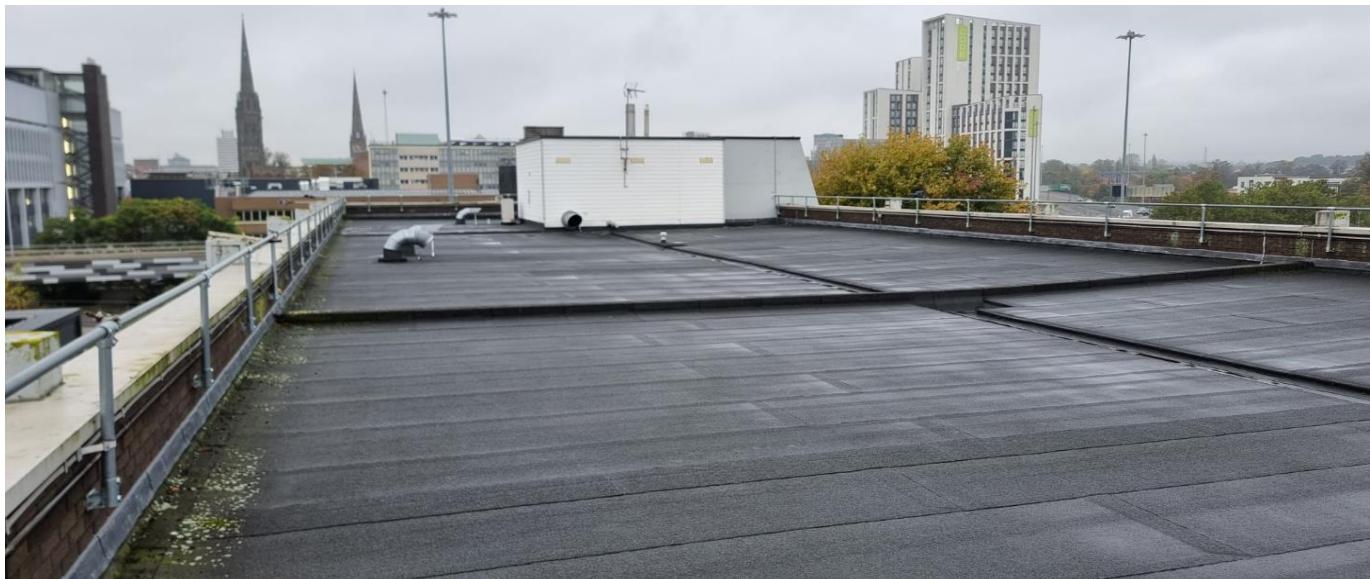
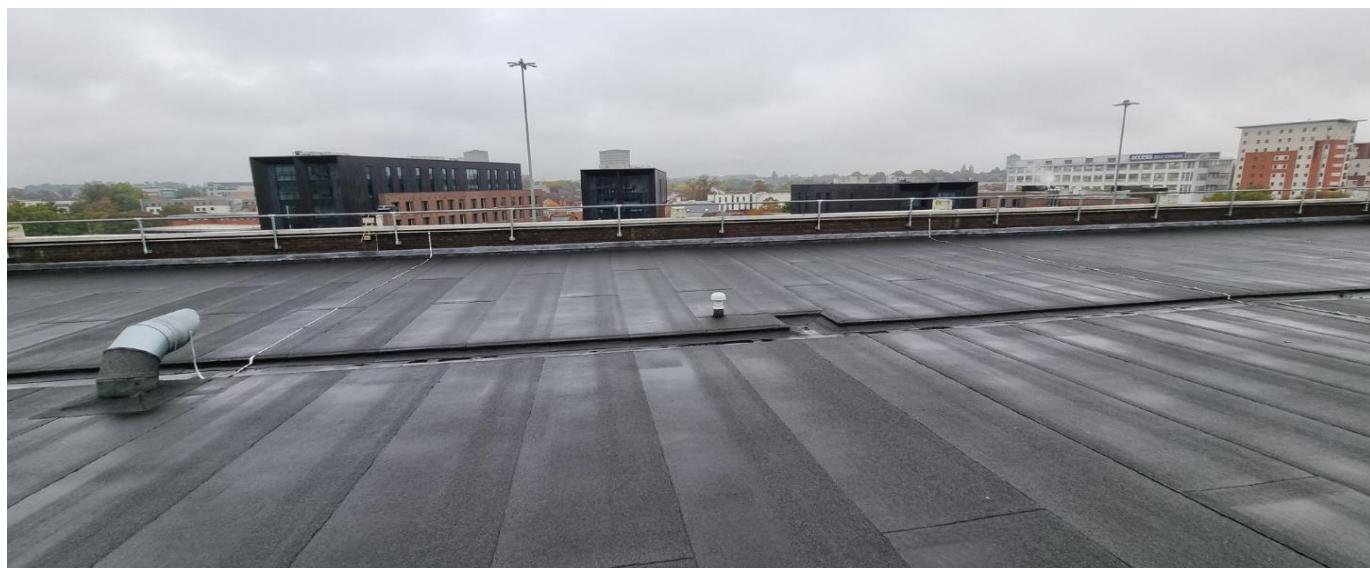
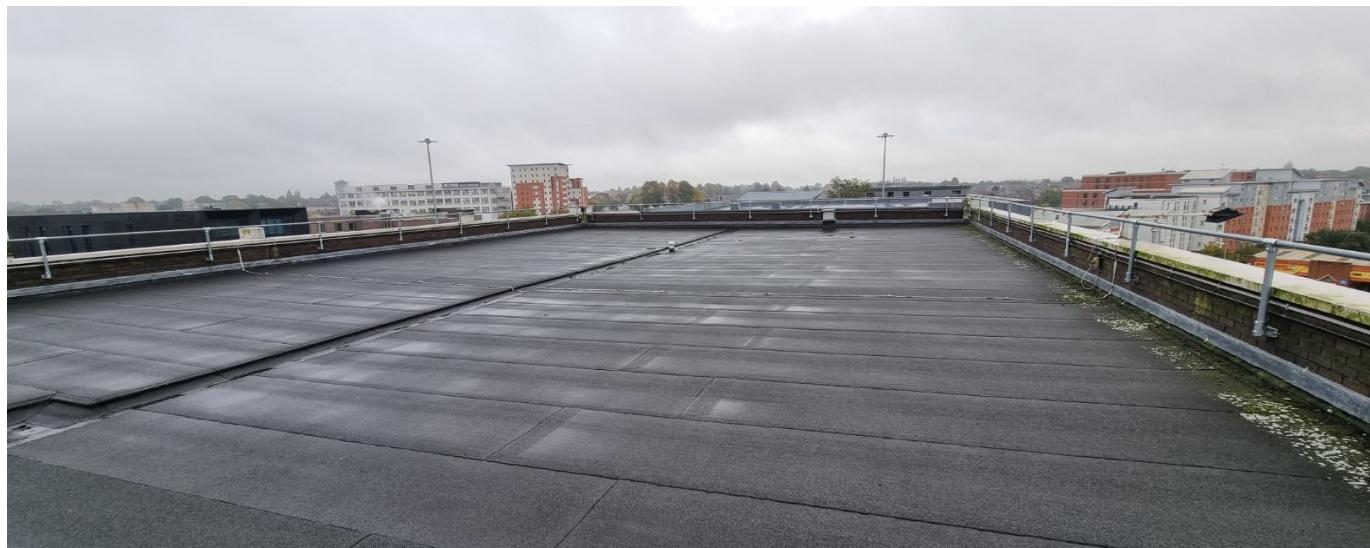
Photos – Roof 1

Area	Roof Area 1		Roof height	Approx 40m								
Access	Hatch	Door	Fixed Ladder	Temp Ladder	MEWP	Other						
Access Comments												
The roof areas are accessed on a case-by-case basis by site maintenance staff and contractors, this roof area is covered by collective protection and is within compliance.												
Roof area accessed by fixed ladder.												
We advise no lone working on this roof.												
Tasks	Comments											
Gutter maintenance	There are gutters located to the perimeter of the building, these are to be cleaned/maintained whilst staying in the confines of the collective protection.											
Air Vents	There are air vents located within the confines of the collective protection, these are to be maintained whilst staying in the confines of the collective protection.											
Lightning Protection	Lightning Protection located within the confines of the collective protection, these are to be maintained whilst staying in the confines of the collective protection.

Chimney Flue	Chimney Flue located within the confines of the collective protection, these are to be maintained whilst staying in the confines of the collective protection.											
Access Suggestions												
A permit to work system could help control who goes on the roof area to ensure they understand the risk associated with this area and the procedures in place also to identify that the engineers/contractors are trained and competent and that their RAMS are identified and suitable for the works required of them regarding access methods/Rescue.												
We suggest that anyone going to the roof areas should always work in pairs in case of an emergency, this roof area is covered by collective protection although the access is via fixed ladder, therefore we could advise that additional ladder training would benefit the end user, also the inclusion of suitable PPE, in this case Mandatory site PPE as specified by Coventry University.

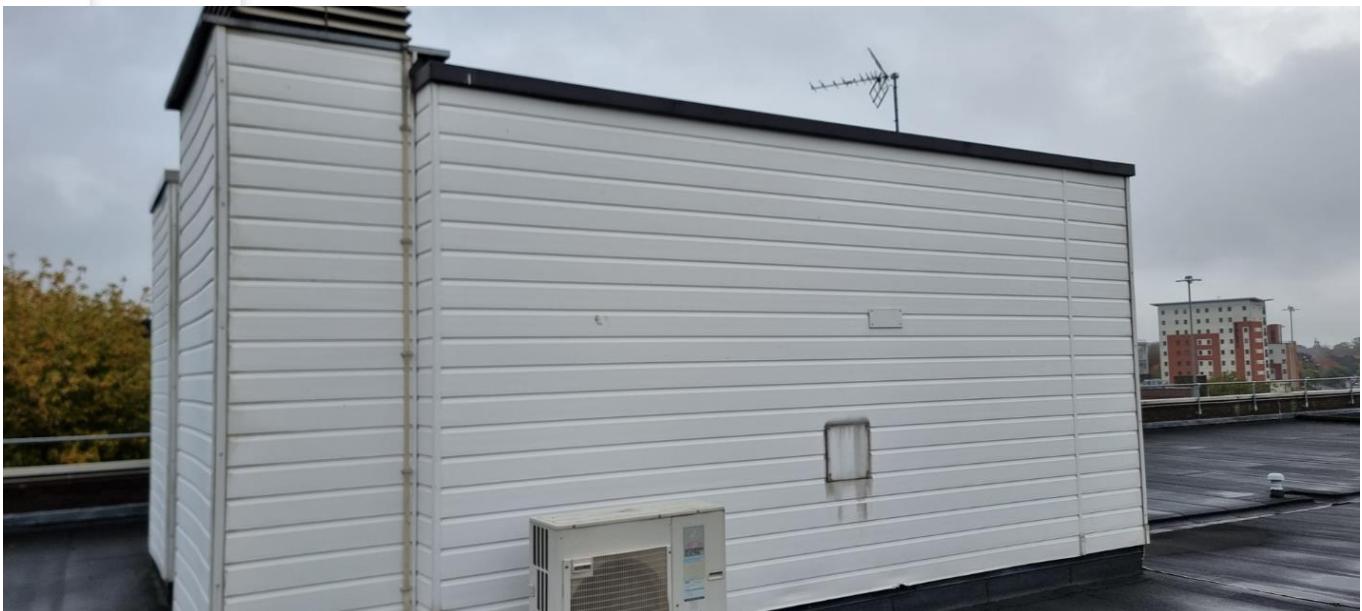
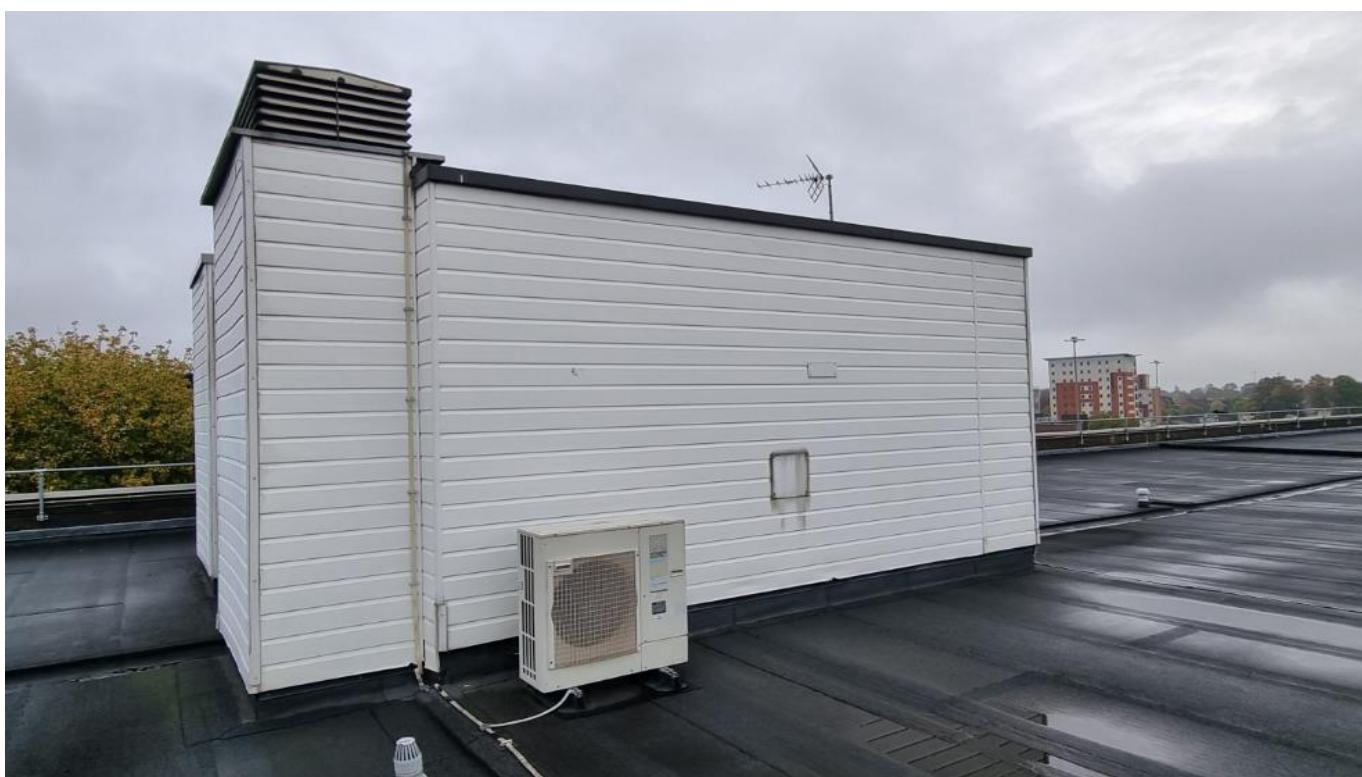
Roof 2

Roof Area 2		Roof height	Approx 4m		
Hatch	Door	Fixed Ladder	Temp Ladder	MEWP	Other
			x		
Access Comments					
<p>The roof areas are accessed on a case-by-case basis by site maintenance staff and contractors</p> <p>Roof area accessed by 4m temp ladder; no fall protection present therefore a SSOW is required.</p> <p>We advise no lone working on this roof.</p>					
Tasks	Comments				
N/A	No Assets present.

Access Suggestions
<p>A permit to work system could help control who goes on the roof area to ensure they understand the risk associated with this area and the procedures in place also to identify that the engineers/contractors are trained and competent and that their RAMS are identified and suitable for the works required of them regarding access methods/Rescue.</p>
<p>We suggest that anyone going to the roof areas should always work in pairs in case of an emergency, this roof area is not covered by any fall protection although there are no serviceable assets located on this upper section, no cause for access.</p>

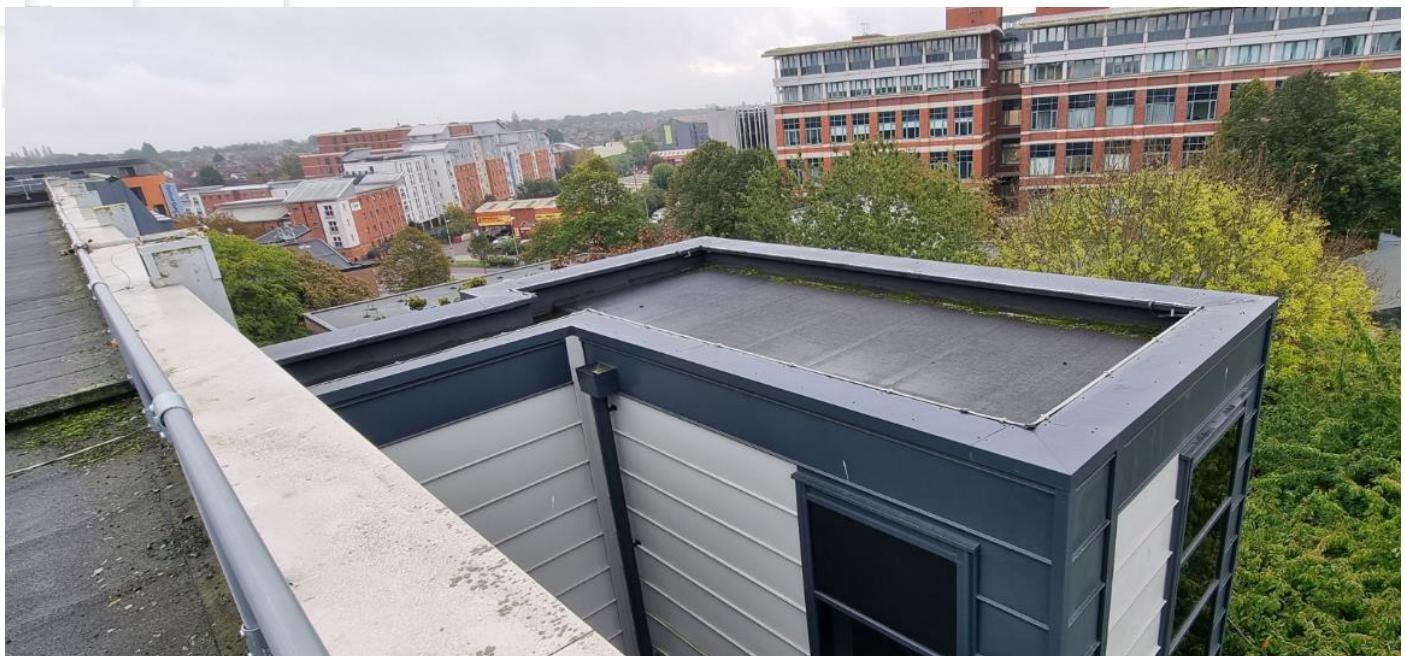
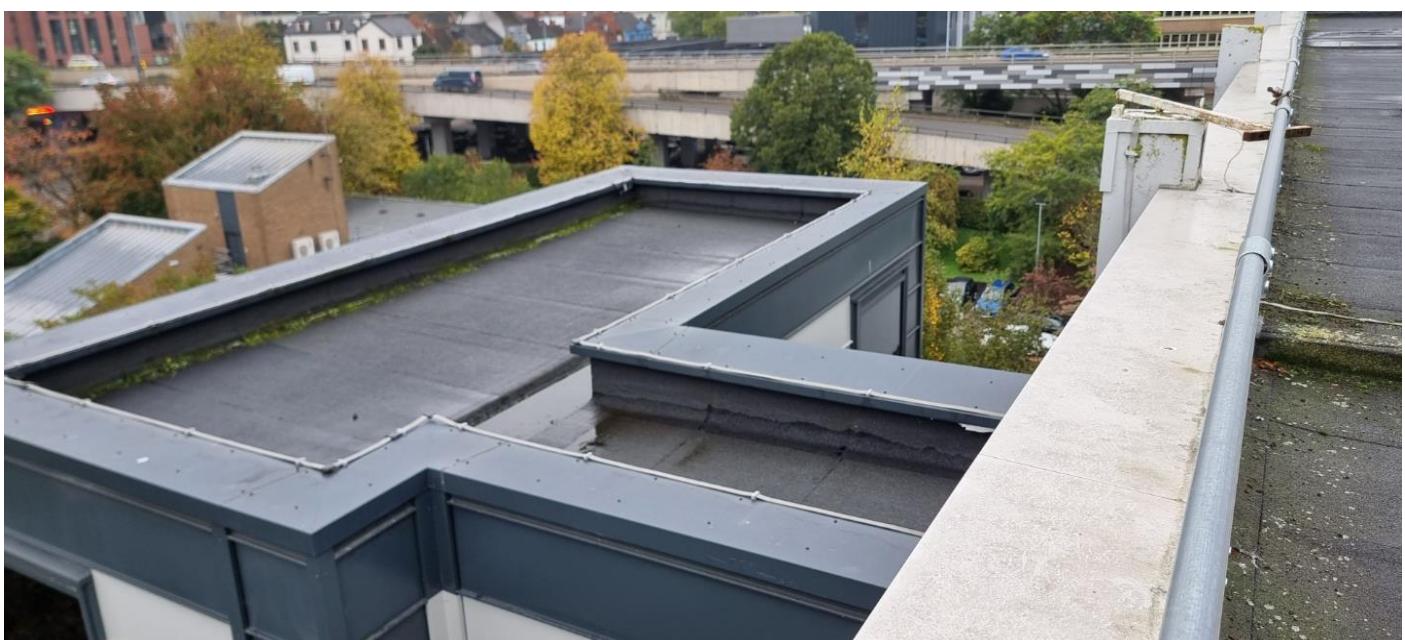
Roof 3

Roof Area 3		Roof height	Approx 40m		
Hatch	Door	Fixed Ladder	Temp Ladder	MEWP	Other
					No safe access
Access Comments					
The roof areas are accessed on a case-by-case basis by site maintenance staff and contractors					
Roof area has no current safe access/Fall protection present, SSOW required.					
We advise no lone working on this roof.					
Tasks	Comments				
Lightning protection maintenance	No safe access, no fall protection present, Bespoke SSOW required.

Access Suggestions
A permit to work system could help control who goes on the roof area to ensure they understand the risk associated with this area and the procedures in place also to identify that the engineers/contractors are trained and competent and that their RAMS are identified and suitable for the works required of them regarding access methods/Rescue.
We suggest that anyone going to the roof areas should always work in pairs in case of an emergency, this roof area is not covered by any fall protection although there are no serviceable assets located on this upper section, no cause for access.
