Height Safety Asset Management Report

Site Assessment & Report

Coventry University – Beatrice shilling building, Coventry, West midlands, CV1 5JH

Surveyed on behalf of Coventry University

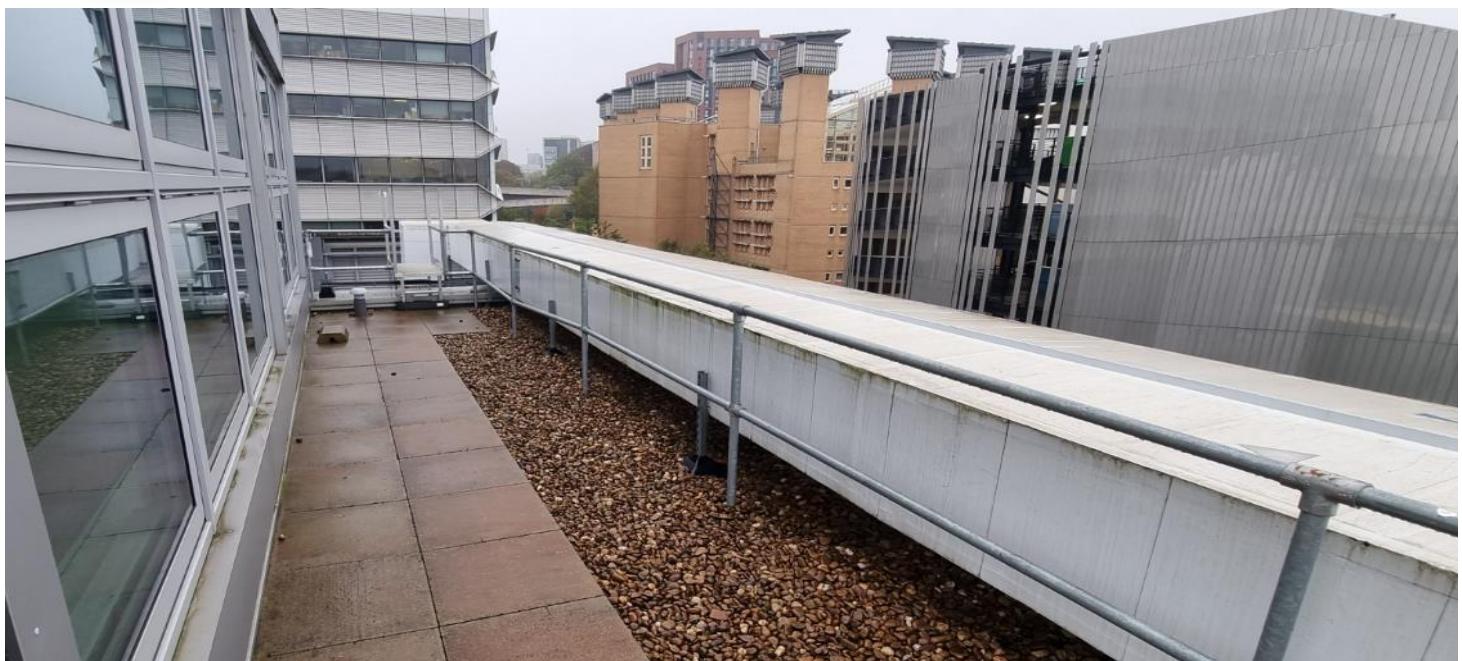
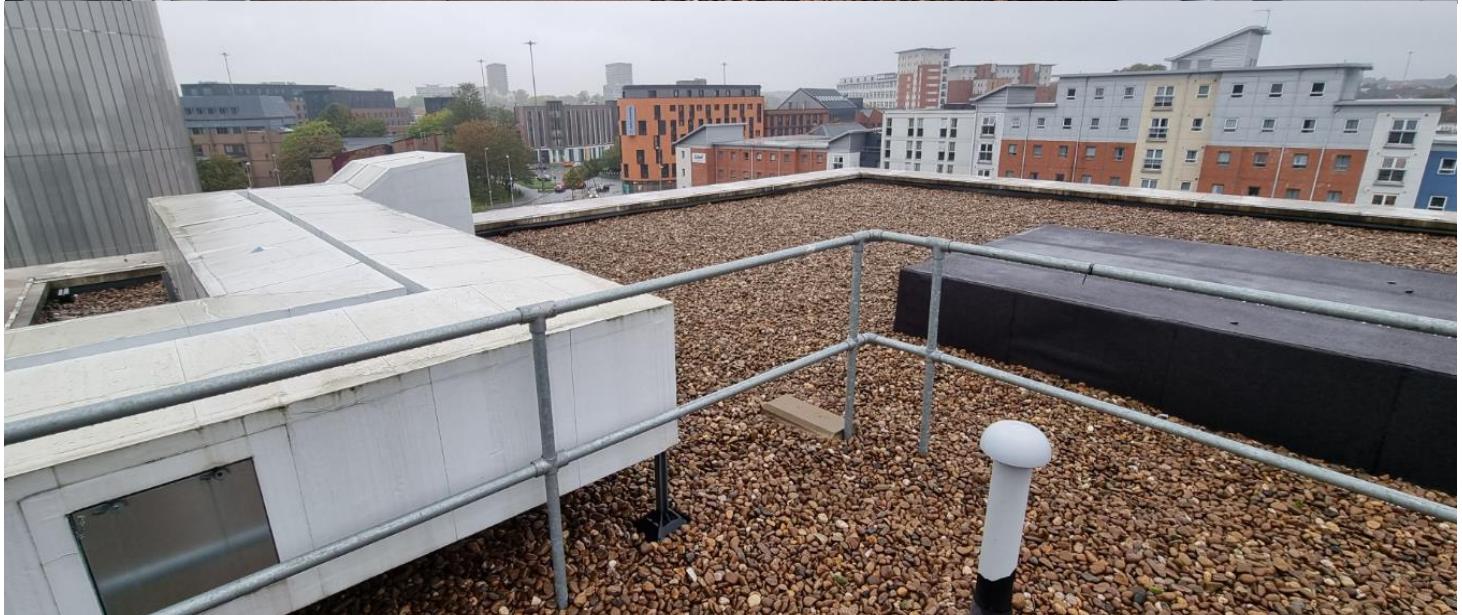
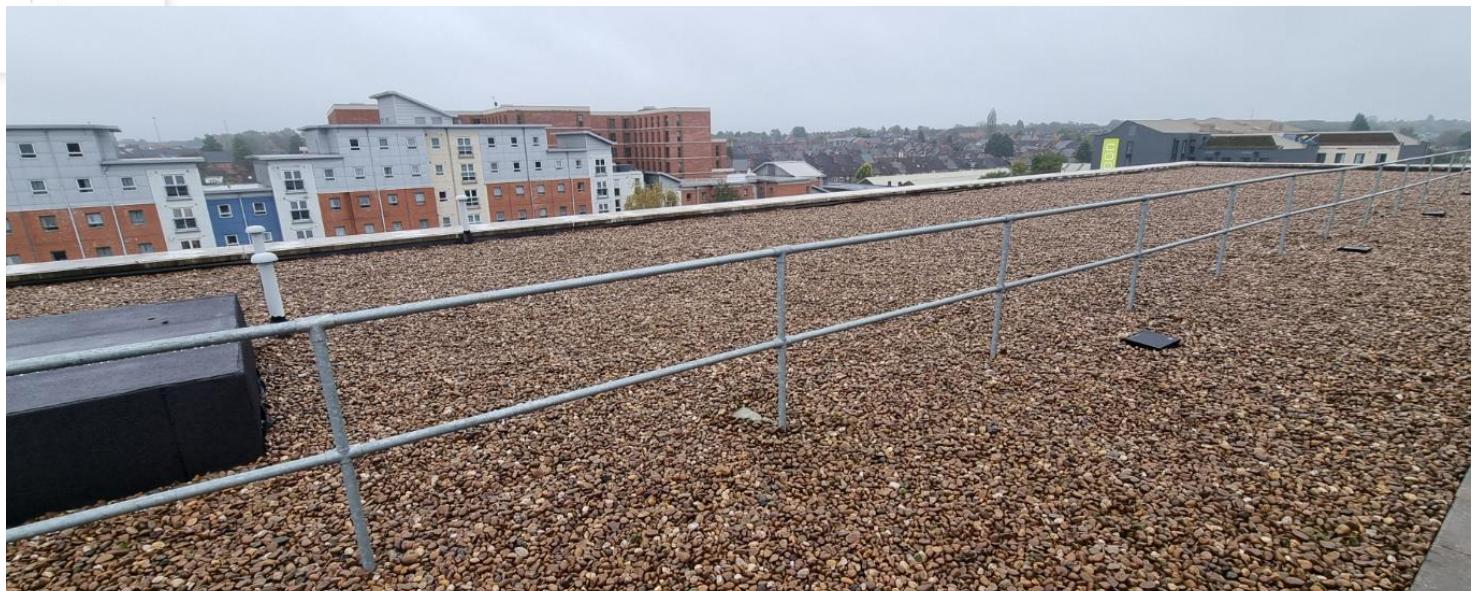
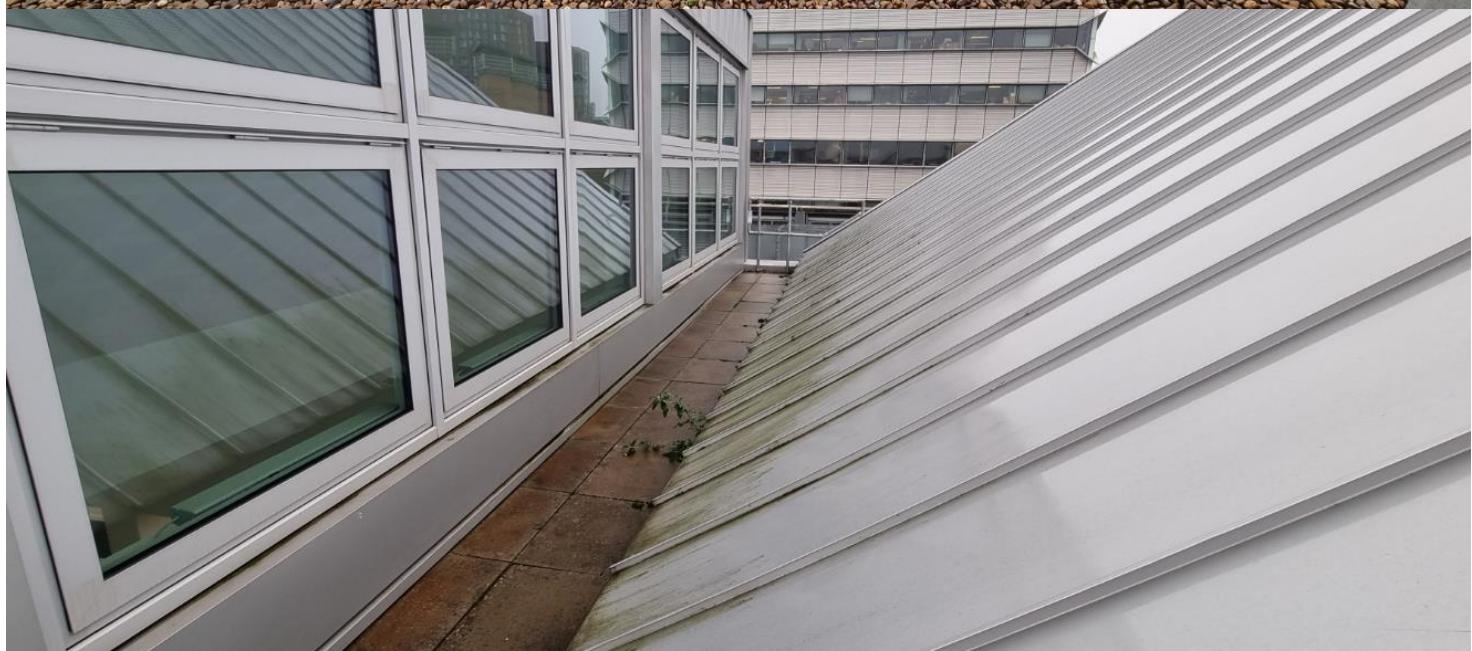
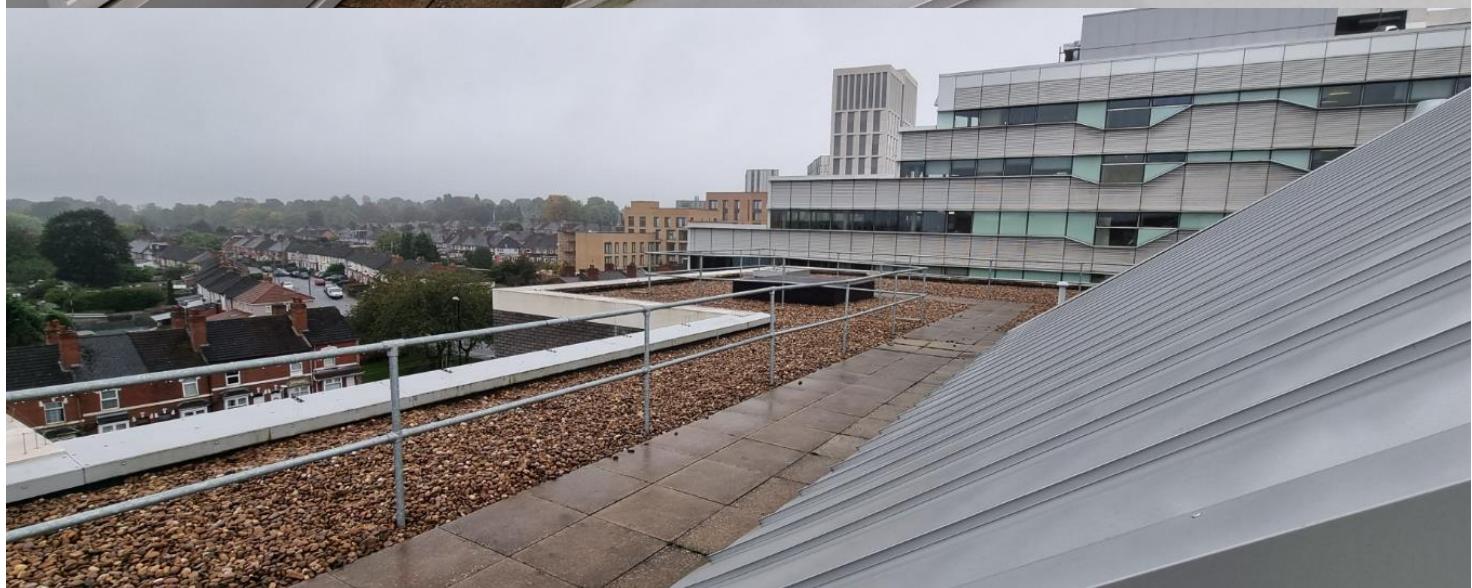
Photos Building 1/Roof 1

Area	Building 1/Roof 1		Roof height	Approx 25m		
Access	Hatch	Door	Fixed Ladder	Temp Ladder	MEWP	Other
Access Comments						
The roof areas are accessed on a case-by-case basis by site maintenance staff and contractors, this roof area is covered by collective protection and is certified and within compliance						
Roof area accessed via door.						
We advise no lone working on this roof with consideration towards evacuation.						
Tasks	Comments					
Window Maintenance	These are located within the confines of the collective protection, these are to be maintained whilst staying in the confines of the collective protection.					
Chimney Flue Maintenance	Chimney Flues are located both within the confines of the collective protection & outside it, should maintenance be required on those that are located outside the boundaries of the collective protection then an SSOW, training and additional equipment is required.

Lightning Protection Maintenance	Lightning Protection is both within the confines of the collective protection & outside it, should maintenance be required on those that are located outside the boundaries of the collective protection then an SSOW, training and additional equipment is required.					
Air Vent Maintenance	Air Vents are located both within the confines of the collective protection & outside it, should maintenance be required on those that are located outside the boundaries of the collective protection then an SSOW, training and additional equipment is required.

A permit to work system could help control who goes on the roof area to ensure they understand the risk associated with this area and the procedures in place also to identify that the engineers/contactors are trained and competent and that their RAMS are identified and suitable for the works required of them regarding access methods/Rescue.

We suggest that anyone going to the roof areas should always work in pairs in case of an emergency, especially with the specialist access/traversal methods required on this roof by way of work positioning and the minimal fall protection installed, in most cases we would advise that additional Horizontal cable systems are installed to aid the safe movement around these roof areas in an aim to keep the end user away from any potential fall hazard, currently the access methods fall down to the end user and their competency/training, there is excess potential for human error involved that could potentially be mitigated by the installation of additional equipment.

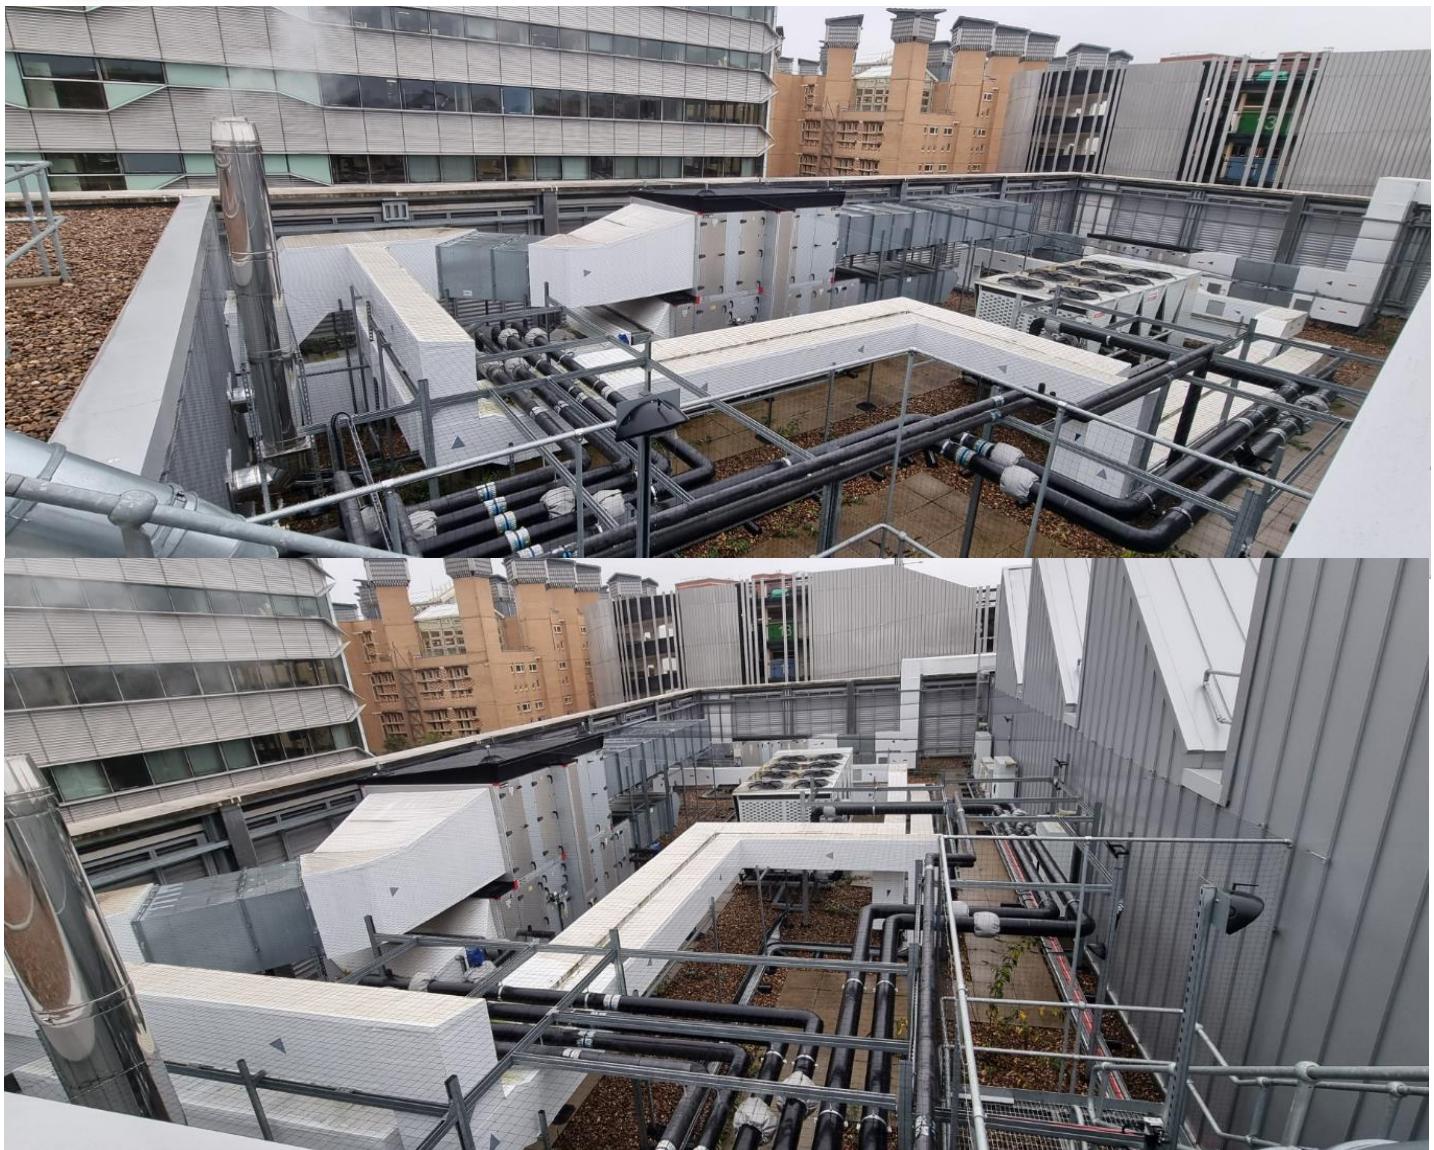
Area	Building 1/Roof 2		Roof height	Approx 20m		
Access	Hatch	Door	Fixed Ladder	Temp Ladder	MEWP	Other
		x				
Access Comments						
The roof areas are accessed on a case-by-case basis by site maintenance staff and contractors, this roof area is covered by collective protection (Parapet)						
Roof area accessed via door.						
We advise no lone working on this roof with consideration towards evacuation.						
Tasks		Comments				
Plant work maintenance		Plant works located within the confines of the collective protection; these are to be maintained whilst staying in the confines of the collective protection.

A permit to work system could help control who goes on the roof area to ensure they understand the risk associated with this area and the procedures in place also to identify that the engineers/contactors are trained and competent and that their RAMS are identified and suitable for the works required of them regarding access methods/Rescue.

We suggest that anyone going to the roof areas should always work in pairs in case of an emergency, this roof area is covered by collective protection, mandatory site PPE as specified by Coventry University required.

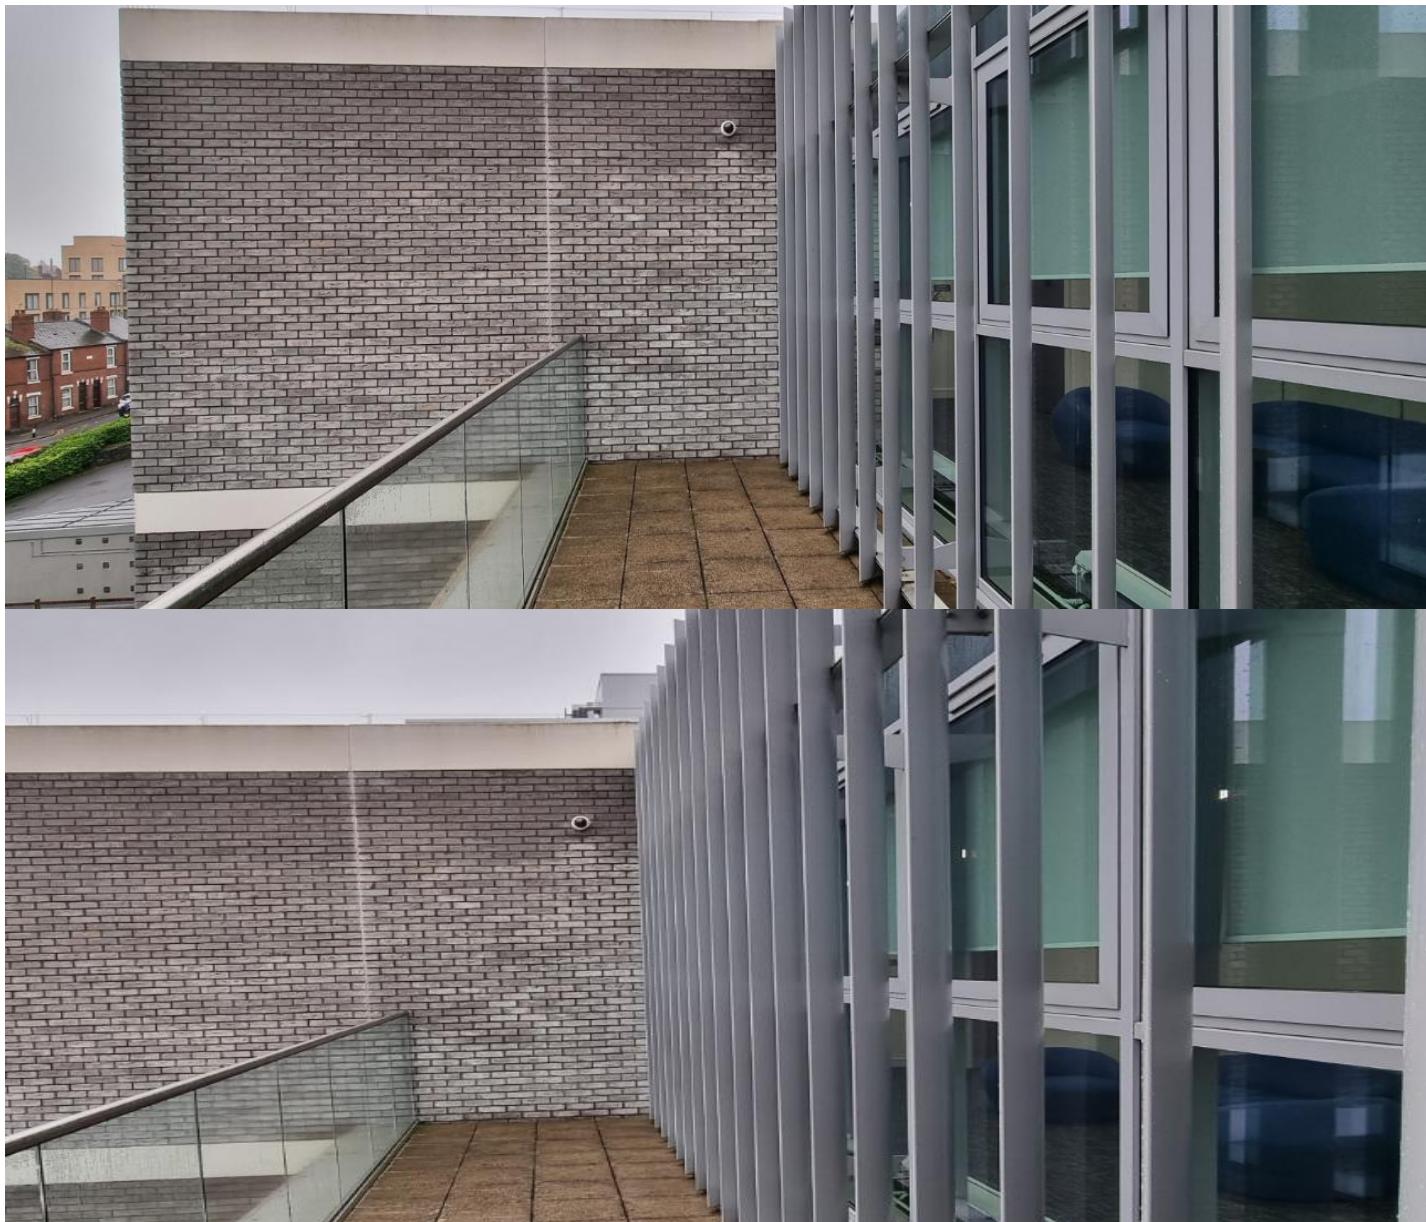
Area	Building 1/Roof 3			Roof height	Approx 20m	
Access	Hatch	Door	Fixed Ladder	Temp Ladder	MEWP	Other
Access Comments						
The roof areas are accessed on a case-by-case basis by site maintenance staff and contractors, this roof area is covered by collective protection and is certified and within compliance						
Roof area accessed via door.						
We advise no lone working on this roof with consideration towards evacuation.						
Tasks	Comments					
Plant Work Maintenance	Plant Works located within the confines of the collective protection; these are to be maintained whilst staying in the confines of the collective protection.					
Window Cleaning	Windows located within the confines of the collective protection; these are to be maintained/cleaned whilst staying in the confines of the collective protection.					
Brise Soleil	Brise Soleil located within the confines of the collective protection, these are to be maintained whilst staying in the confines of the collective protection.

Access Suggestions
A permit to work system could help control who goes on the roof area to ensure they understand the risk associated with this area and the procedures in place also to identify that the engineers/contractors are trained and competent and that their RAMS are identified and suitable for the works required of them regarding access methods/Rescue.
We suggest that anyone going to the roof areas should always work in pairs in case of an emergency, this roof area is covered by collective protection, mandatory site PPE as specified by Coventry University required.
