Height Safety Asset Management Report

Site Assessment & Report

Coventry University – Charles Ward, Cope Street, Coventry, CV1 5FD

Date: 20/10/2023

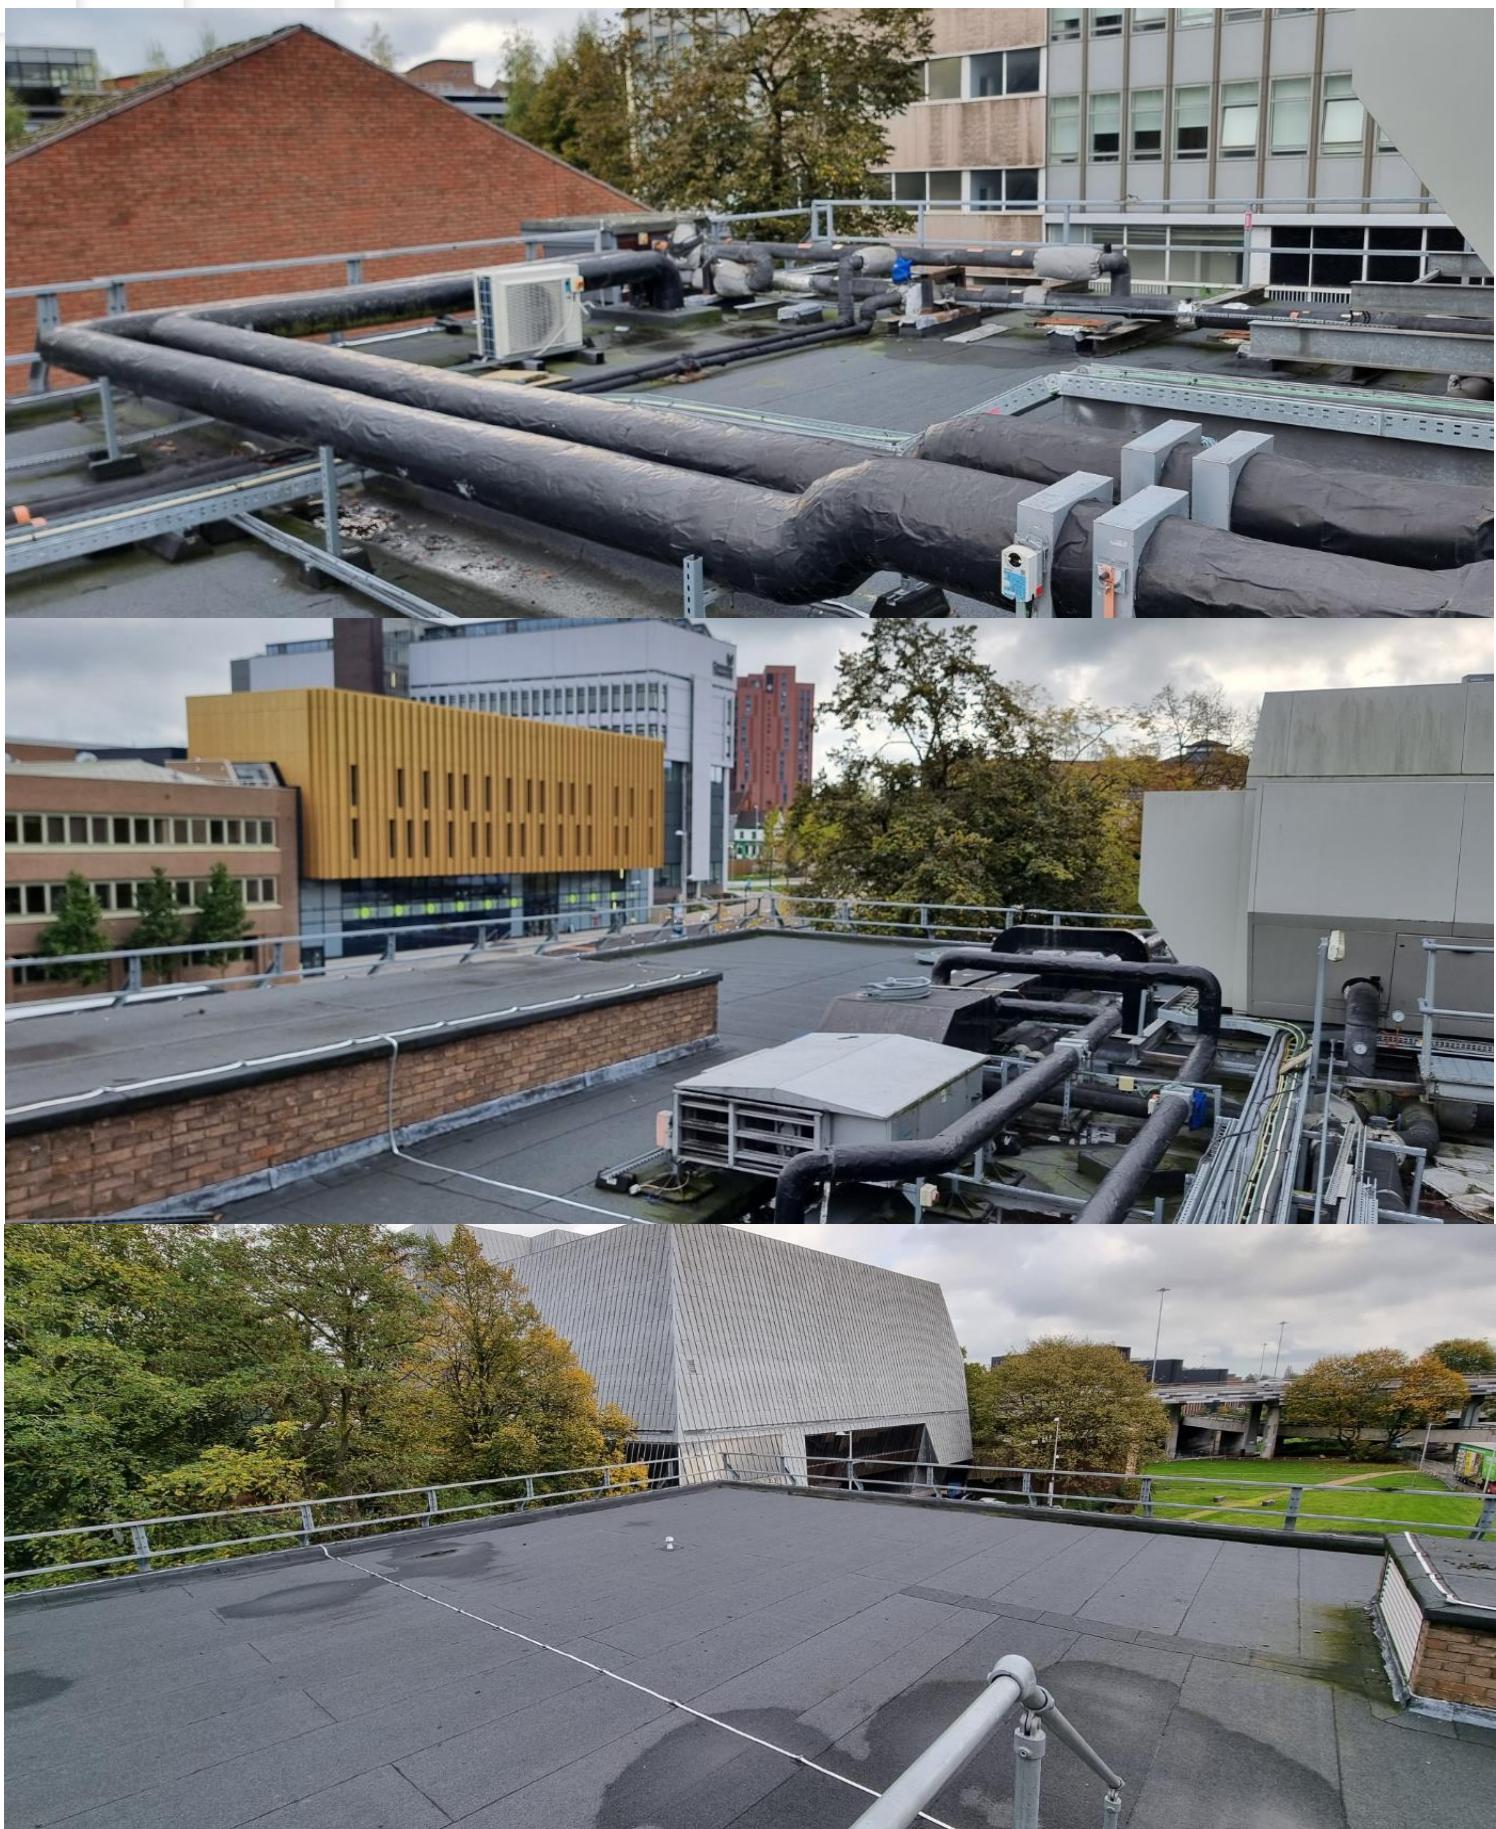
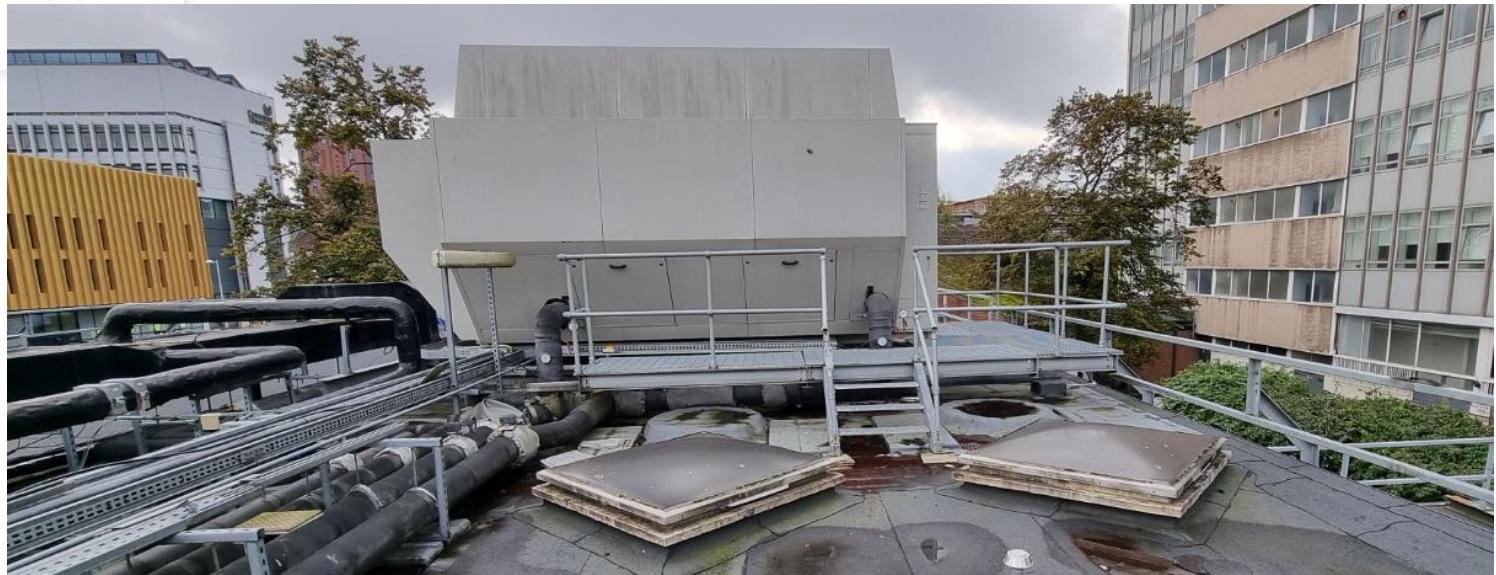
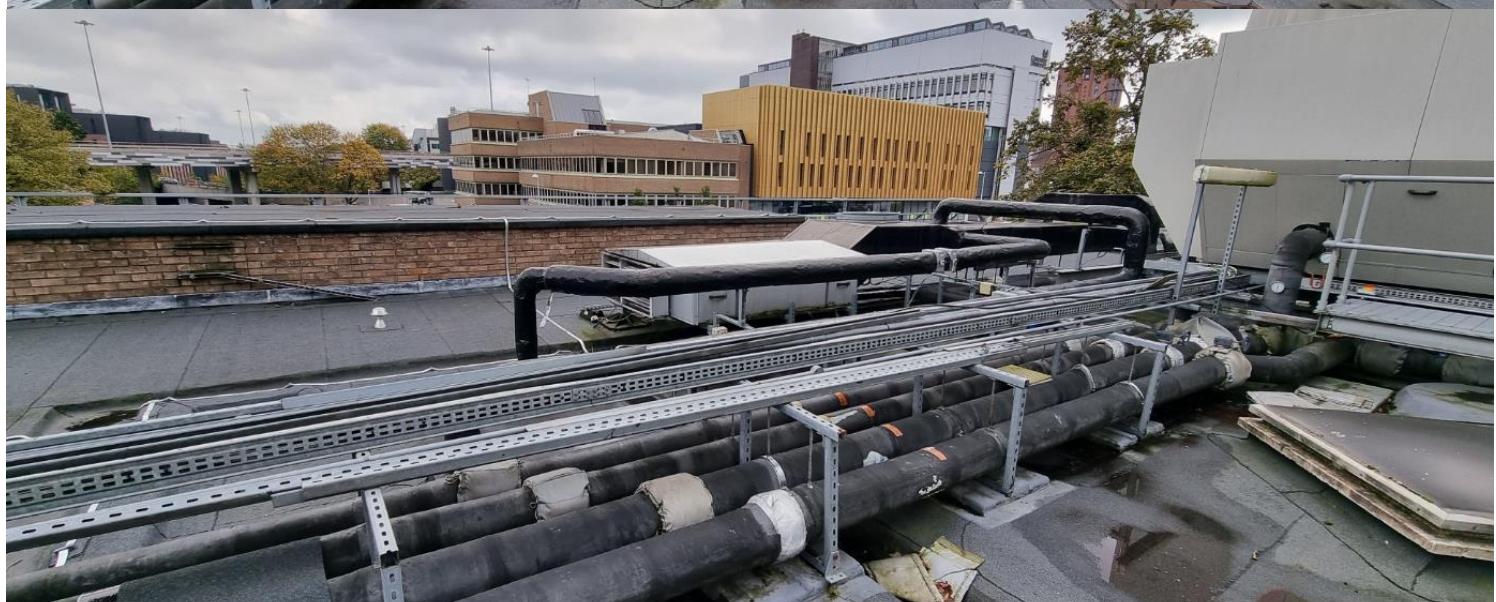
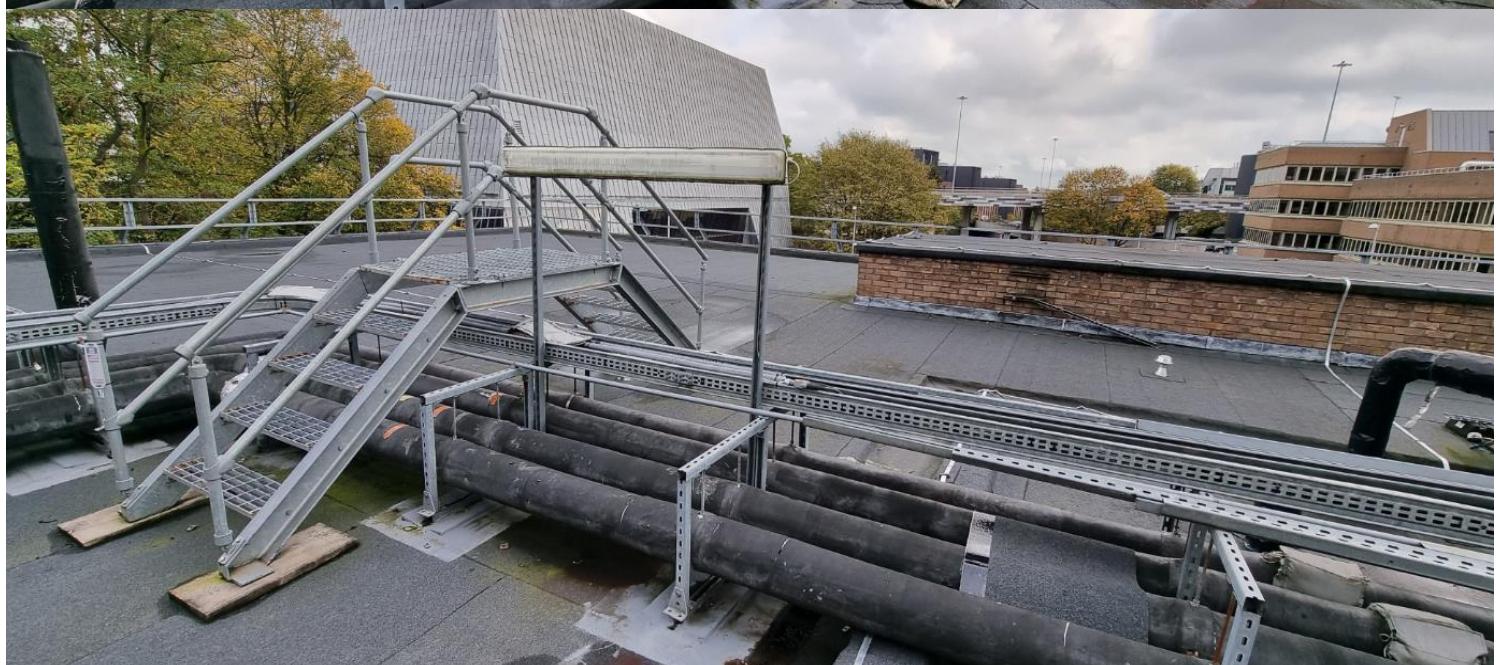
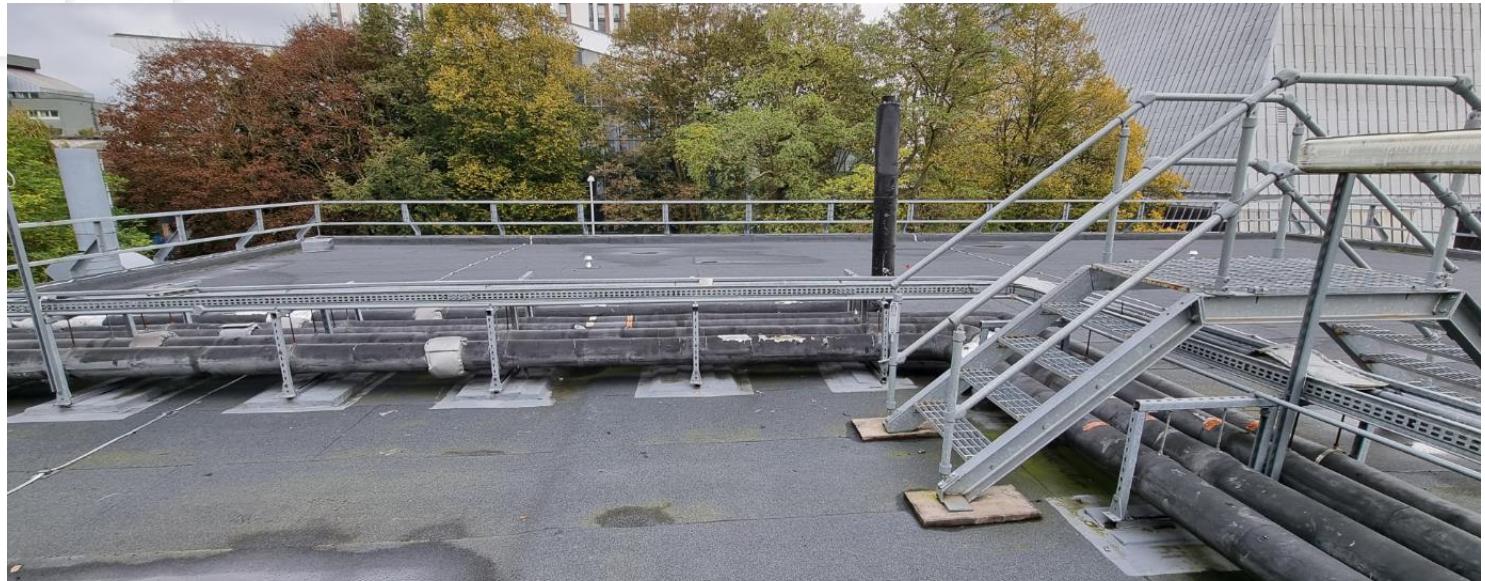
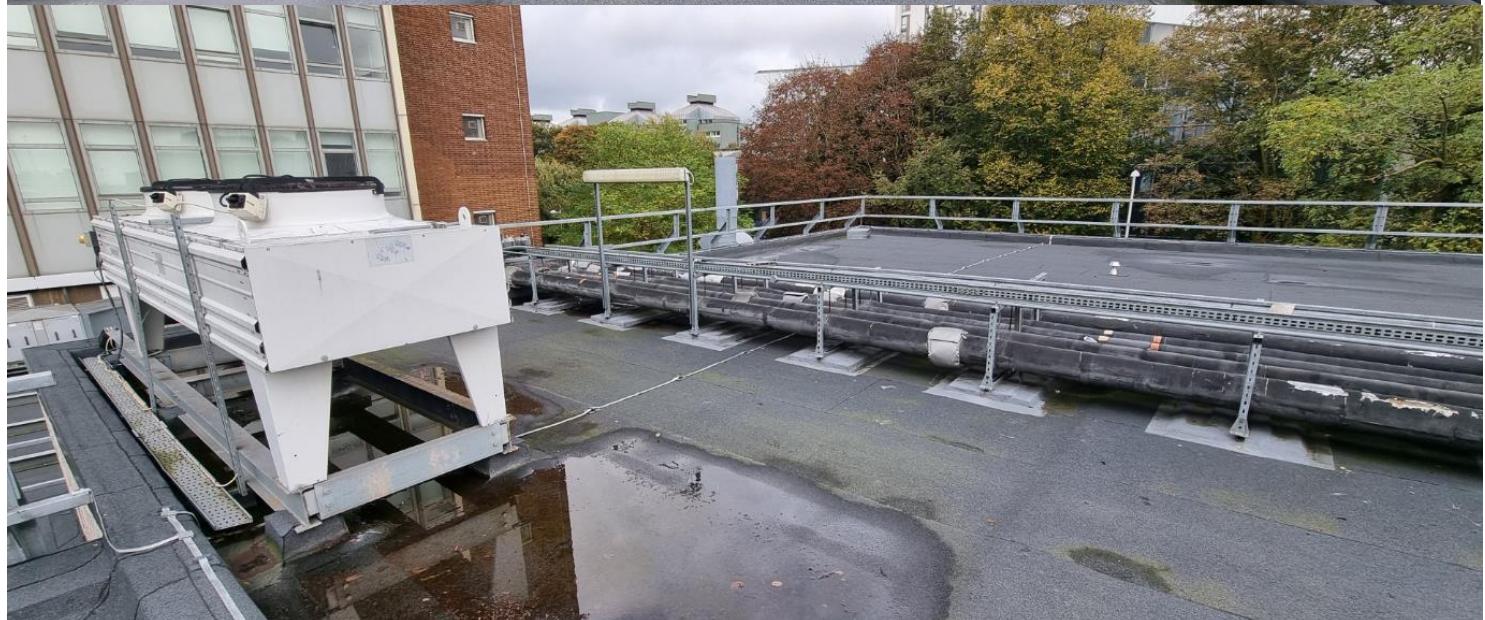
Photos – Building 1/Roof 1

Building 1/ Roof area 1		Roof height	Approx 12m		
Hatch	Door	Fixed Ladder	Temp Ladder	MEWP	Other
		X			
Access Comments					
The roof areas are accessed on a case-by-case basis by site maintenance staff and contractors. This roof area is covered by collective protection in the form of guardrail, mandatory PPE required on this roof only.					
Roof area is accessed via Fixed ladder, additional considerations are to be made regarding rescue and evacuation.					
Guardrail is not within Compliance.					
We advise no lone working on this roof.					
Tasks	Comments				
Maintenance of Air Conditioning Units	Collective protection present, although is non-compliant in regard to the current Standards. SSOW required.				
Maintenance of Air vents	Collective protection present, although is non-compliant in regard to the current Standards. SSOW required.				
Lightning Protection Maintenance	Collective protection present, although is non-compliant in regard to the current Standards. SSOW required.

Generator Maintenance	Collective protection present, although is non-compliant in regard to the current Standards. SSOW required.

Access Suggestions
A permit to work system could help control who goes on the roof area to ensure they understand the risk associated with this area and the procedures in place also to identify that the engineers/contractors are trained and competent and that their RAMS are identified and suitable for the works required of them regarding access methods/Rescue.
The Guardrail located on this roof is not fully compliant with the current British and European standards therefore this must be risk assessed prior to access.

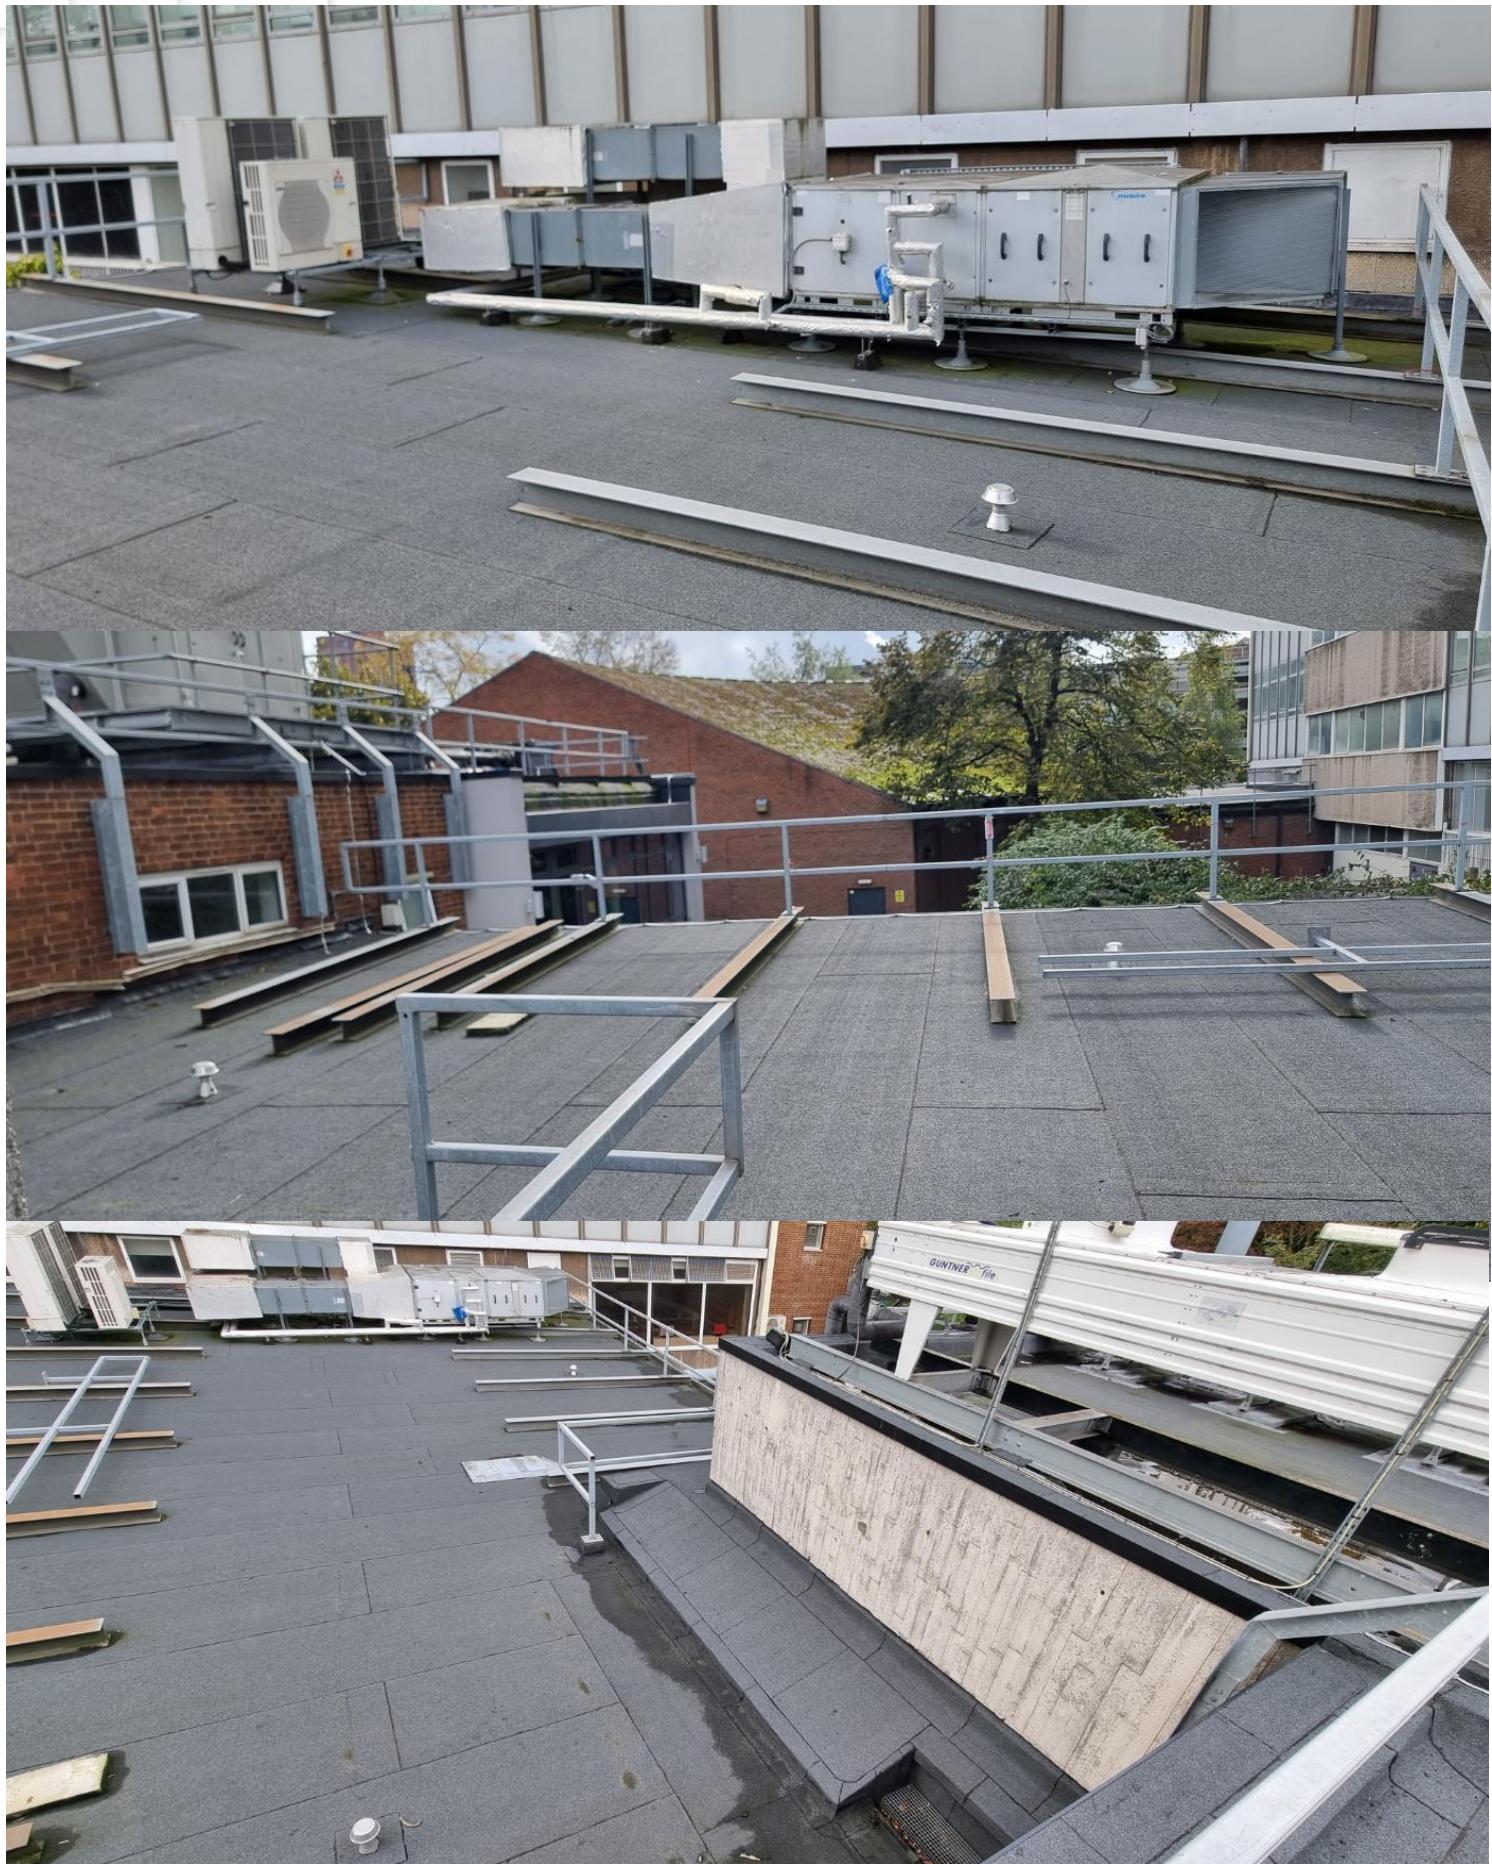
Building 1/Roof 2

Building 1/ Roof area 2		Roof height	Approx 10m		
Hatch	Door	Fixed Ladder	Temp Ladder	MEWP	Other
		X			
Access Comments					
The roof areas are accessed on a case-by-case basis by site maintenance staff and contractors. This roof area is covered by collective protection in the form of guardrail, mandatory PPE required on this roof only.					
Roof area is accessed via Fixed ladder, additional considerations are to be made regarding rescue and evacuation.					
Guardrail is not within Compliance.					
We advise no lone working on this roof.					
Tasks		Comments			
Maintenance of Air Conditioning Units		Collective protection present, although is non-compliant in regard to the current Standards. SSOW required.			
Maintenance of Air vents		Collective protection present, although is non-compliant in regard to the current Standards. SSOW required.			
Lightning Protection Maintenance		Collective protection present, although is non-compliant in regard to the current Standards. SSOW required.

Window Cleaning/Maintenance		Collective protection present, although is non-compliant in regard to the current Standards. SSOW required.

Access Suggestions
A permit to work system could help control who goes on the roof area to ensure they understand the risk associated with this area and the procedures in place also to identify that the engineers/contractors are trained and competent and that their RAMS are identified and suitable for the works required of them regarding access methods/Rescue.
The Guardrail located on this roof is not fully compliant with the current British and European standards therefore this must be risk assessed prior to access.

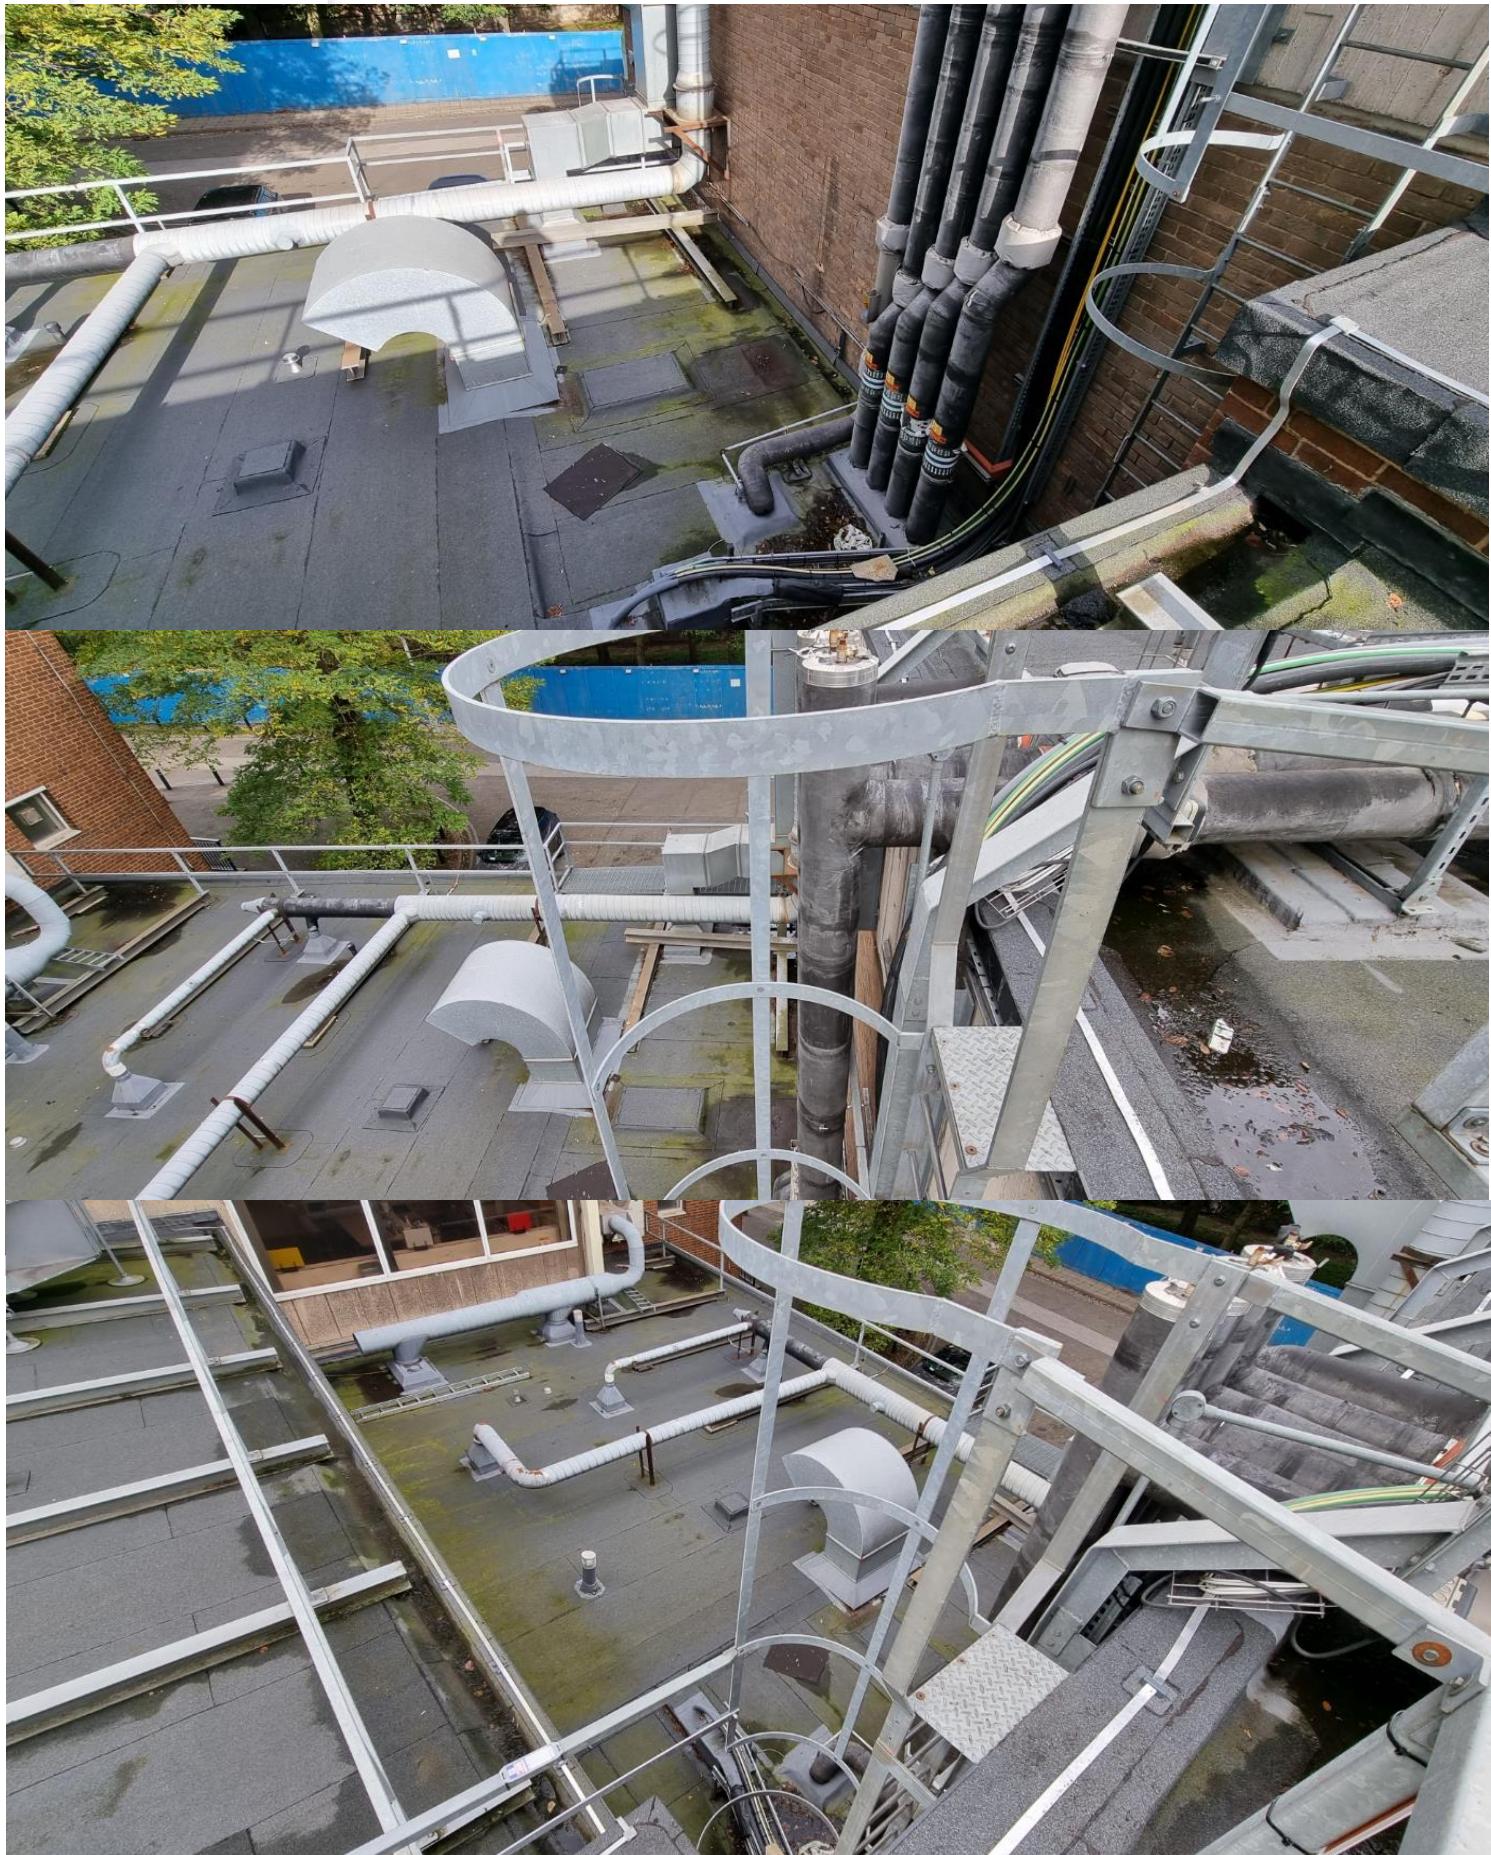
Building 1/Roof 3

Building 1/ Roof area 3		Roof height	Approx 6m		
Hatch	Door	Fixed Ladder	Temp Ladder	MEWP	Other
		X			
Access Comments					
The roof areas are accessed on a case-by-case basis by site maintenance staff and contractors. This roof area is covered by collective protection in the form of guardrail, mandatory PPE required on this roof only.					
Roof area is accessed via Fixed ladder, additional considerations are to be made regarding rescue and evacuation.					
Guardrail is not within Compliance.					
We advise no lone working on this roof.					
Tasks		Comments			
Maintenance of Air Conditioning Units		Collective protection present, although is non-compliant in regard to the current Standards. SSOW required.			
Maintenance of Air vents		Collective protection present, although is non-compliant in regard to the current Standards. SSOW required.			
Chimney Flue Maintenance		Collective protection present, although is non-compliant in regard to the current Standards. SSOW required.

Window Cleaning/Maintenance		Collective protection present, although is non-compliant in regard to the current Standards. SSOW required.

Access Suggestions
A permit to work system could help control who goes on the roof area to ensure they understand the risk associated with this area and the procedures in place also to identify that the engineers/contactors are trained and competent and that their RAMS are identified and suitable for the works required of them regarding access methods/Rescue.
The Guardrail located on this roof is not fully compliant with the current British and European standards therefore this must be risk assessed prior to access.

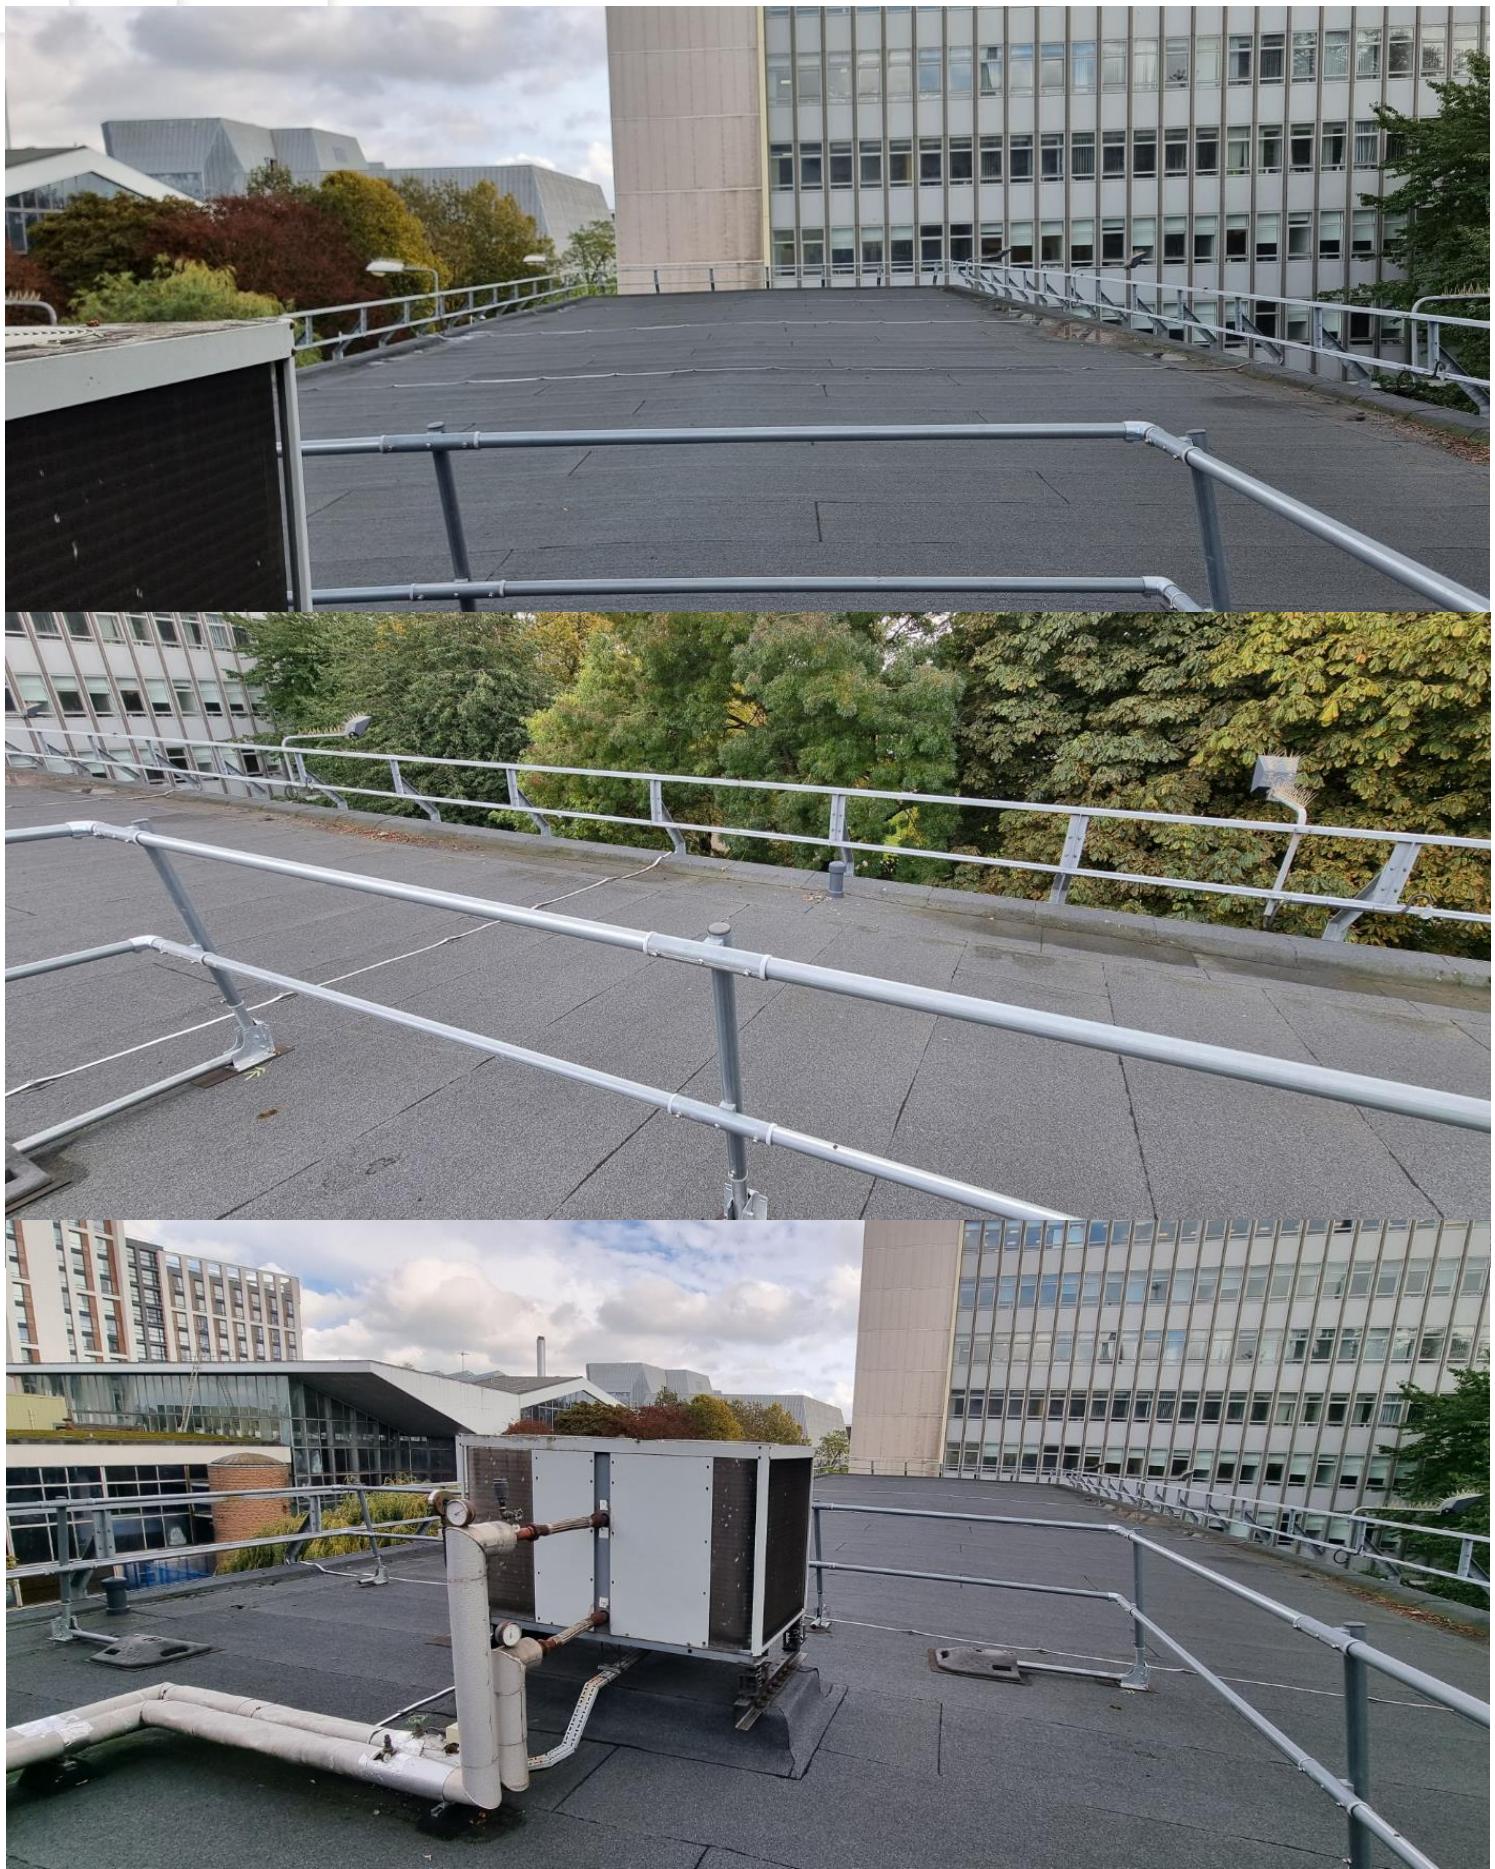
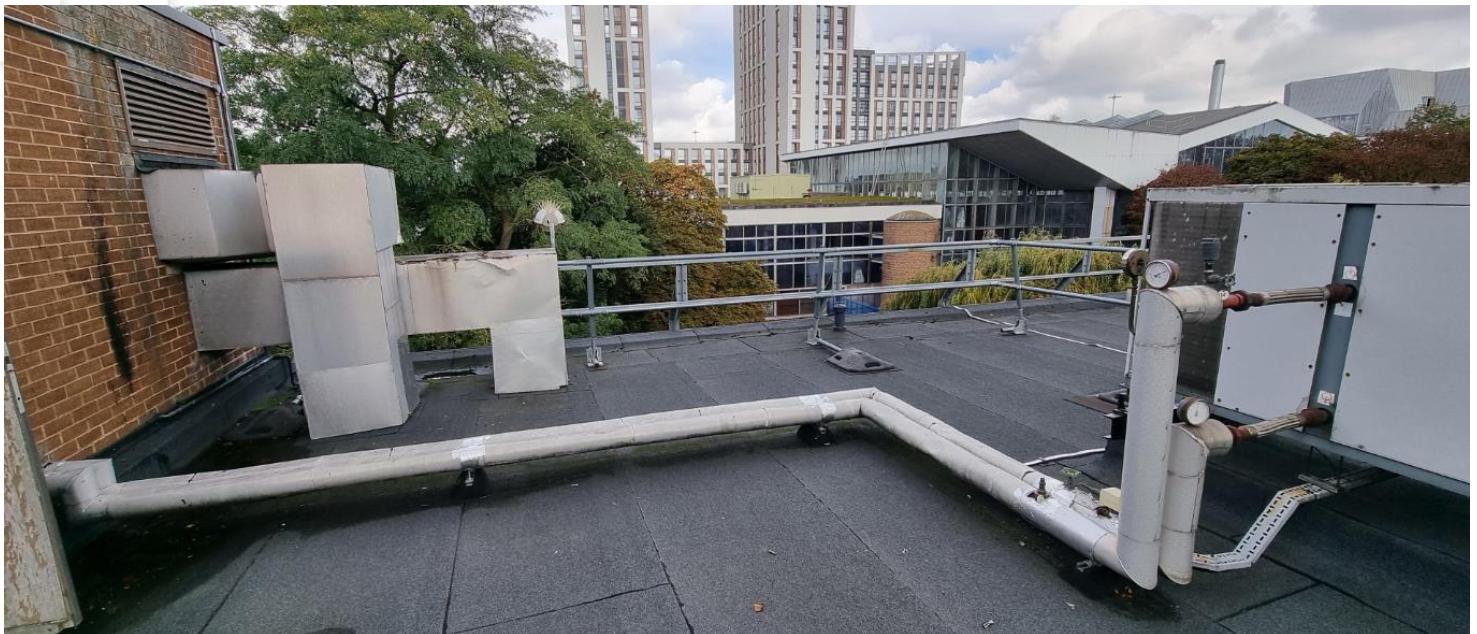
Building 2/Roof 4

Building 2/ Roof area 4		Roof height	Approx 20m						
Hatch	Door	Fixed Ladder	Temp Ladder	MEWP	Other				
	x								
Access Comments									
The roof areas are accessed on a case-by-case basis by site maintenance staff and contractors. This roof area is covered by collective protection in the form of guardrail, mandatory PPE required on this roof only.									
Roof area is accessed via Fixed ladder, additional considerations are to be made regarding rescue and evacuation.									
Guardrail GR08 is not within Compliance. Guardrail GR09 is within Compliance.									
We advise no lone working on this roof.									
Tasks		Comments							
Gutter Cleaning/Maintenance		Collective protection present, although is non-compliant in regard to the current Standards. SSOW required.							
Chimney Flue Maintenance		Collective protection present, although is non-compliant in regard to the current Standards. SSOW required.

Lightning Protection Maintenance		Collective protection present, although is non-compliant in regard to the current Standards. SSOW required.							
Air Conditioning unit Maintenance		Collective protection present, mandatory site PPE required.							
Air Ventilation Maintenance		Collective protection present, mandatory site PPE required.							
Lightning Protection Maintenance		Collective protection present, mandatory site PPE required. (Located within the confines of GR09)							
Access Suggestions									
A permit to work system could help control who goes on the roof area to ensure they understand the risk associated with this area and the procedures in place also to identify that the engineers/contactors are trained and competent and that their RAMS are identified and suitable for the works required of them regarding access methods/Rescue.									
The Guardrail located on this roof is not fully compliant with the current British and European standards therefore this must be risk assessed prior to access.

Any assets covered within the confines of GR09 can be accessed safely with mandatory PPE and basic training.
