Height Safety Asset Management Report

Site Assessment & Report

Coventry University – Delia Derbyshire, Gosford Street, Coventry, CV1 5PH

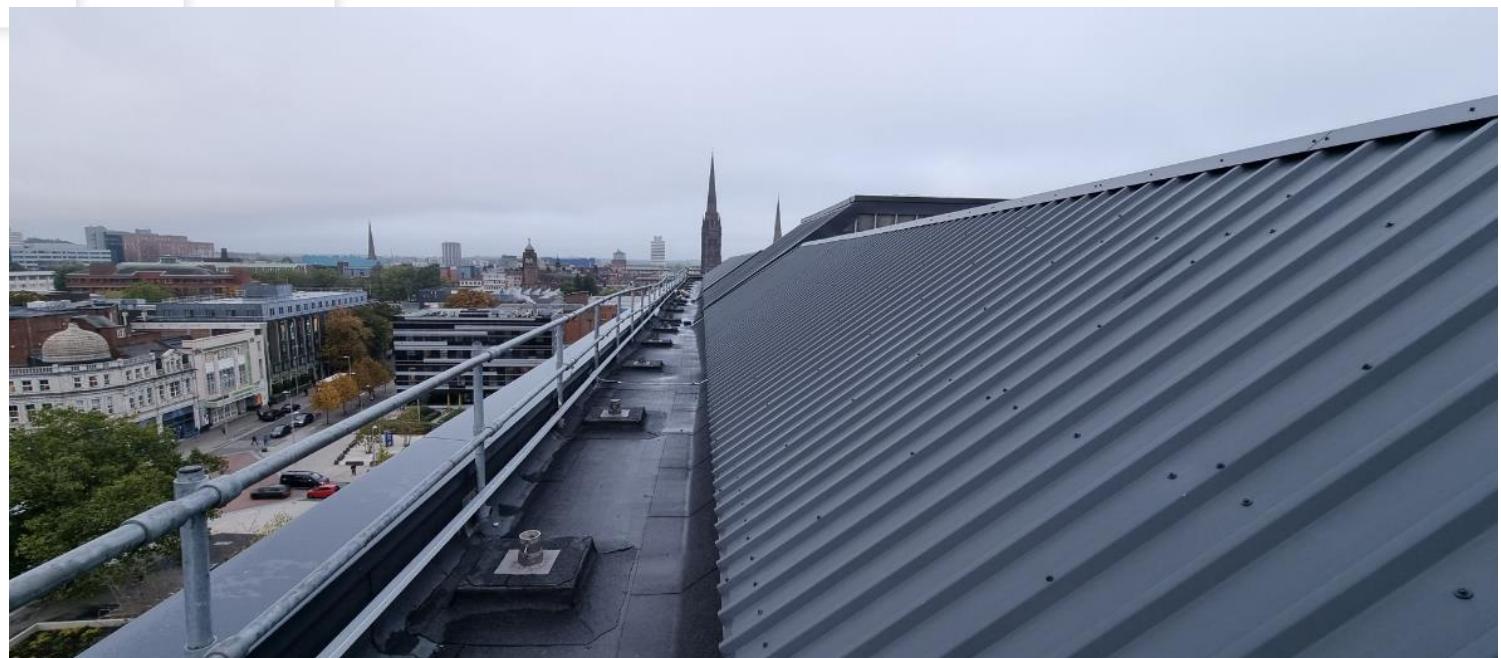
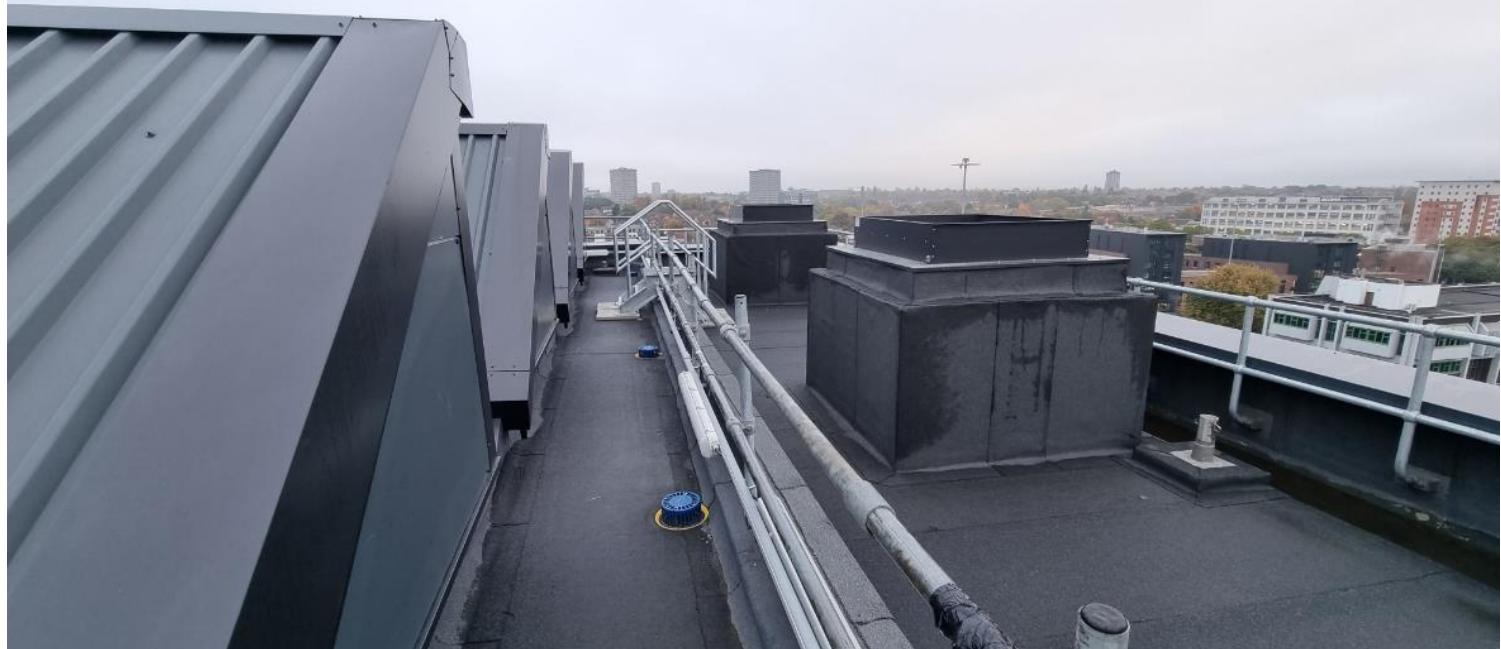
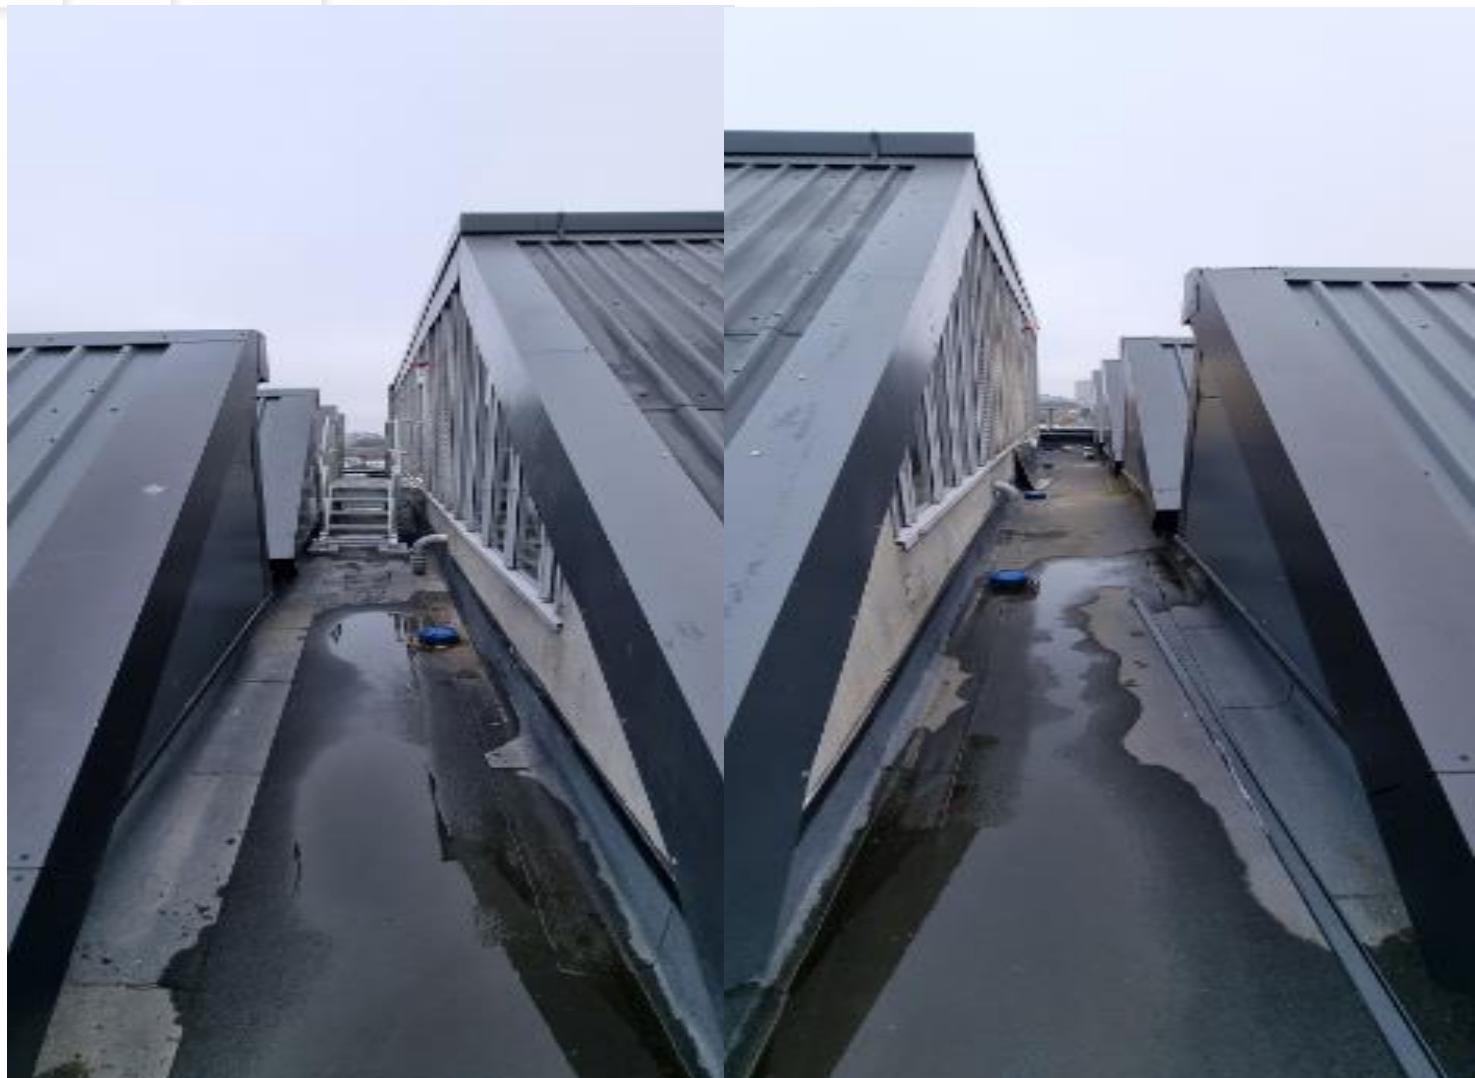
Photos – Building 1/Roof 1

Area	Building 1/Roof area 1		Roof height	Approx 50m		
Access	Hatch	Door	Fixed Ladder	Temp Ladder	MEWP	Other
Access Comments						
The roof areas are accessed on a case-by-case basis by site maintenance staff and contractors, this roof area is covered by collective protection in the form of guardrail.						
Guardrail is within compliance.						
Davit sockets are also present within the confines of the guardrail, these are not within compliance and are believed to be in situ to access the exterior windows.						
Roof area accessed by Door.						
We advise no lone working on this roof.						
Tasks	Comments					
Lightning Protection maintenance	Lightening protection is located and can be maintained from within the confines of the collective protection, Mandatory PPE required specified by Coventry University.					
Gutter Cleaning/Maintenance	Gutters are located and can be maintained from within the confines of the collective protection, Mandatory PPE required specified by Coventry University.

A permit to work system could help control who goes on the roof area to ensure they understand the risk associated with this area and the procedures in place also to identify that the engineers/contractors are trained and competent and that their RAMS are identified and suitable for the works required of them regarding access methods/Rescue.

We suggest that anyone going to the roof areas should always work in pairs in case of an emergency, This roof is covered by collective protection therefore personnel must remain within the confines of the edge protection at all times.

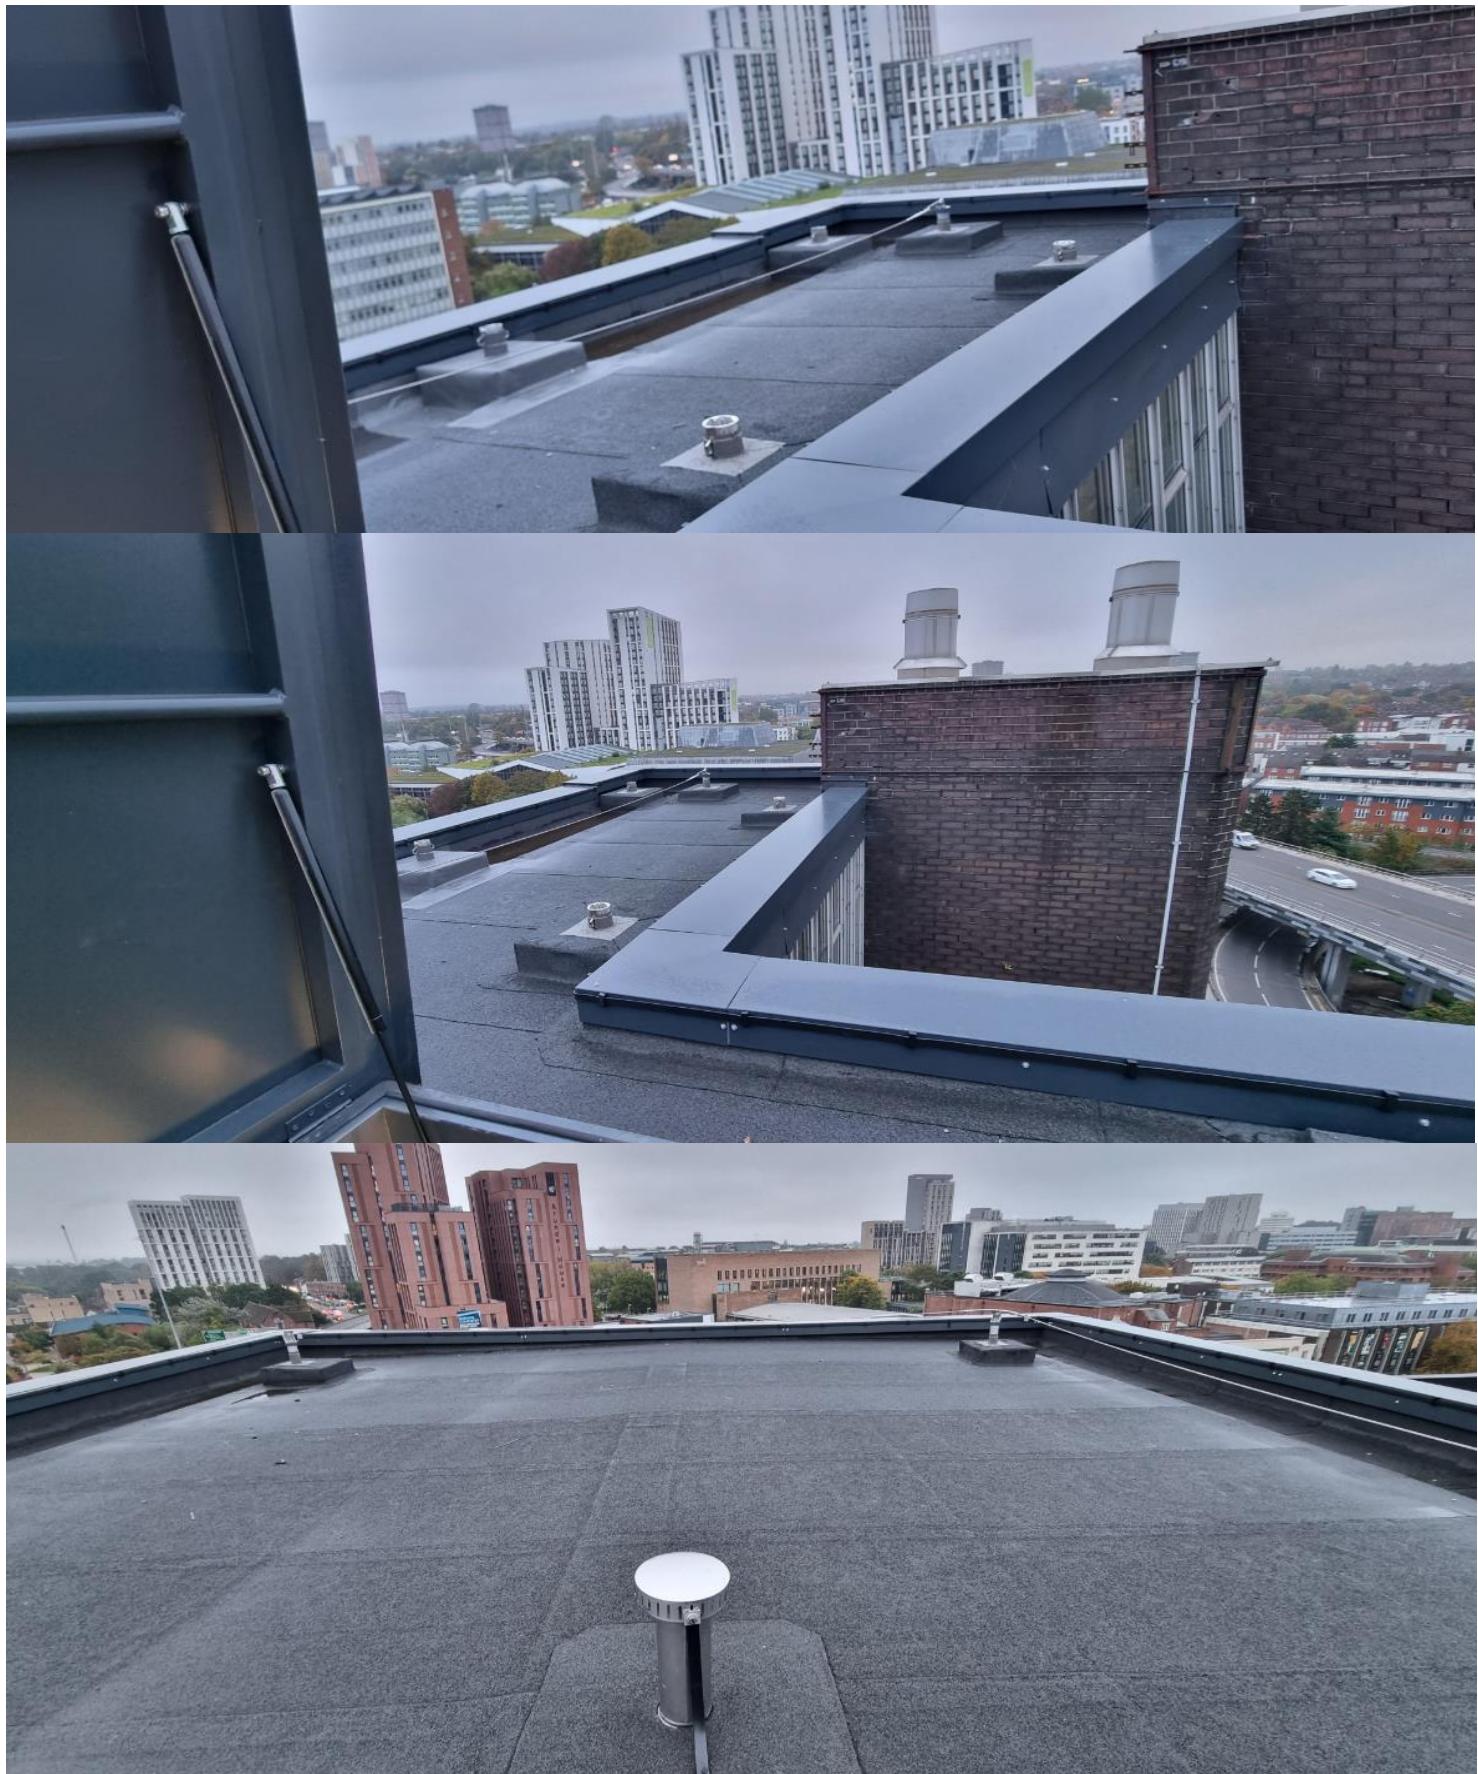
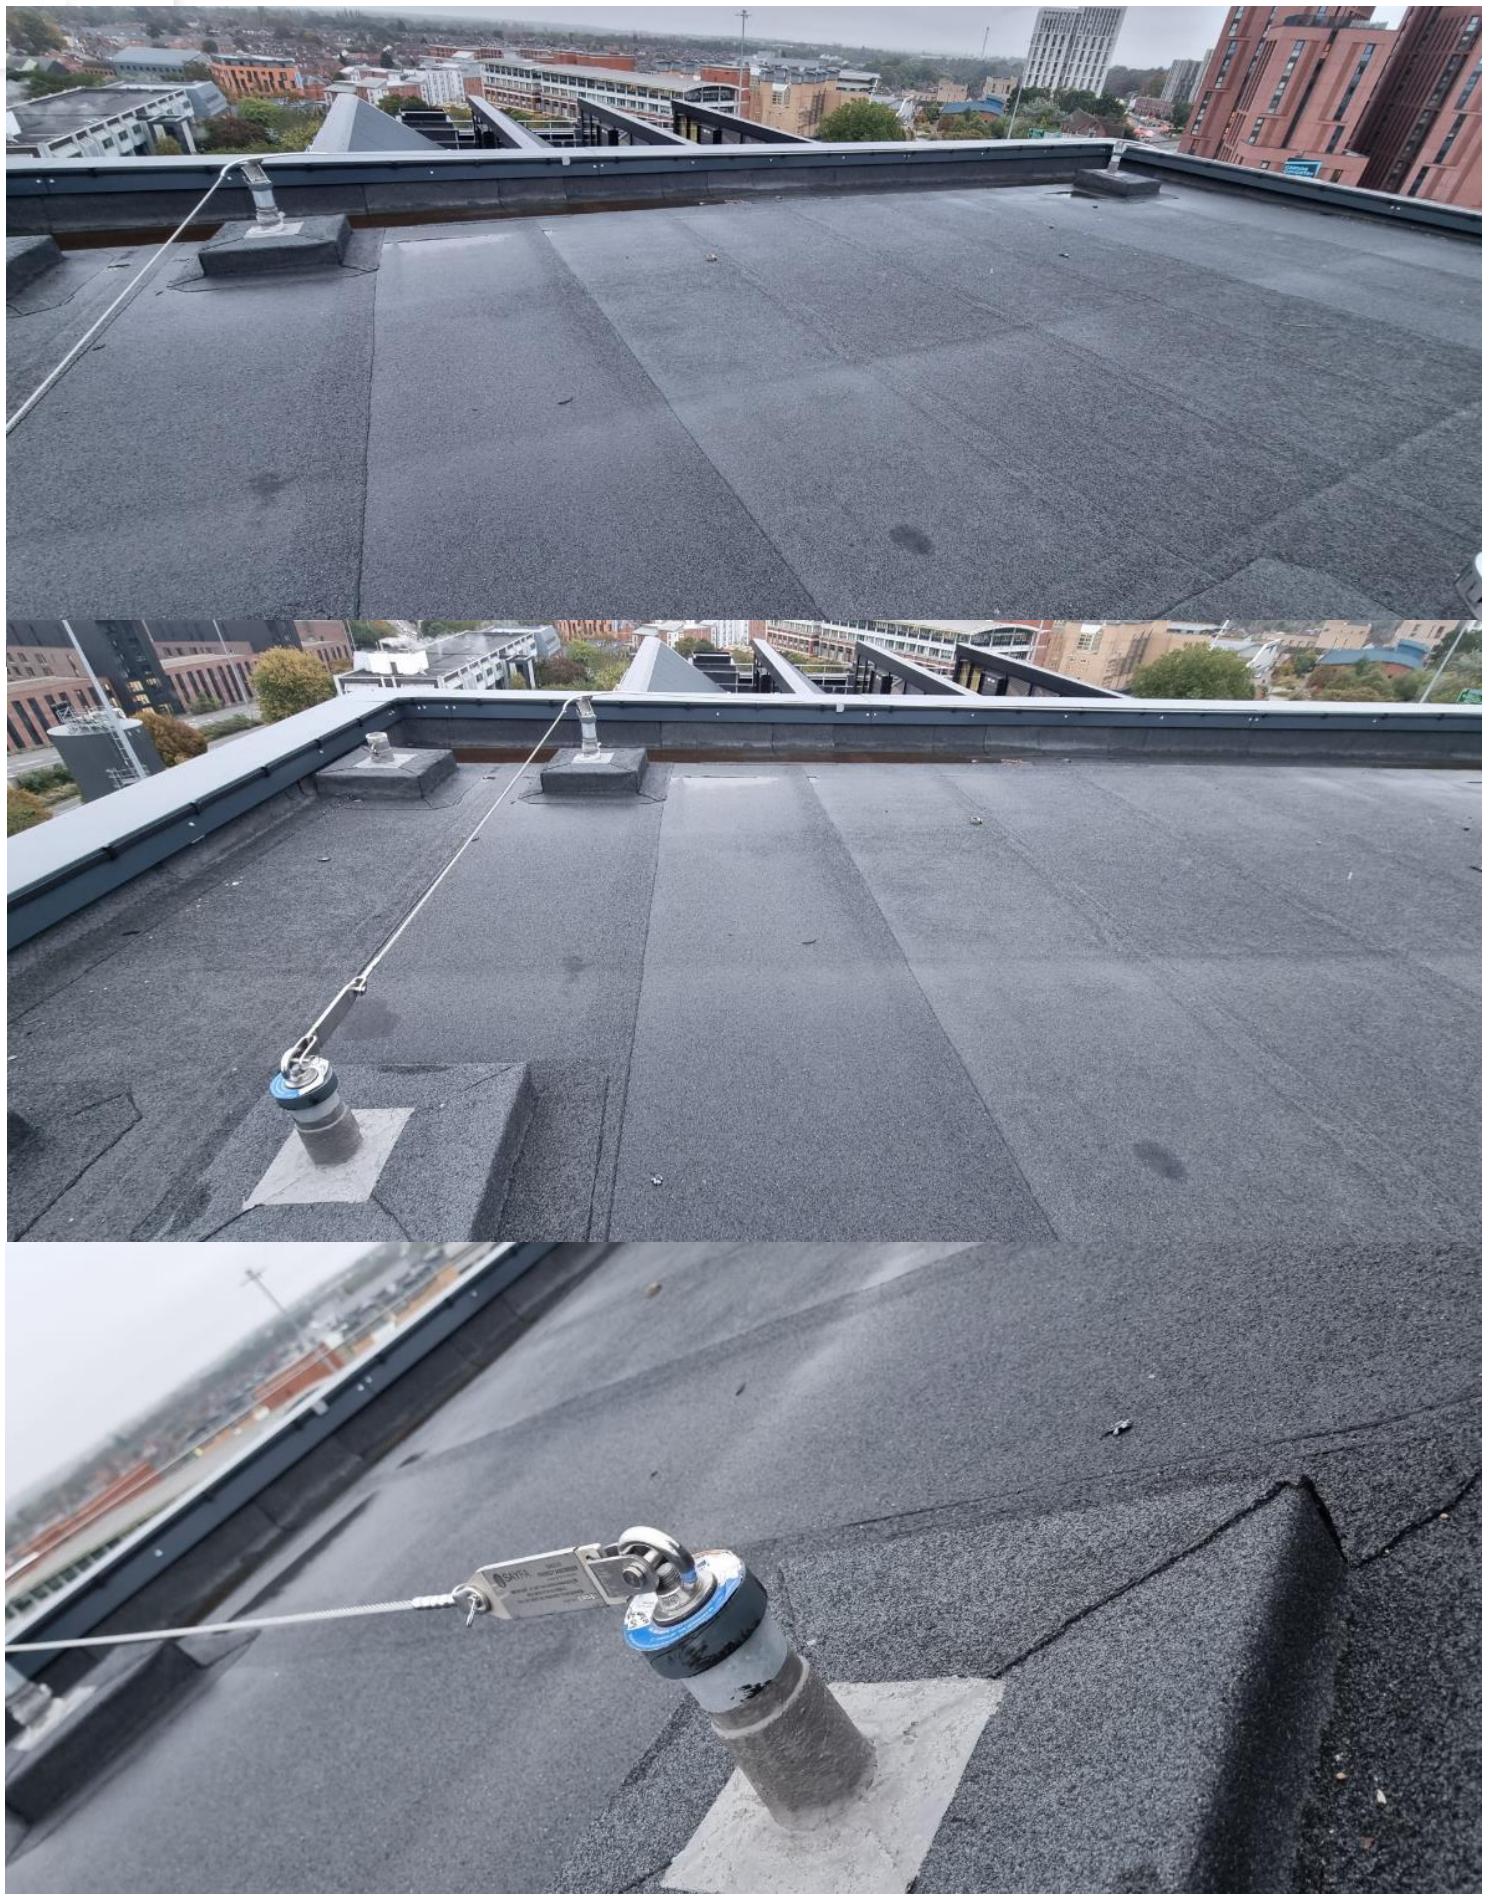
Building 1/Roof 2

The roof areas are accessed on a case-by-case basis by site maintenance staff and contractors, this roof area is covered by Fall protection in the form of a mansafe system.

Mansafe system is not within compliance.

Davit sockets are also present on this roof area, these are not within compliance and are believed to be in situ to access the exterior windows.

Specialist equipment and training is required for rope access in addition to an SSOW.

A permit to work system could help control who goes on the roof area to ensure they understand the risk associated with this area and the procedures in place also to identify that the engineers/contactors are trained and competent and that their RAMS are identified and suitable for the works required of them regarding access methods/Rescue.

We suggest that anyone going to the roof areas should always work in pairs in case of an emergency, this roof is covered by a mansafe system although the assets/tasks present require the user to have to deviate from the system using advanced work positioning techniques.

The addition of fall protection equipment would benefit here.

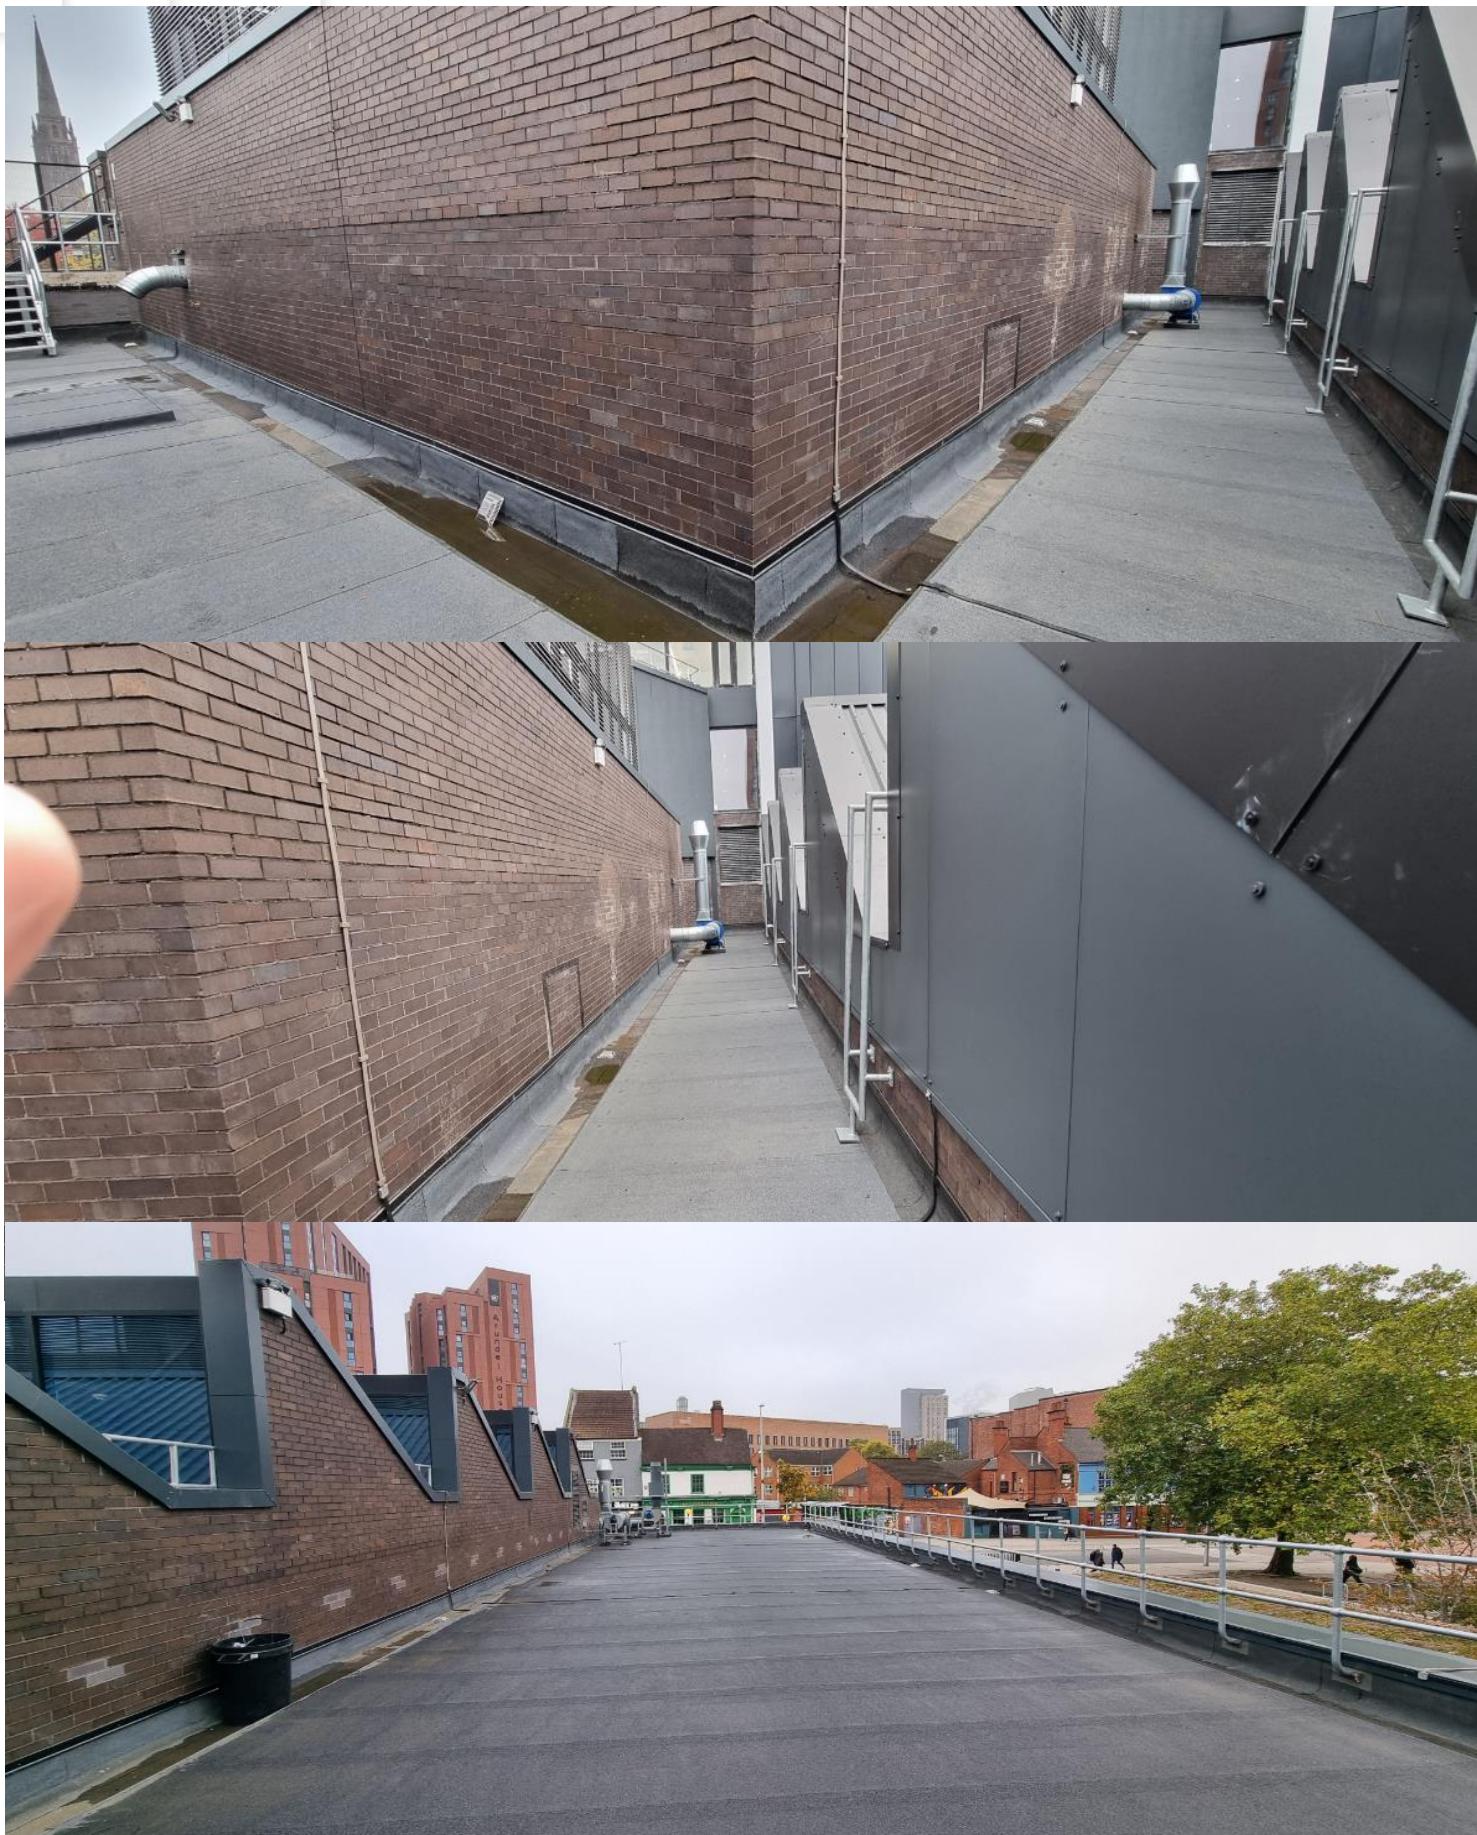
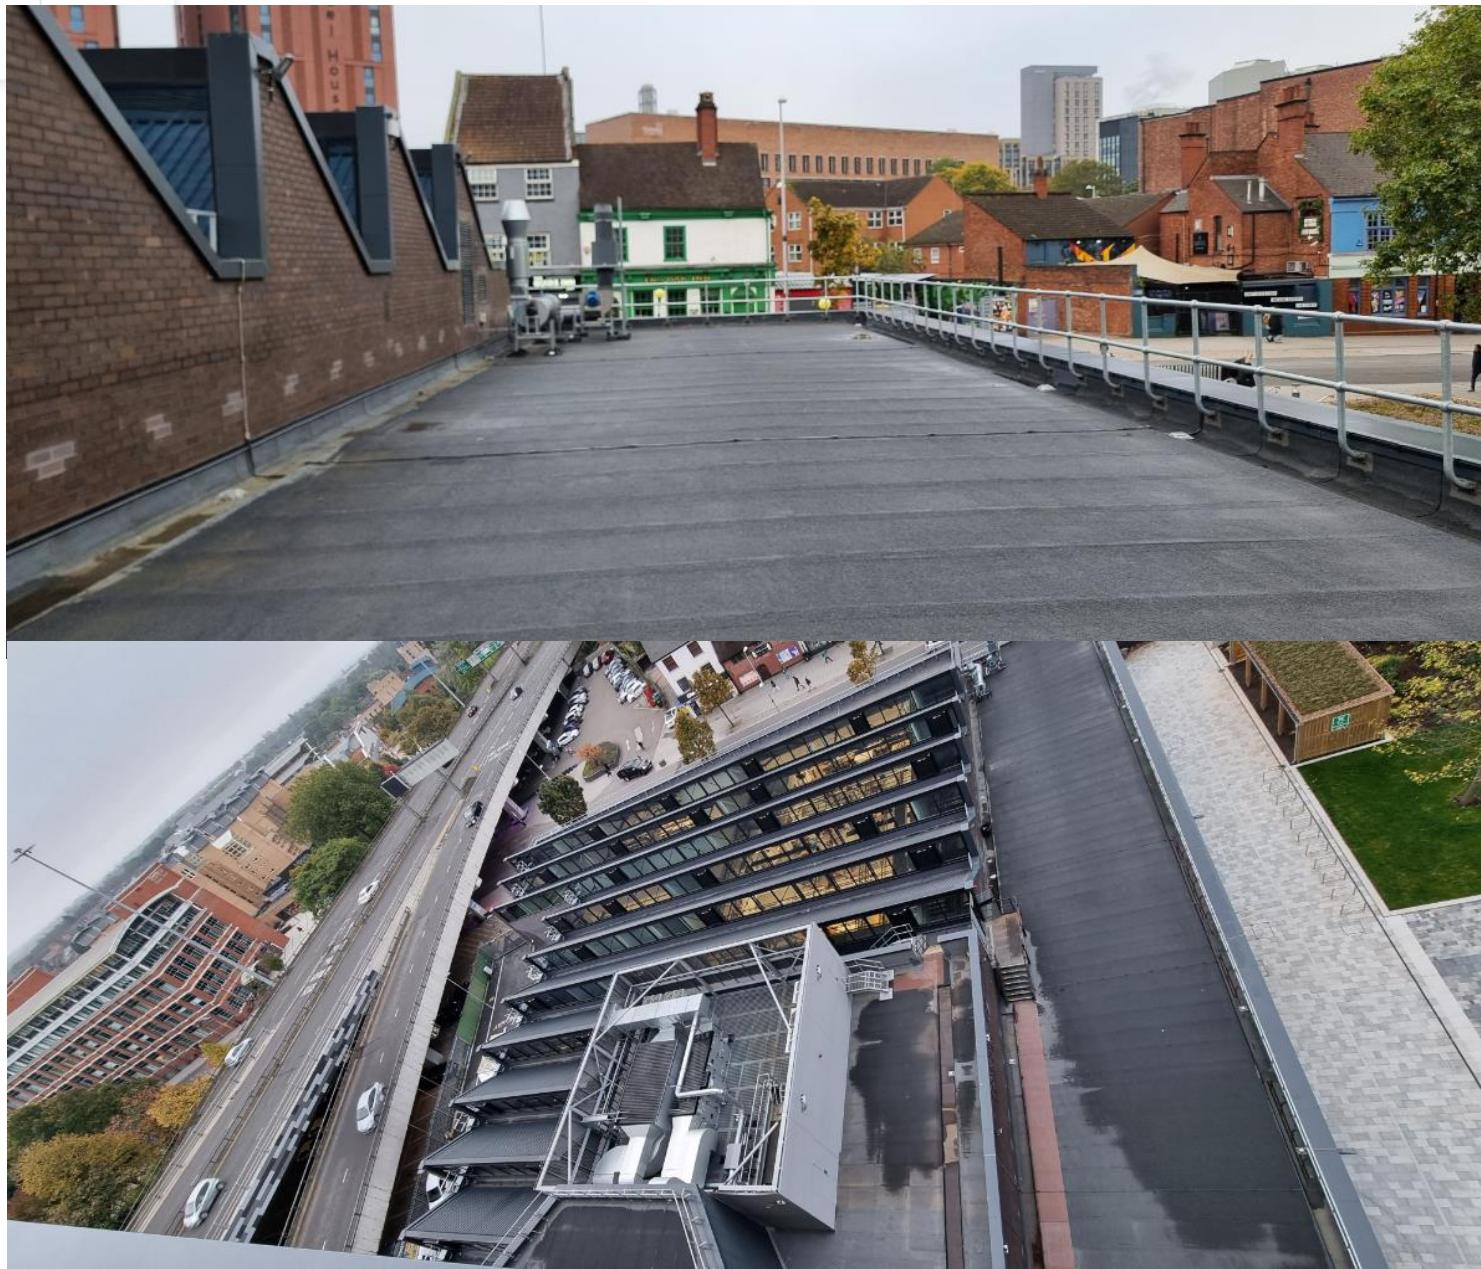
Building 1/Roof 3

The roof areas are accessed on a case-by-case basis by site maintenance staff and contractors, this roof area is covered by collective protection via parapet/Guardrail, although there may be a requirement to venture outside of the confines of the collective protection to access certain assets.

This Guardrail is not withing compliance.

A permit to work system could help control who goes on the roof area to ensure they understand the risk associated with this area and the procedures in place also to identify that the engineers/contractors are trained and competent and that their RAMS are identified and suitable for the works required of them regarding access methods/Rescue.

We suggest that anyone going to the roof areas should always work in pairs in case of an emergency, this roof area is covered by a collective protection.
