Height Safety Asset Management Report

Site Assessment & Report

Coventry University – Ellen Terry, Coventry, West midlands, CV1 5RW

Date: 20/10/2023

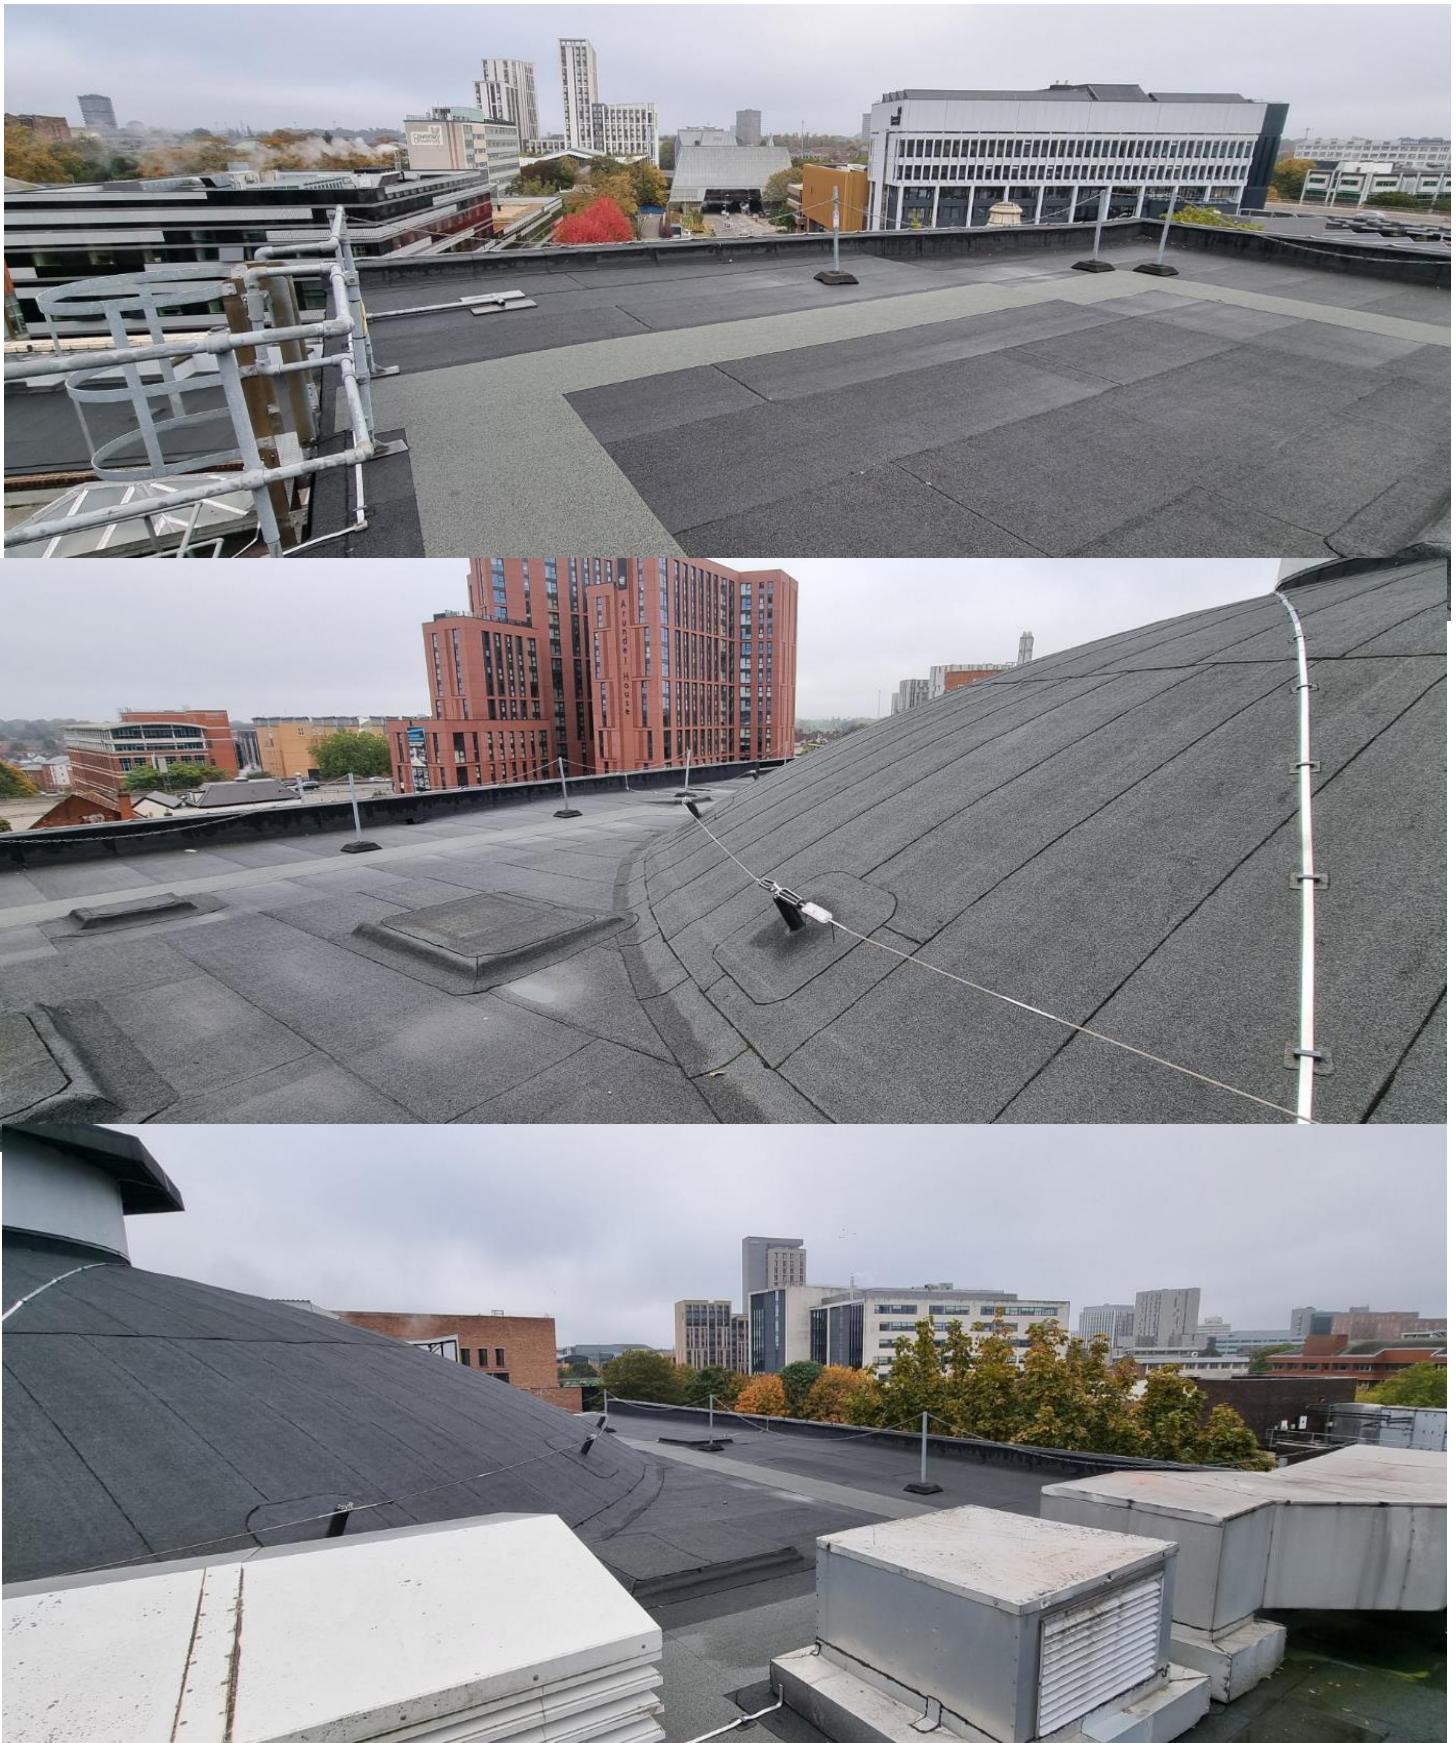
Photos Building 1/Roof 1

Area	Building 1/Roof 1		Roof height	Approx 25m								
Access	Hatch	Door	Fixed Ladder	Temp Ladder	MEWP	Other						
Access Comments												
<p>The roof areas are accessed on a case-by-case basis by site maintenance staff and contractors, this roof area is covered by collective protection and is certified and within compliance. Areas that are not covered by collective protection is covered by a mansafe system, additional training and specialized PPE should be utilized. Also, demarcation is present on this roof area, this is not a form of fall protection and should not be considered as such, this is to highlight a collective walking route, this should be highlighted in risk assessment and should be adhered to.</p>												
Roof area accessed via fixed ladder; additional considerations should be made in regard to rescue.												
We advise no lone working on this roof with consideration towards evacuation.

Tasks	Comments											
Gutter Maintenance	Gutters are located within the confines of the collective protection; these are to be maintained whilst staying in the confines of the collective protection.											
Lightning Protection Maintenance	Lightning are both located within the confines of the collective protection and outside, should maintenance be required on those that are located outside the boundaries of the collective protection then an SSOW, use of existing mansafe systems, training and additional equipment/work positioning is required.											
Air Vent Maintenance	Air vents are located within the confines of the collective protection, these are to be maintained whilst staying in the confines of the collective protection.											
Access Suggestions												
<p>A permit to work system could help control who goes on the roof area to ensure they understand the risk associated with this area and the procedures in place also to identify that the engineers/contractors are trained and competent and that their RAMS are identified and suitable for the works required of them regarding access methods/Rescue.</p>

We suggest that anyone going to the roof areas should always work in pairs in case of an emergency, especially with the requirement to use the existing mansafe systems and the potential to have to utilize work positioning to access the lightning protection that is located outside of the boundaries of the collective protection.

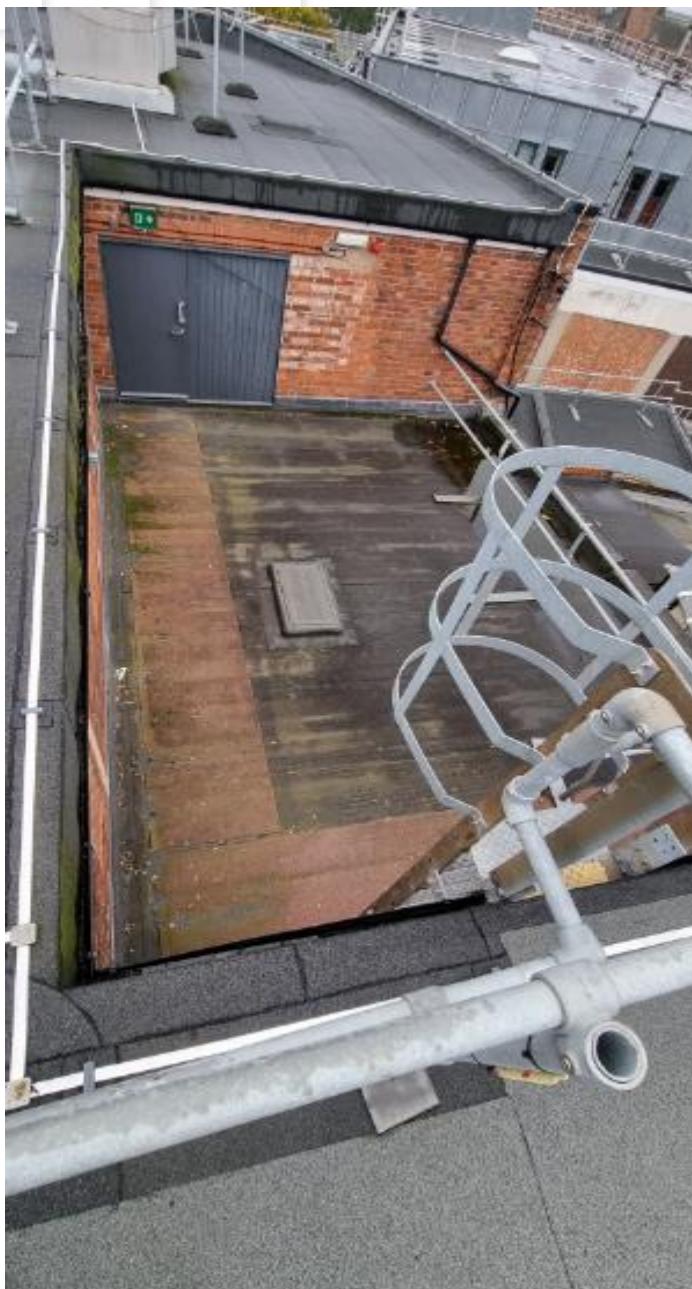
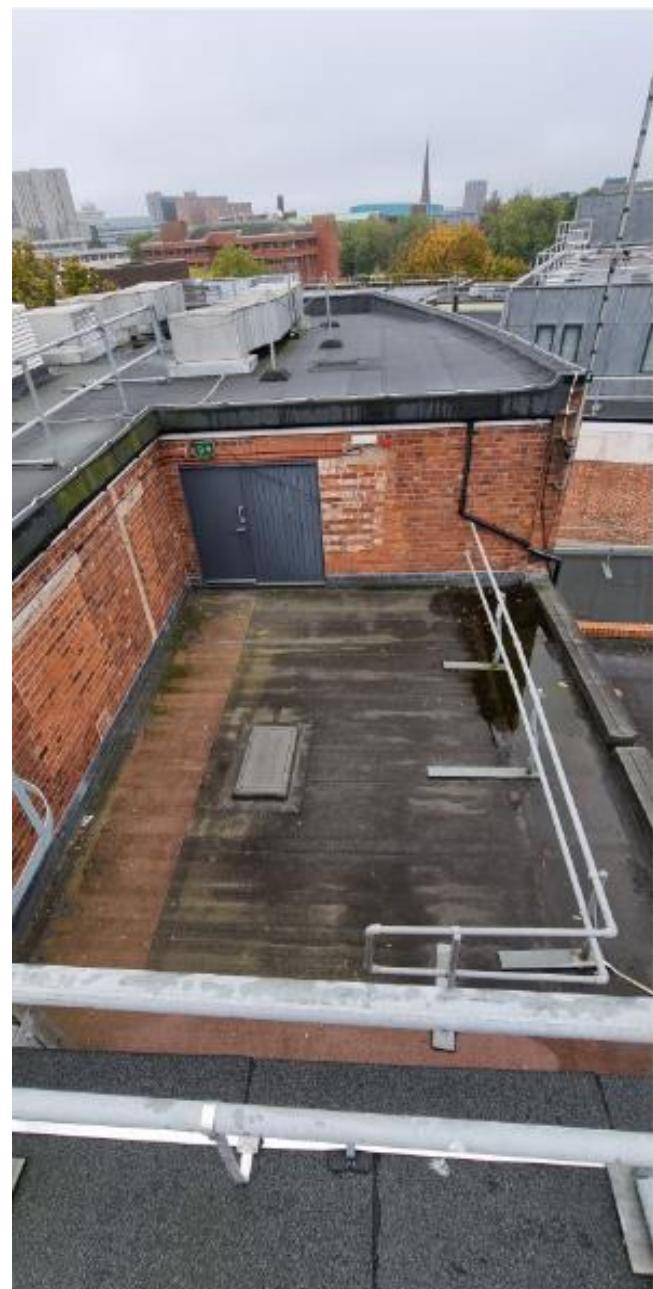
Area	Building 1/Roof 2		Roof height	Approx 20m		
Access	Hatch	Door	Fixed Ladder	Temp Ladder	MEWP	Other
		X				
Access Comments						
<p>The roof areas are accessed on a case-by-case basis by site maintenance staff and contractors, this roof area is covered by collective protection and is certified and within compliance.</p> <p>Roof area accessed via door.</p> <p>We advise no lone working on this roof with consideration towards evacuation.</p>						
Tasks	Comments					
N/A	No additional assets located on this roof area.					
Access Suggestions						
<p>A permit to work system could help control who goes on the roof area to ensure they understand the risk associated with this area and the procedures in place also to identify that the engineers/contractors are trained and competent and that their RAMS are identified and suitable for the works required of them regarding access methods/Rescue.</p> <p>We suggest that anyone going to the roof areas should always work in pairs in case of an emergency, this roof area is covered by collective protection, mandatory site PPE as specified by Coventry University required.</p>

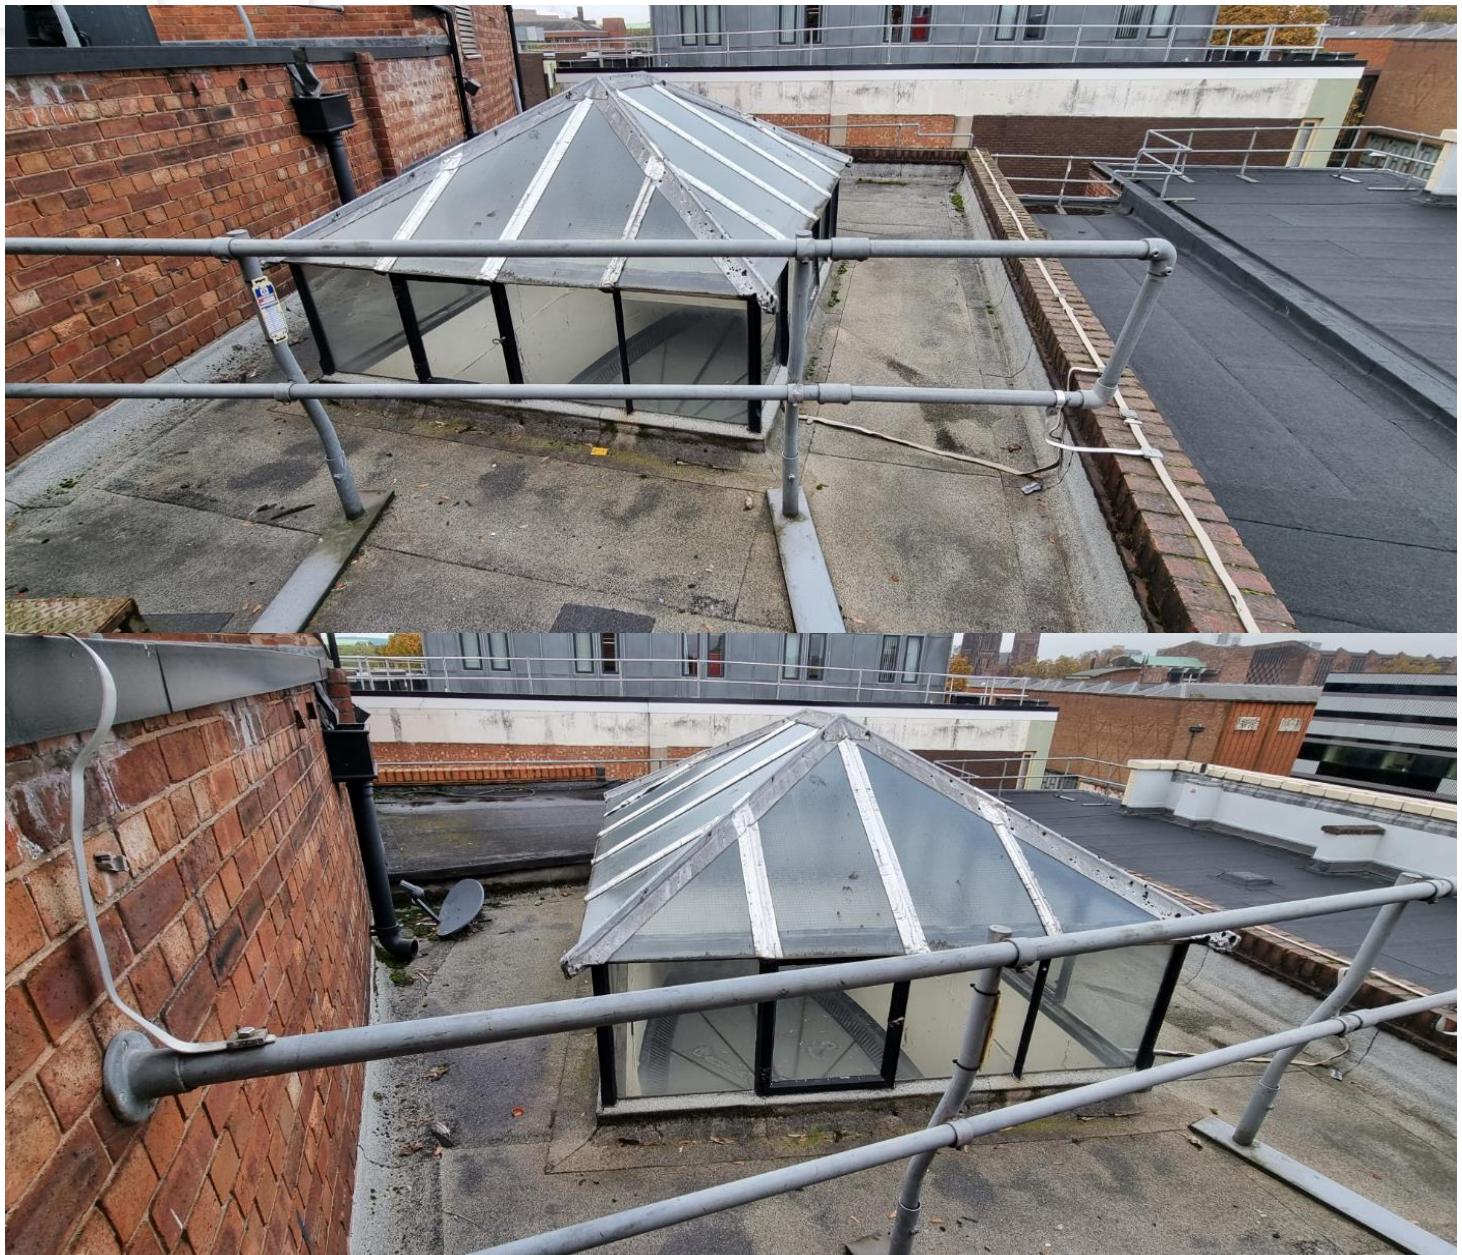
Area	Building 1/Roof 3			Roof height	Approx 20m	
Access	Hatch	Door	Fixed Ladder	Temp Ladder	MEWP	Other
Access Comments						
<p>The roof areas are accessed on a case-by-case basis by site maintenance staff and contractors, this roof area is covered by collective protection and is certified and within compliance. This roof area also has assets located outside the confines of the collective protection, should access to these be required an SSOW will be required as there is no fall protection present.</p>						
<p>Roof area accessed via fixed ladder; additional considerations are to be taken in regards to rescue.</p>						
<p>We advise no lone working on this roof with consideration towards evacuation.</p>						
Tasks	Comments					
Lightning Protection Maintenance	<p>Lightening protection is located within the confines of the collective protection and runs outside of it also, these are to be maintained whilst staying in the confines of the collective protection where possible, otherwise SSOW and additional training/equipment is required.</p>

Window Cleaning	<p>Windows are located outside the confines of the collective protection although could be cleaned from within with the use of suitable equipment.</p>

Roof area 3 is mainly covered by collective protection, although to fully maintain the lightening protection personnel must step out of the collective areas. Due to this an SSOW will be required.

Access Suggestions
<p>A permit to work system could help control who goes on the roof area to ensure they understand the risk associated with this area and the procedures in place also to identify that the engineers/contractors are trained and competent and that their RAMS are identified and suitable for the works required of them regarding access methods/Rescue.</p>
<p>We suggest that anyone going to the roof areas should always work in pairs in case of an emergency, this roof area is covered by collective protection for the most part mandatory site PPE as specified by Coventry University required.</p>
<p>Any requirement to move outside of the collective protection, SSOW, training and additional PPE will be required.</p>

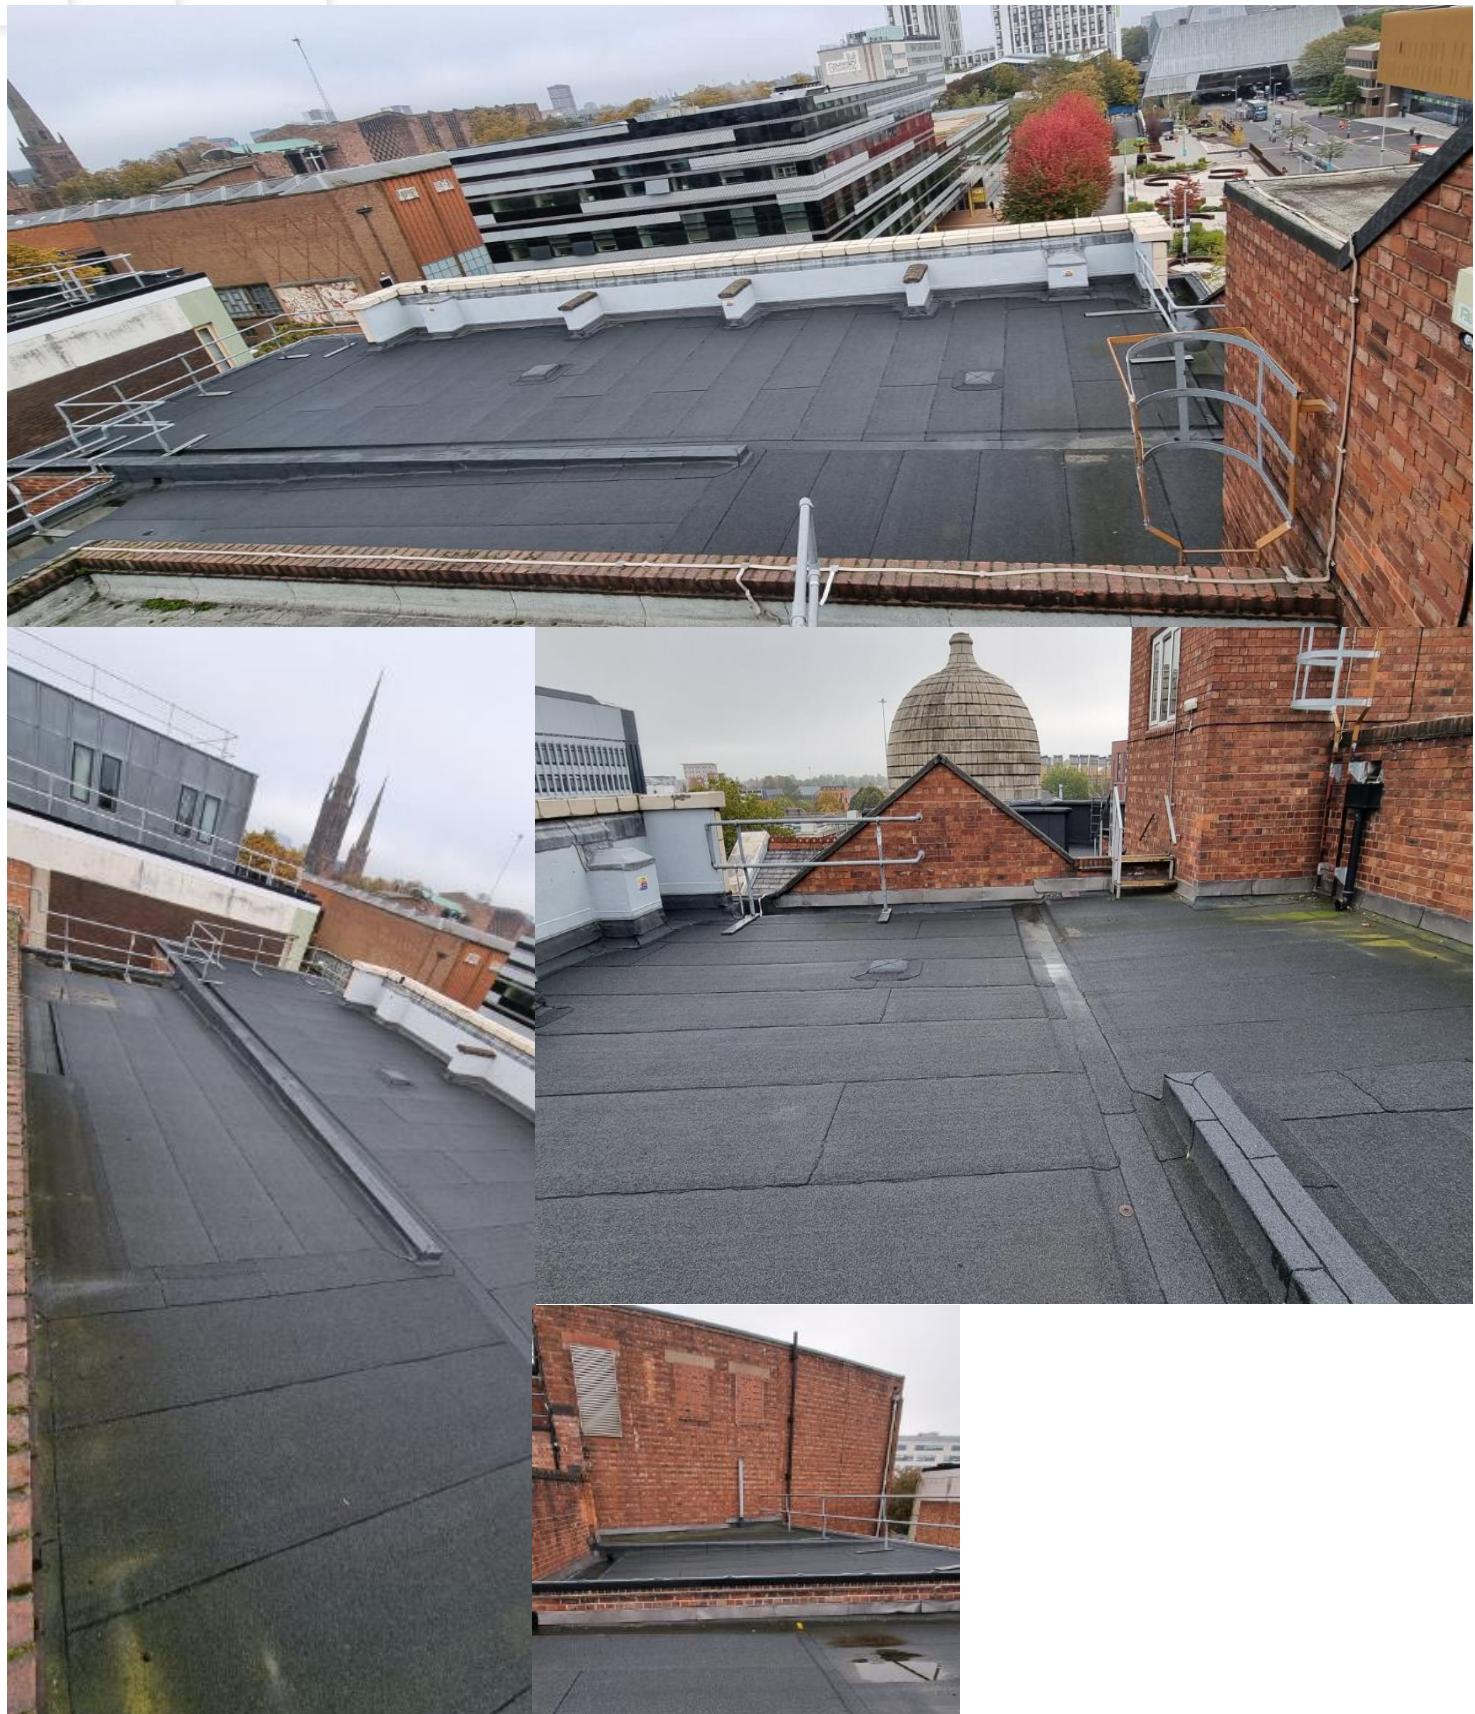
Area	Building 1/Roof 4		Roof height	Approx 18m		
Access	Hatch	Door	Fixed Ladder	Temp Ladder	MEWP	Other
Access Comments						
The roof areas are accessed on a case-by-case basis by site maintenance staff and contractors, this roof area is covered by collective protection and is certified and within compliance.						
Roof area accessed via fixed ladder; additional considerations are to be taken in regards to rescue.						
We advise no lone working on this roof with consideration towards evacuation.						
Tasks	Comments					
Lightning Protection Maintenance	Lightening protection is located within the confines of the collective protection; these are to be maintained whilst staying in the confines of the collective protection.					
Gutter Maintenance	Gutters are located within the confines of the collective protection; these are to be maintained whilst staying in the confines of the collective protection.

Access Suggestions
A permit to work system could help control who goes on the roof area to ensure they understand the risk associated with this area and the procedures in place also to identify that the engineers/contractors are trained and competent and that their RAMS are identified and suitable for the works required of them regarding access methods/Rescue.
We suggest that anyone going to the roof areas should always work in pairs in case of an emergency, this roof area is covered by collective protection for the most part mandatory site PPE as specified by Coventry University required.
