Height Safety Asset Management Report

Site Assessment & Report

Coventry University – Engineering and Computing building (Frank Whittle Building) – 3 Gulson Road,
Coventry, CV1 2JH

Surveyed on behalf of Coventry University

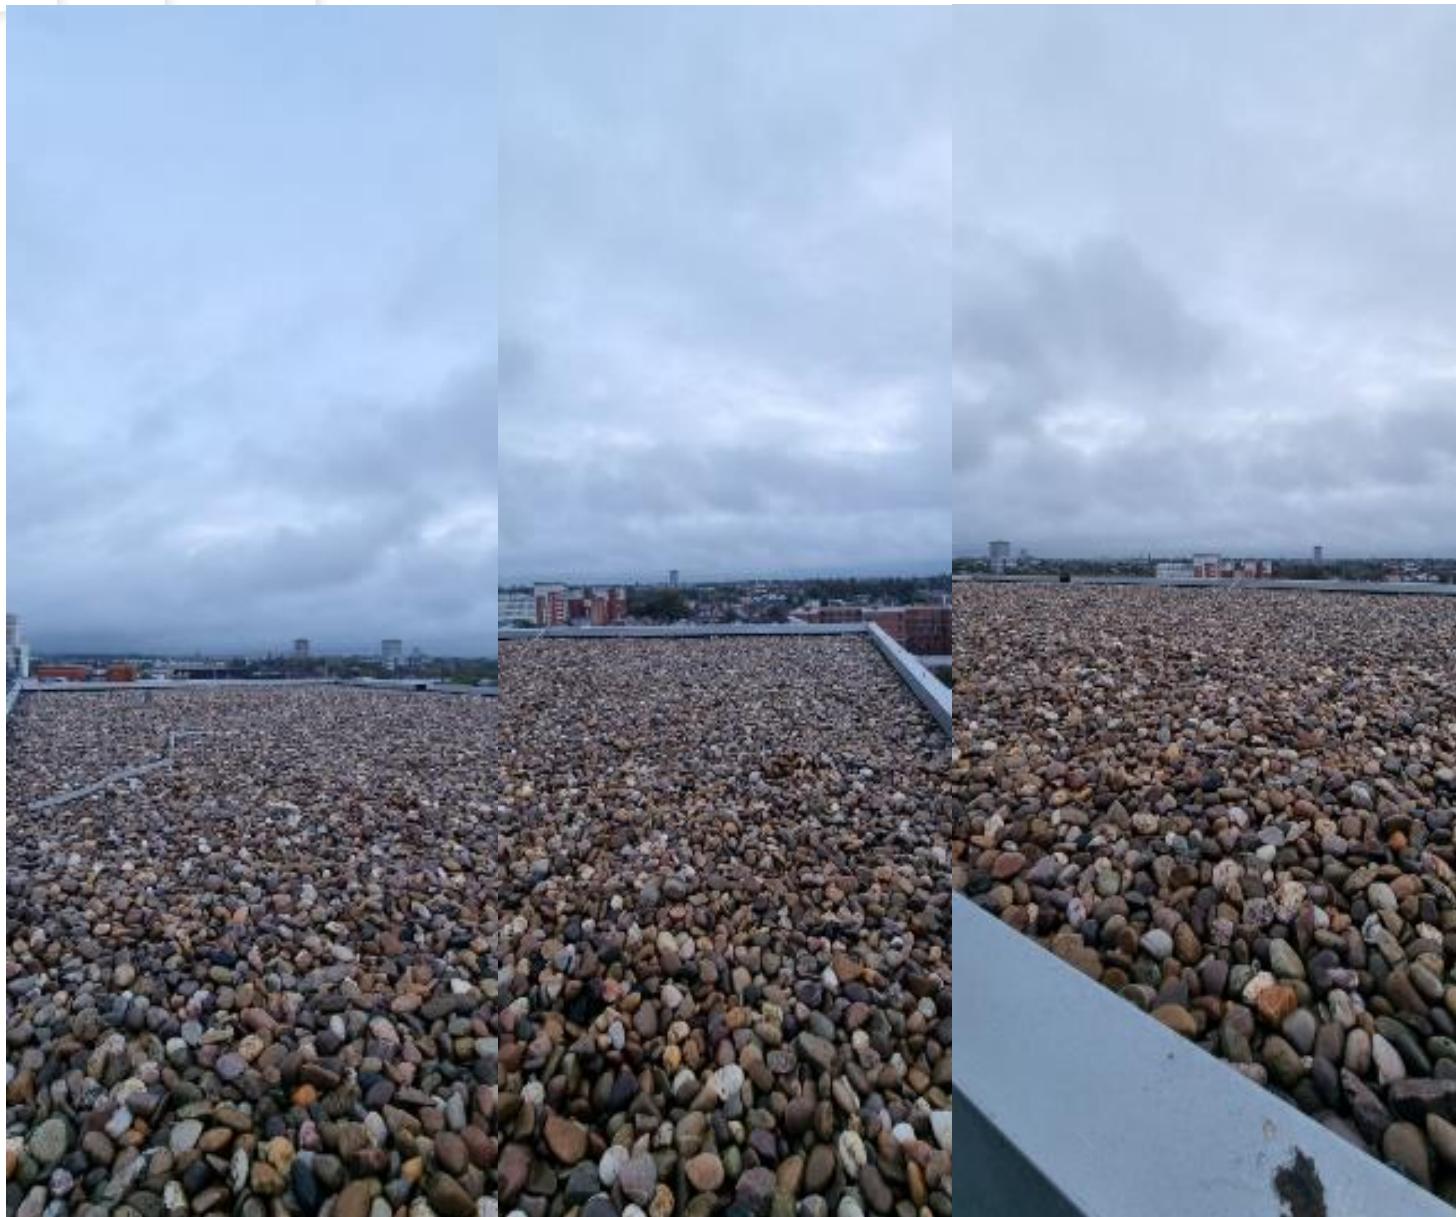
Photos – Building 1/Roof 1

Area	Building 1/Roof area 1		Roof height	Approx 7m		
Access	Hatch	Door	Fixed Ladder	Temp Ladder	MEWP	Other
Access Comments						
<p>The roof areas are accessed on a case-by-case basis by site maintenance staff and contractors, this roof area has fixed access, but no fall protection is present.</p> <p>Roof area accessed by fixed ladder; additional considerations are to be taken in regard to rescue/evacuation.</p>						
We advise no lone working on this roof.						
Tasks	Comments					
Lightning Protection Maintenance	No Fall protection located on this roof area, bespoke SSOW is required.

Access Suggestions
<p>A permit to work system could help control who goes on the roof area to ensure they understand the risk associated with this area and the procedures in place also to identify that the engineers/contractors are trained and competent and that their RAMS are identified and suitable for the works required of them regarding access methods/Rescue.</p>
<p>We suggest that anyone going to the roof areas should always work in pairs in case of an emergency, there is currently so safe means of access to onto this roof. The addition of fall protection equipment would benefit here.</p>

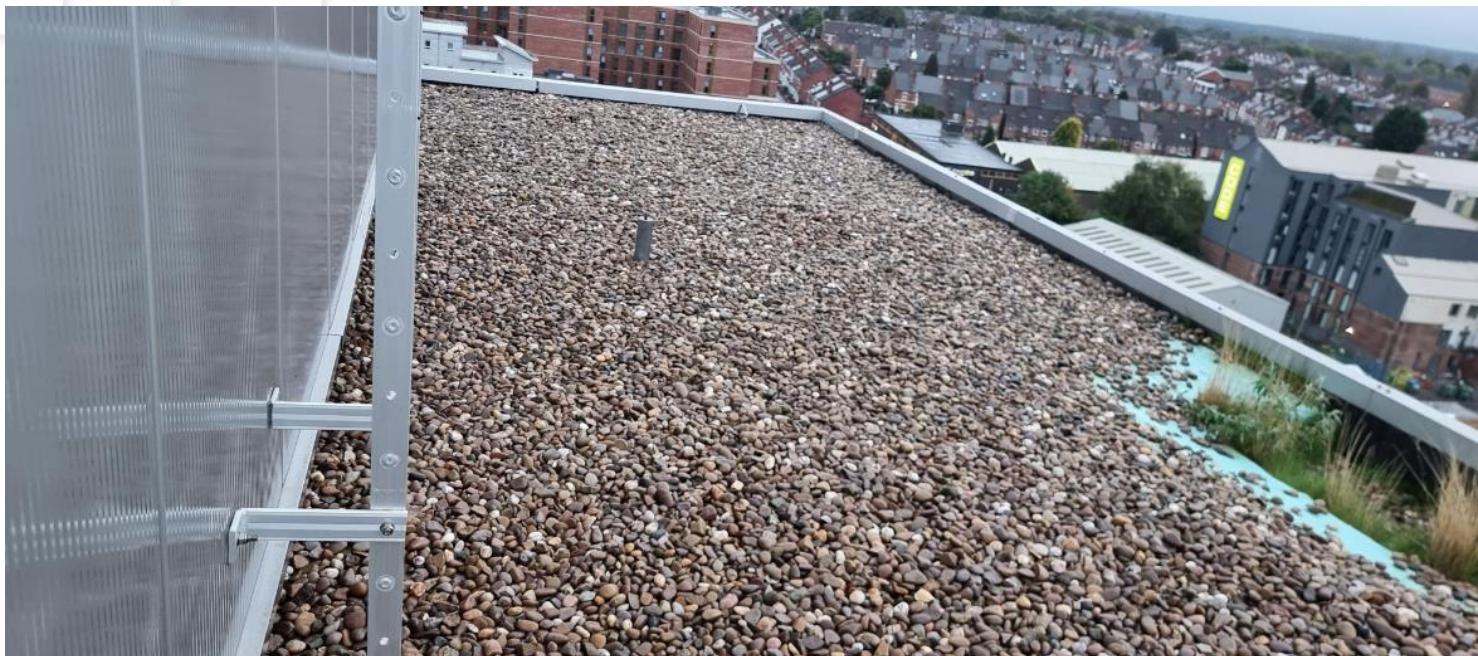
Building 1/Roof 2

Area	Building 1/Roof area 2			Roof height	Approx 6m	
Access	Hatch	Door	Fixed Ladder	Temp Ladder	MEWP	Other
Access Comments						
<p>The roof areas are accessed on a case-by-case basis by site maintenance staff and contractors, this roof area has fixed access, but no fall protection is present.</p> <p>Roof area accessed by fixed ladder; additional considerations are to be taken in regard to rescue/evacuation.</p> <p>We advise no lone working on this roof.</p>						
Tasks	Comments					
Lightning Protection Maintenance	No Fall protection located on this roof area, bespoke SSOW is required.

Access Suggestions
<p>A permit to work system could help control who goes on the roof area to ensure they understand the risk associated with this area and the procedures in place also to identify that the engineers/contractors are trained and competent and that their RAMS are identified and suitable for the works required of them regarding access methods/Rescue.</p>
<p>We suggest that anyone going to the roof areas should always work in pairs in case of an emergency, there is currently so safe means of access to onto this roof. The addition of fall protection equipment would benefit here.</p>

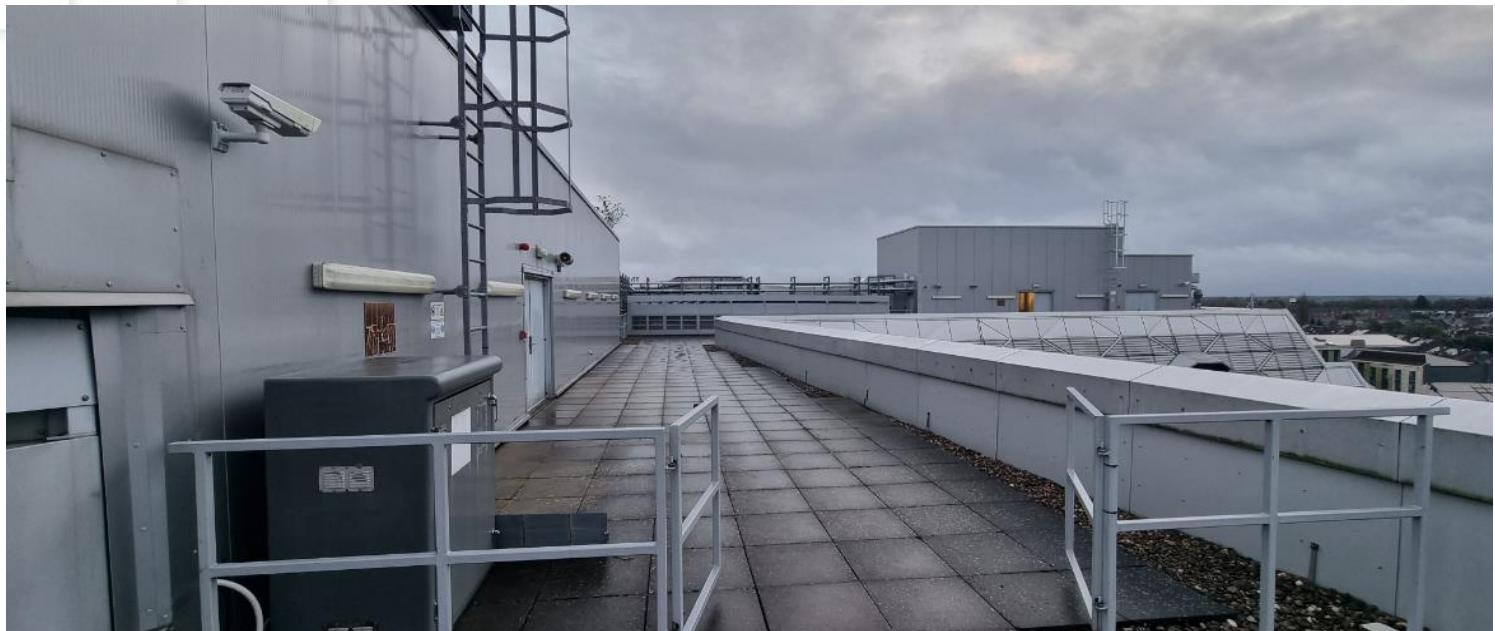
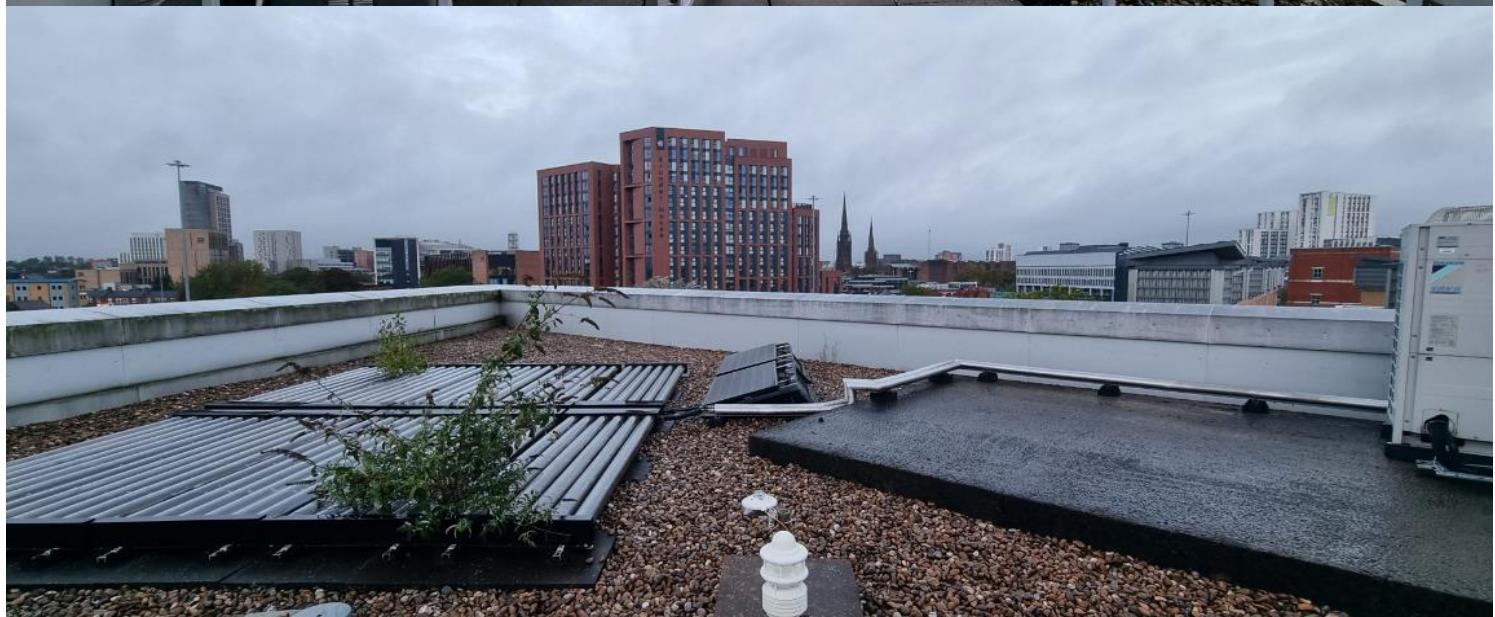
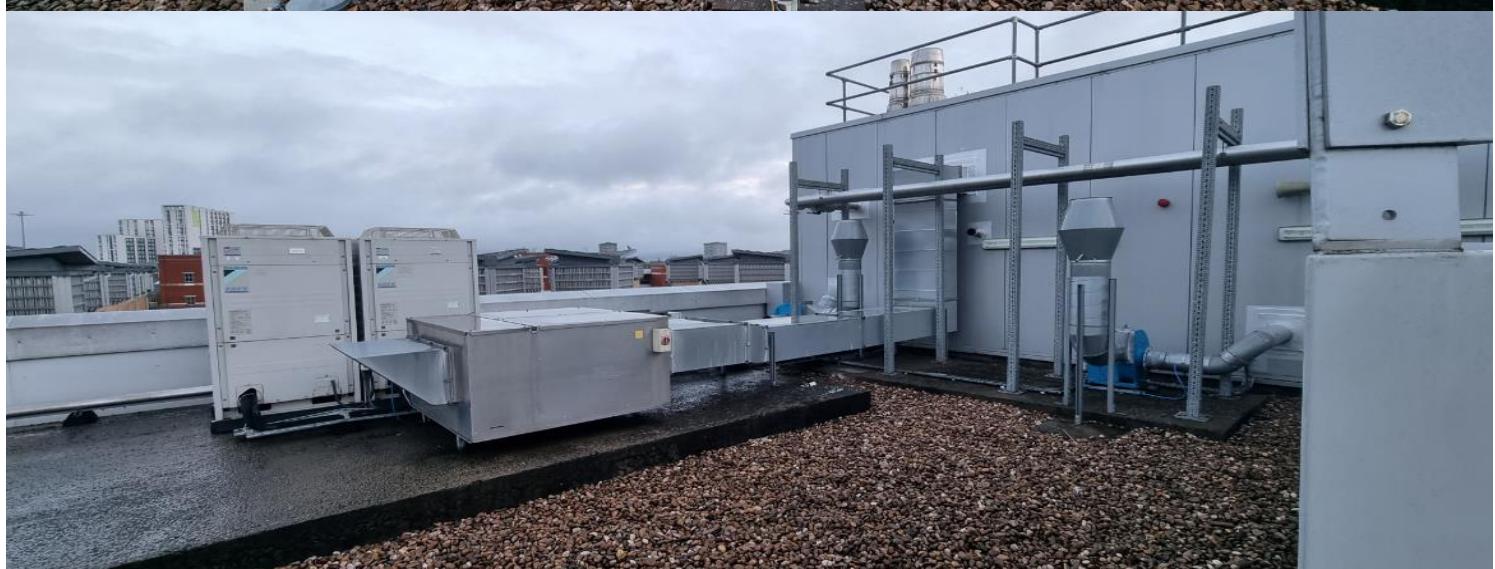
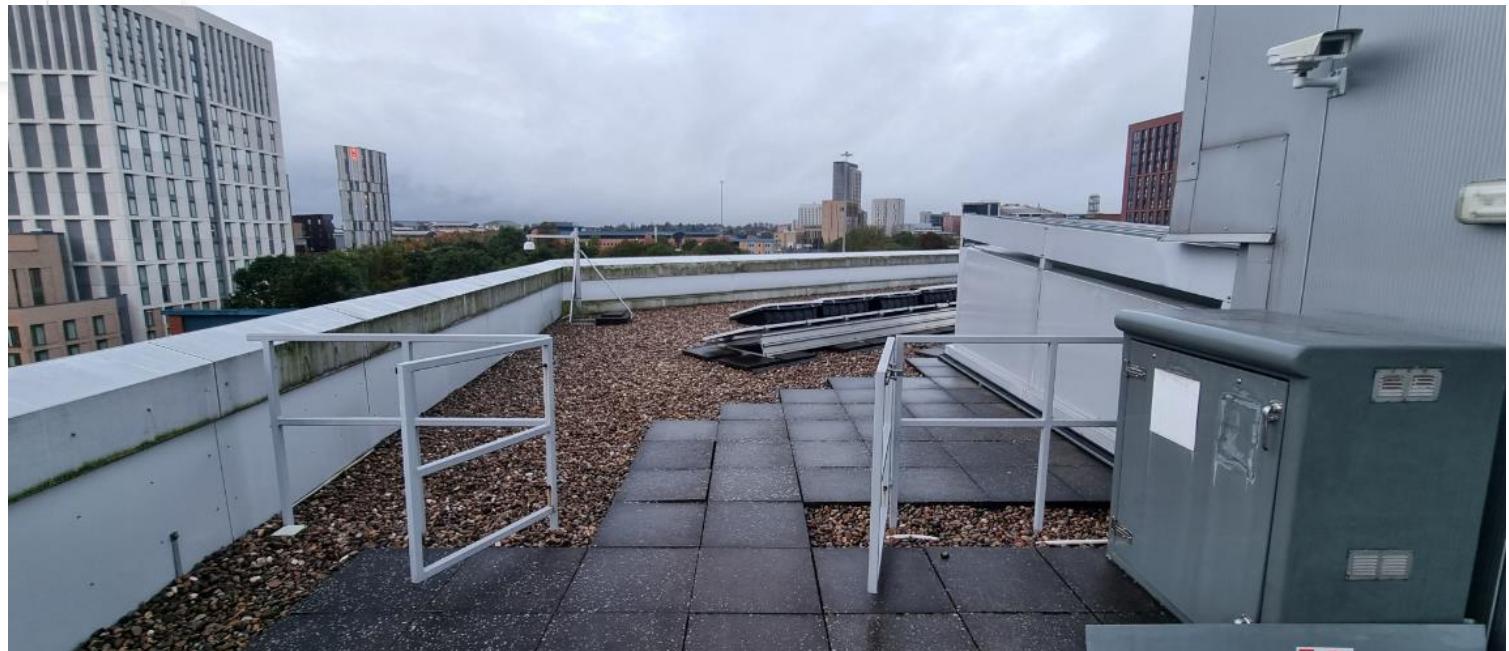
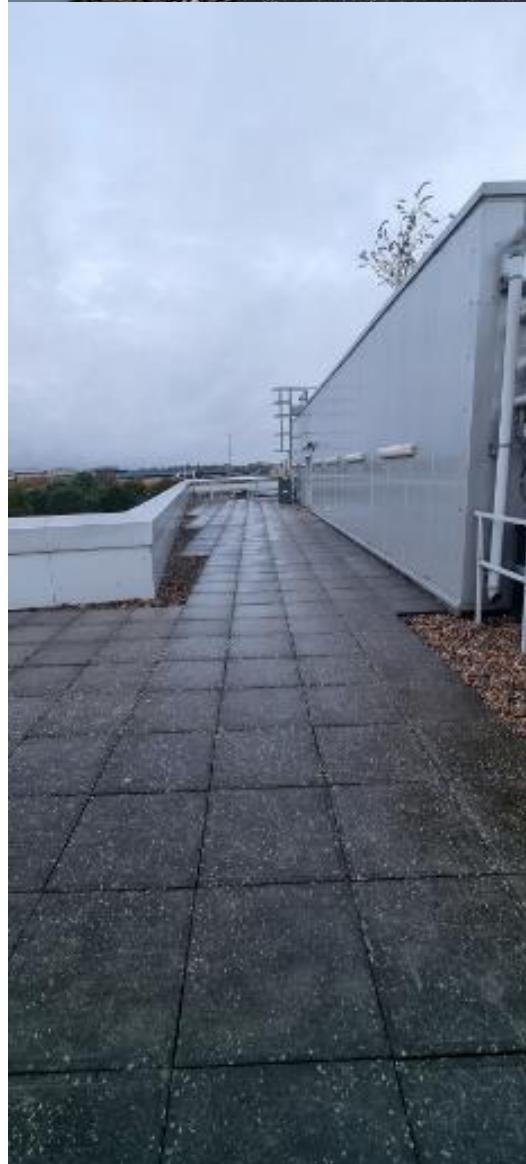
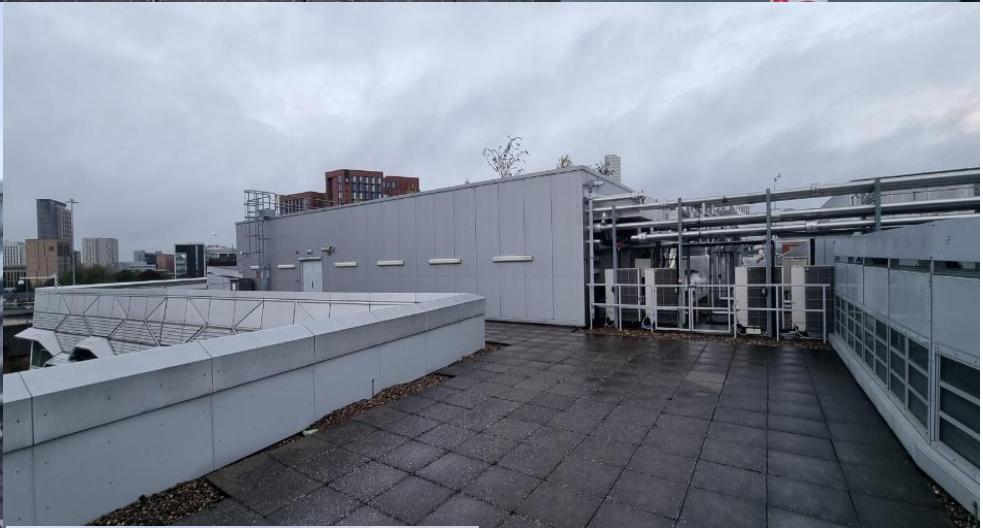
Building 1/Roof 3

The roof areas are accessed on a case-by-case basis by site maintenance staff and contractors, this roof area is covered by collective protection via parapet/Guardrail, although there may be a requirement to venture outside of the confines of the collective protection to access certain assets.

This Guardrail is not withing compliance.

Tasks	Comments
Lightning Protection Maintenance	Lightning protection is located and can be maintained from within the confines of the collective protection, Mandatory PPE required specified by Coventry University.
Plant Maintenance	Plant work is located and can be maintained from within the confines of the collective protection, Mandatory PPE required specified by Coventry University.
CCTV Maintenance	CCTV cameras are located and can be maintained from within the confines of the collective protection, Mandatory PPE required specified by Coventry University.
Air Conditioning Unit Maintenance	Air conditioning units are located and can be maintained from within the confines of the collective protection, Mandatory PPE required specified by Coventry University.
Solar Panel Maintenance	Solar panels located and can be maintained from within the confines of the collective protection, Mandatory PPE required specified by Coventry University.

We advise no lone working on this roof.

A permit to work system could help control who goes on the roof area to ensure they understand the risk associated with this area and the procedures in place also to identify that the engineers/contractors are trained and competent and that their RAMS are identified and suitable for the works required of them regarding access methods/Rescue.

We suggest that anyone going to the roof areas should always work in pairs in case of an emergency, this roof area is covered by a collective protection.

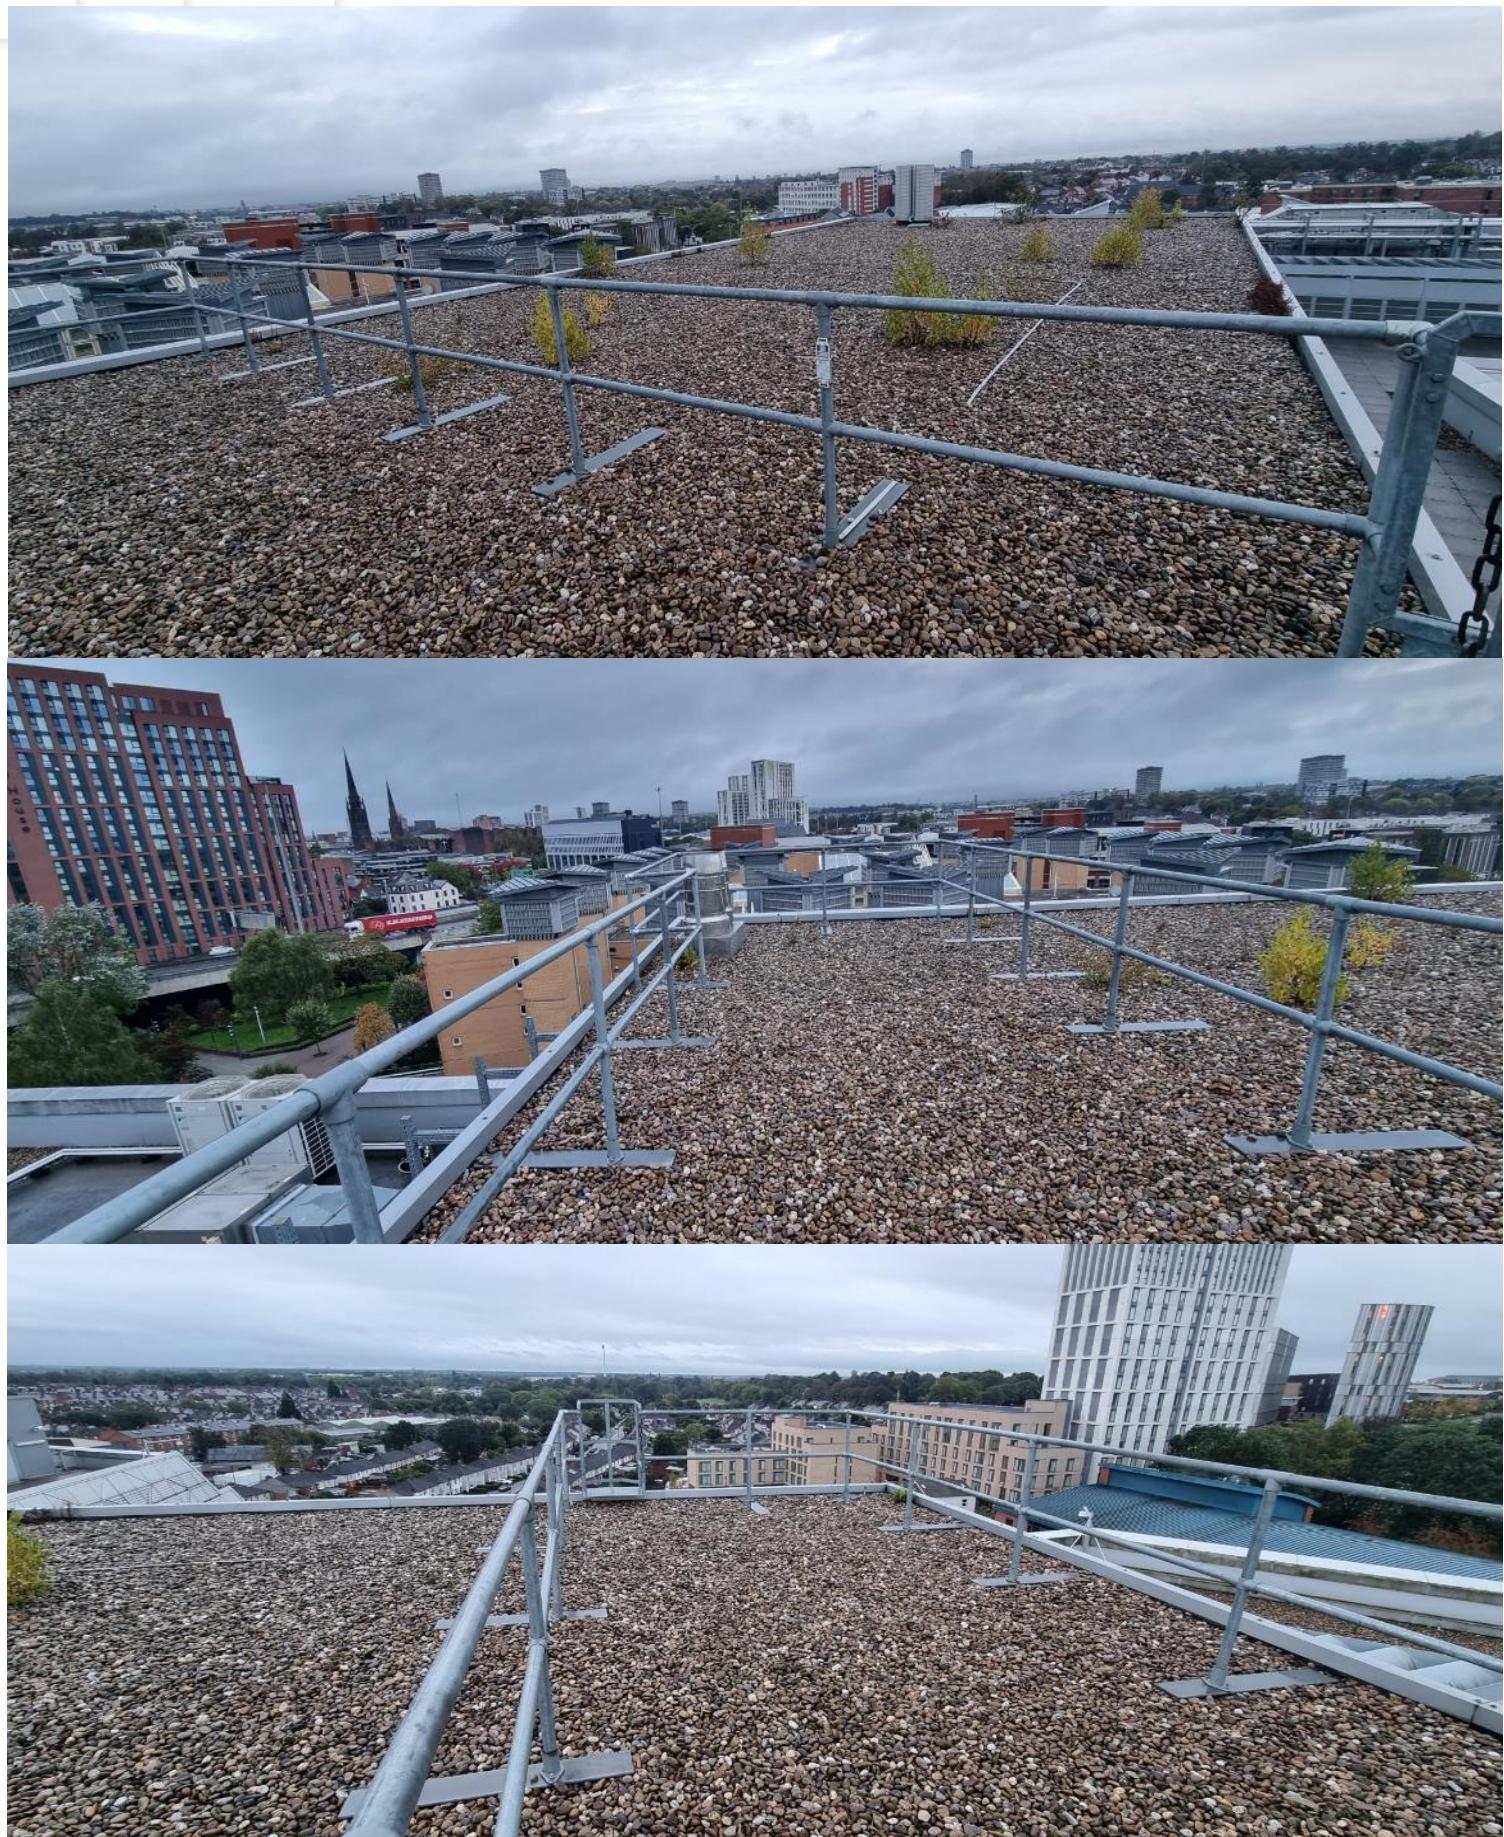
Building 1/roof 4

Area	Building 1/Roof area 4			Roof height	Approx 4m	
Access	Hatch	Door	Fixed Ladder	Temp Ladder	MEWP	Other
Access Comments						
The roof areas are accessed on a case-by-case basis by site maintenance staff and contractors, his roof area is covered by collective protection via Guardrail, although there may be a requirement to venture outside of the confines of the collective protection to access certain assets.						
This Guardrail is within compliance.						
Roof area accessed by fixed ladder; additional considerations are to be made in regard to rescue/evacuation.						
We advise no lone working on this roof.						
Tasks	Comments					
Lightening Protection Maintenance	<p>Lightening Protection is located and can be maintained from within the confines of the collective protection, Mandatory PPE required specified by Coventry University.</p> <p>Further to the above, some of the lightening protection is located outside the confines of the collective protection, bespoke SSOW will be required to access.</p>

Chimney Flue Maintenance	<p>Chimney flues are located and can be maintained from within the confines of the collective protection, Mandatory PPE required specified by Coventry University.</p> <p>Further to the above, some of the Flues are located outside the confines of the collective protection, bespoke SSOW will be required to access.</p>

Access Suggestions
A permit to work system could help control who goes on the roof area to ensure they understand the risk associated with this area and the procedures in place also to identify that the engineers/contractors are trained and competent and that their RAMS are identified and suitable for the works required of them regarding access methods/Rescue.
We suggest that anyone going to the roof areas should always work in pairs in case of an emergency, this roof area is covered by collective protection. Although there may be a requirement to venture outside the confines of the collective protection therefore additional SSOW will be required.

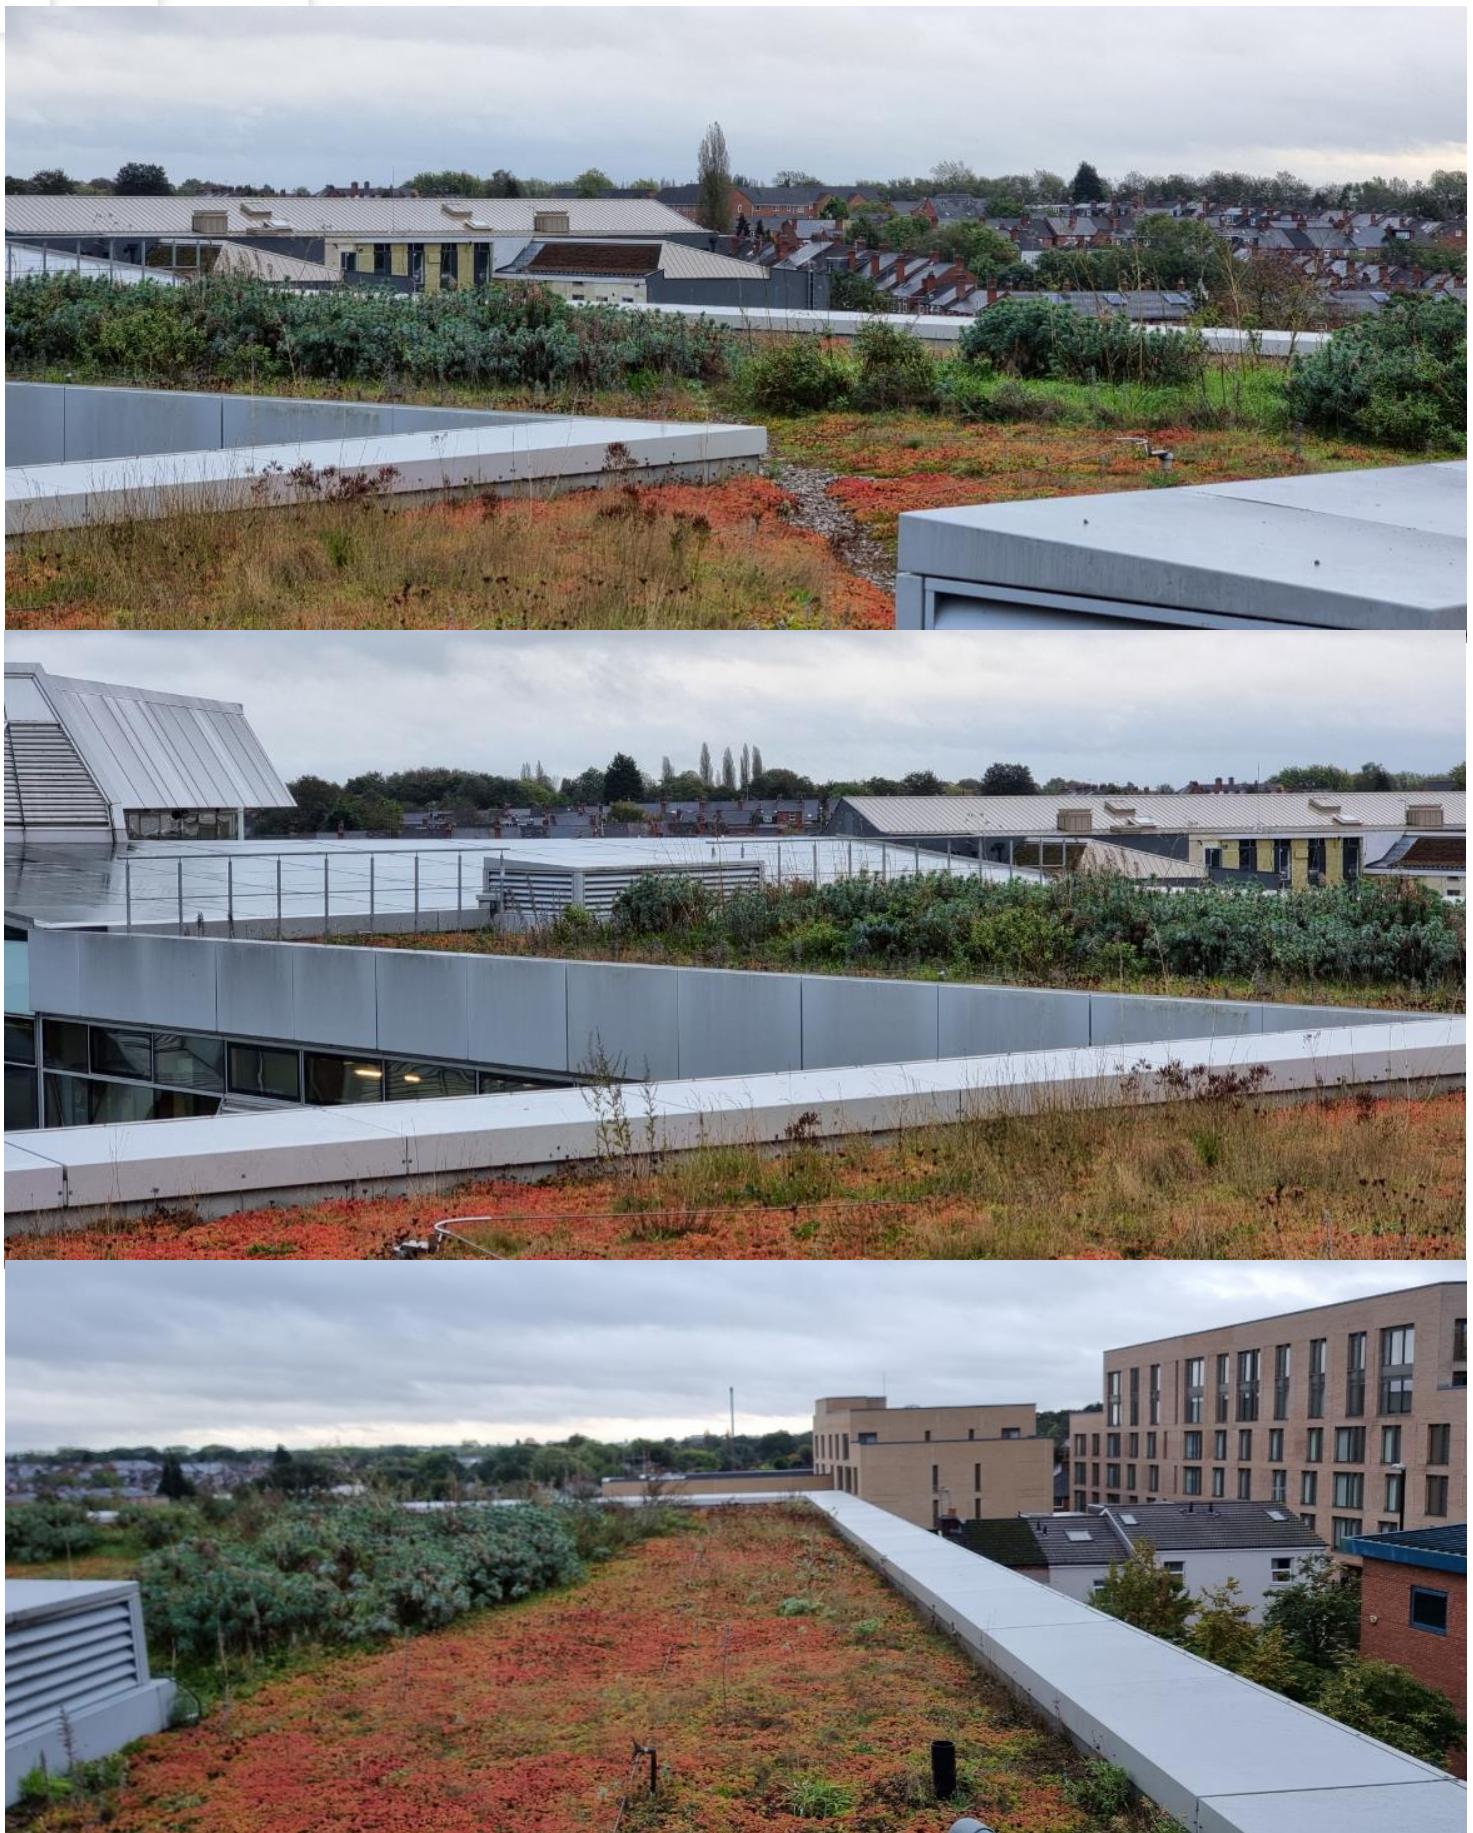
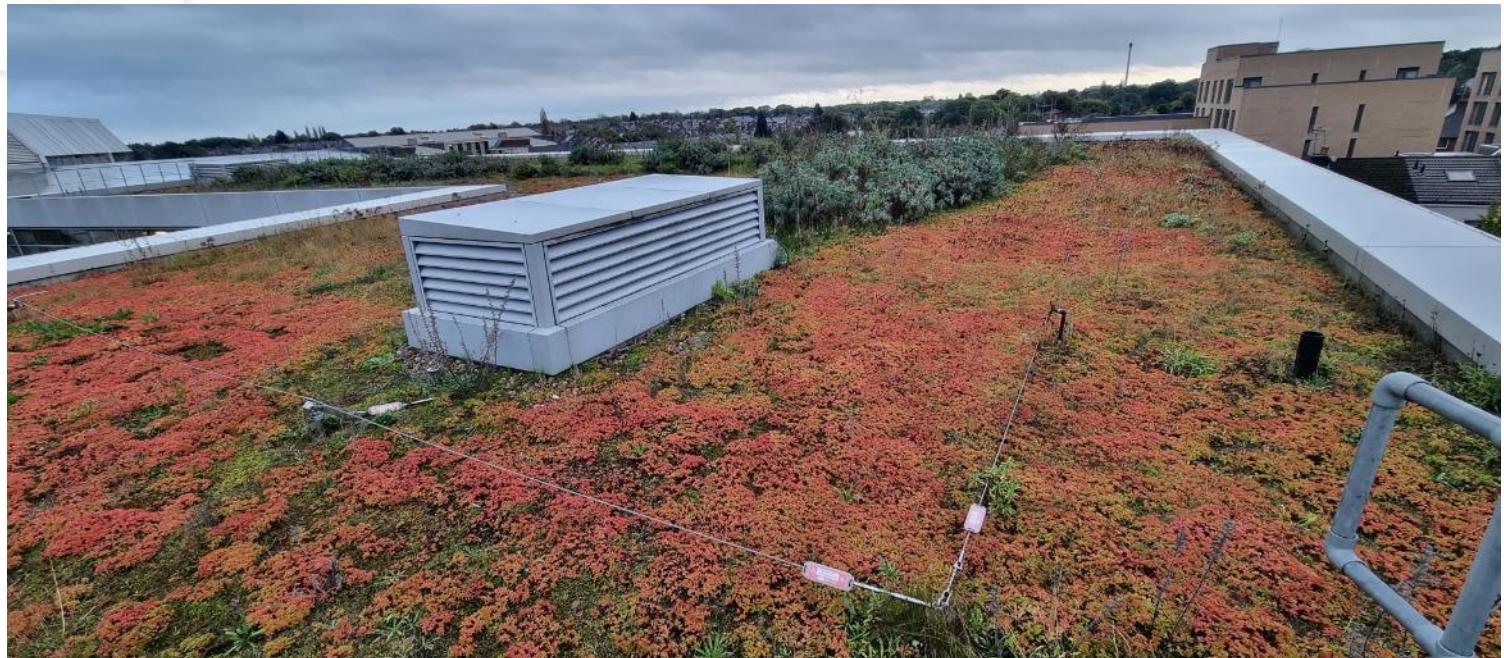
Building 1/roof 5

Area	Building 1/Roof area 5		Roof height	Approx 20m		
Access	Hatch	Door	Fixed Ladder	Temp Ladder	MEWP	Other
Access Comments						
The roof areas are accessed on a case-by-case basis by site maintenance staff and contractors, this roof area is covered by Fall protection in the form of a mansafe systems and guardrail. All of which are not withing compliance.						
Roof area accessed by door.						
We advise no lone working on this roof.						
Tasks	Comments					
Lightning Protection Maintenance	Lightning Protection is located away from the mansafe system and therefore advance work at height training and work positioning will be required to access.					
Chimney Flue Maintenance	Chimney flues are located away from the mansafe system and therefore advance work at height training and work positioning will be required to access.					
Air Ventilation Maintenance	Air vents are located away from the mansafe system and therefore advance work at height training and work positioning will be required to access.

Maintenance of Green Roof	To maintain the green roof advance work at height training and work positioning will be required to access.

Access Suggestions
A permit to work system could help control who goes on the roof area to ensure they understand the risk associated with this area and the procedures in place also to identify that the engineers/contractors are trained and competent and that their RAMS are identified and suitable for the works required of them regarding access methods/Rescue.
We suggest that anyone going to the roof areas should always work in pairs in case of an emergency, this roof area is covered by a mansafe system therefore additional work at height training/rescue training will be required.
Due to the work positioning requirements of this roof advanced work at height/rescue training would be required.

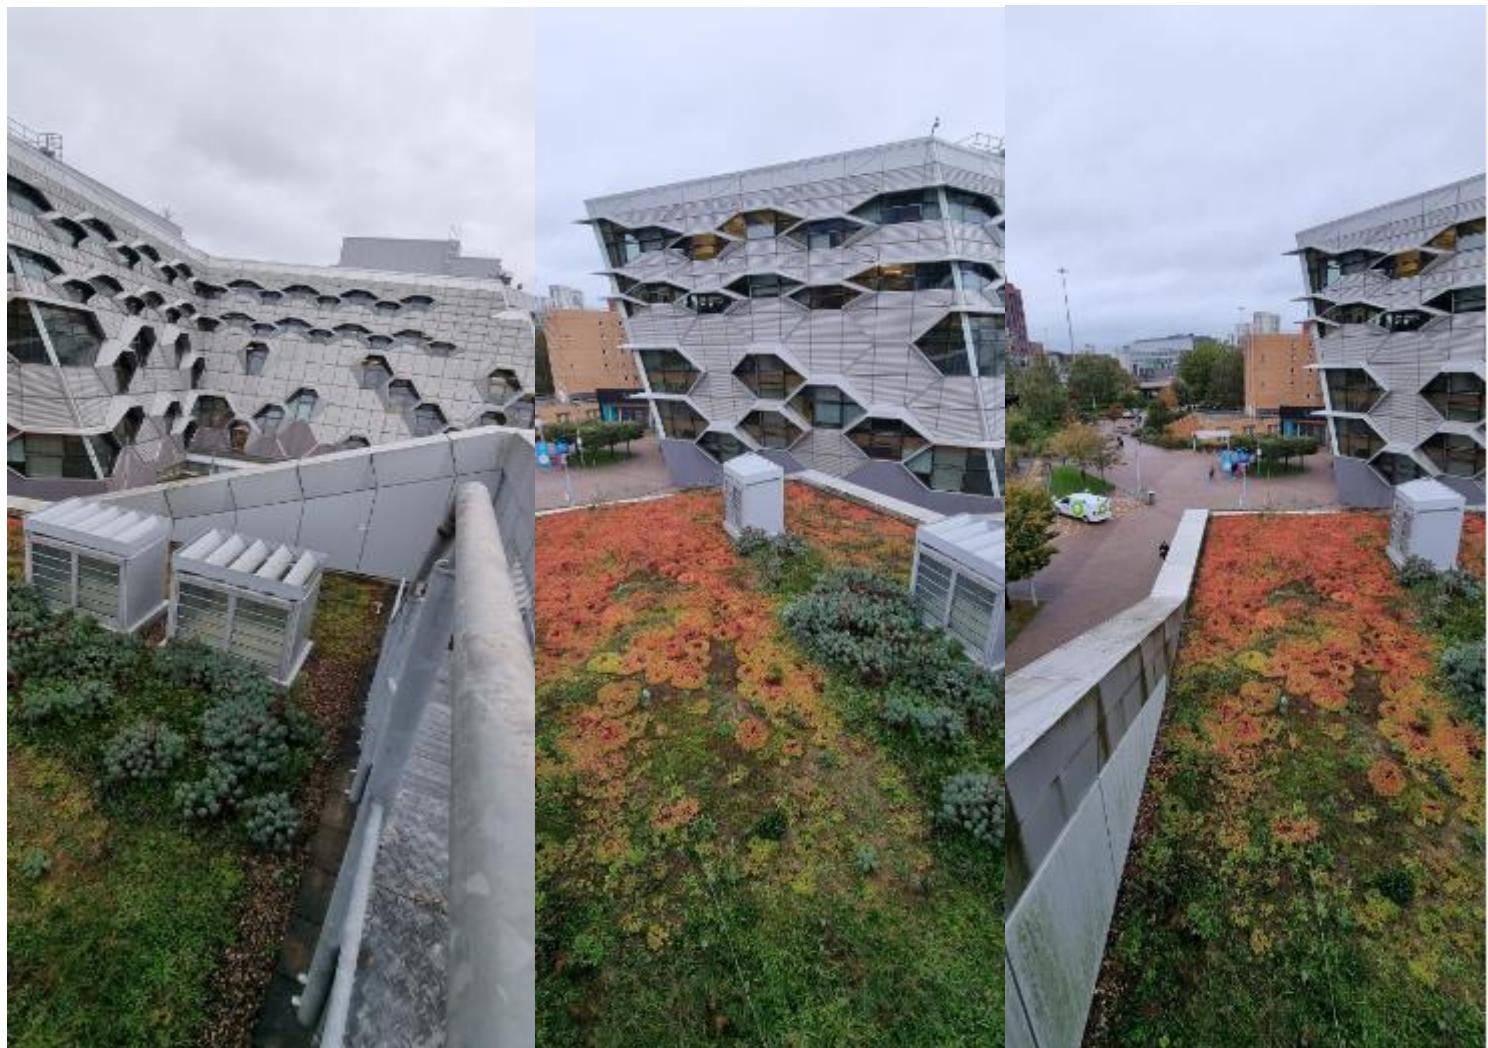
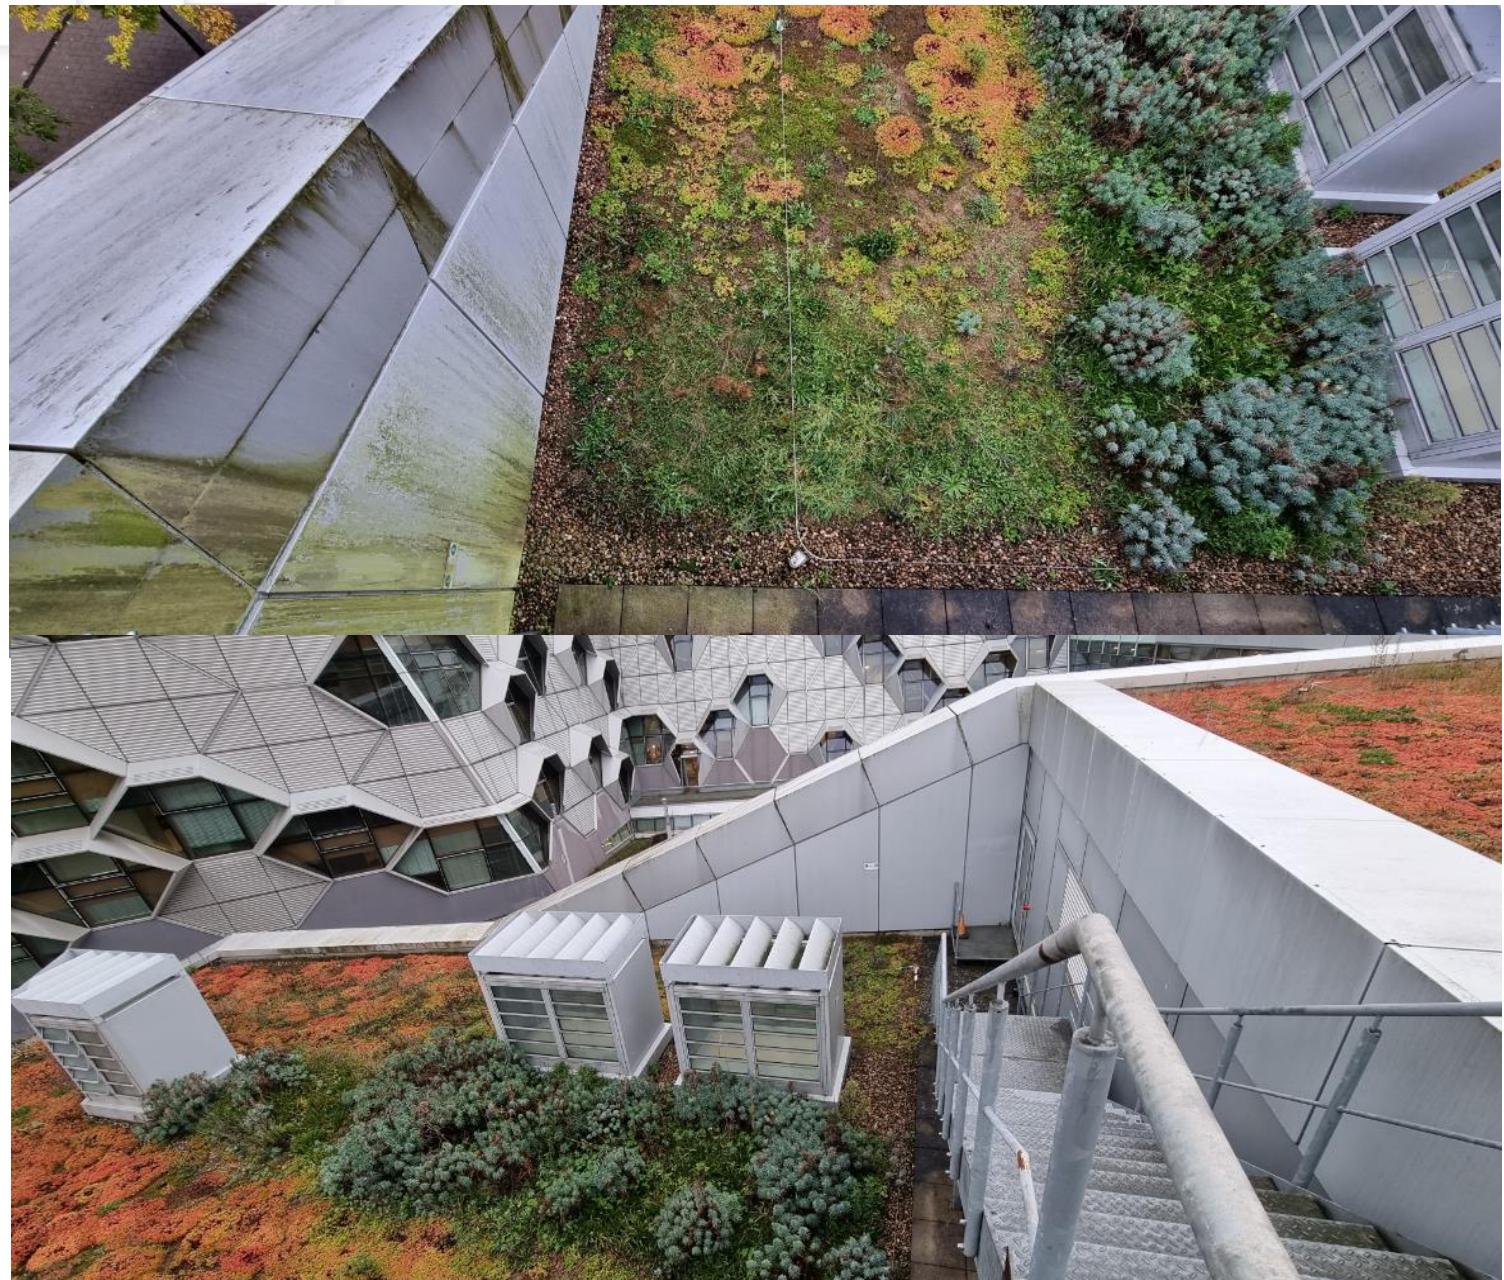
Building 1/Roof 6

Area	Building 1/Roof area 6		Roof height	Approx 15m		
Access	Hatch	Door	Fixed Ladder	Temp Ladder	MEWP	Other
Access Comments						
The roof areas are accessed on a case-by-case basis by site maintenance staff and contractors, this roof area is covered by Fall protection in the form of a mansafe system. This system is within compliance						
Roof area accessed by Door						
We advise no lone working on this roof.						
Tasks	Comments					
Lightning Protection Maintenance	Lightning Protection is located away from the mansafe system and therefore advance work at height training and work positioning will be required to access.					
Air Ventilation Maintenance	Air vents are located away from the mansafe system and therefore advance work at height training and work positioning will be required to access.

Access Suggestions
A permit to work system could help control who goes on the roof area to ensure they understand the risk associated with this area and the procedures in place also to identify that the engineers/contractors are trained and competent and that their RAMS are identified and suitable for the works required of them regarding access methods/Rescue.
We suggest that anyone going to the roof areas should always work in pairs in case of an emergency, this roof area is covered by a mansafe system therefore additional work at height training/rescue training will be required.
Due to the work positioning requirements of this roof advanced work at height/rescue training would be required.
