Height Safety Asset Management Report

Site Assessment & Report

Coventry University – George Eliot, Priory street, CV1 5FB

Date: 20/10/2023

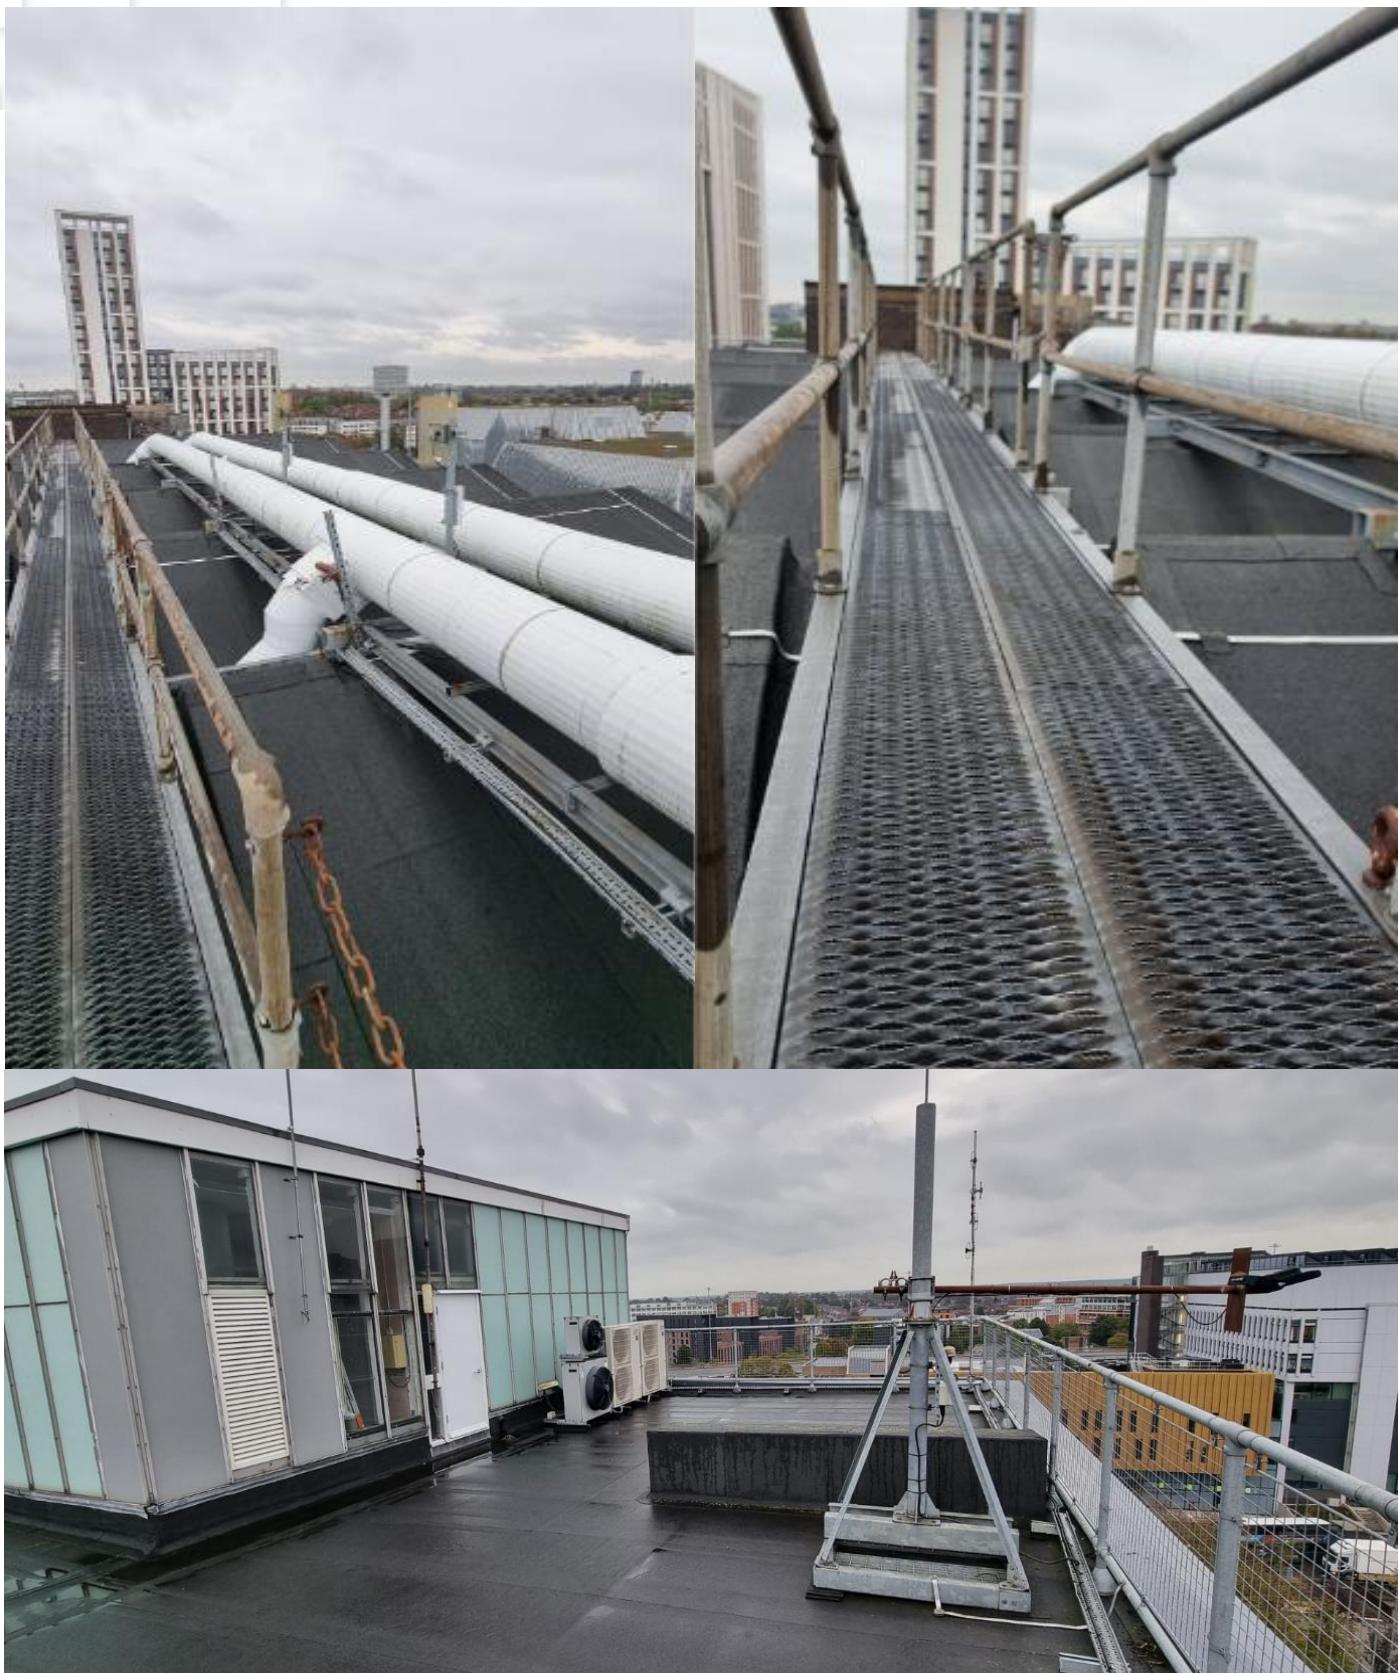
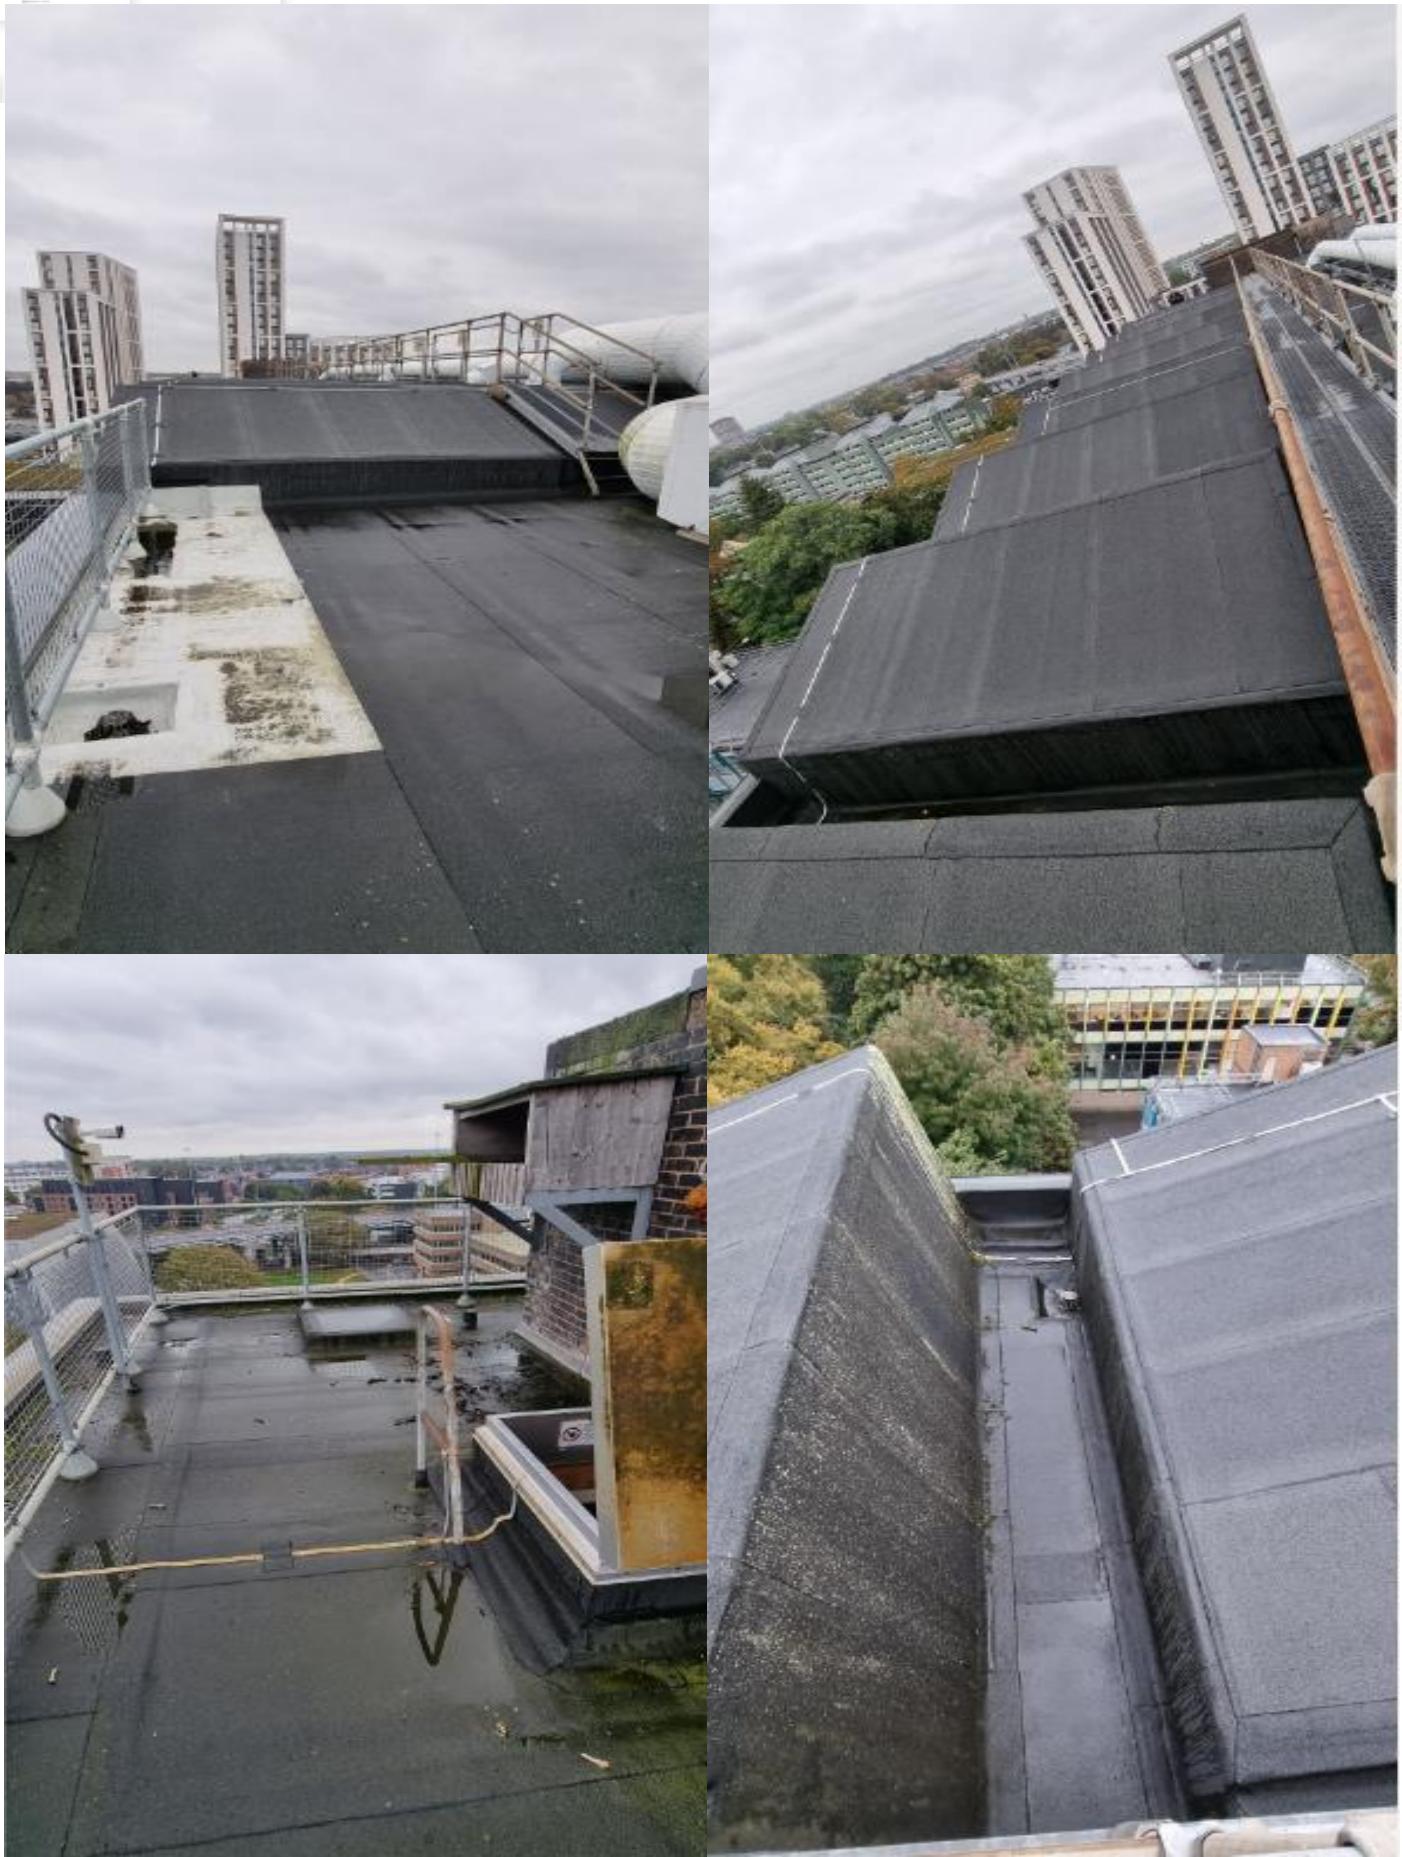
Photos – Building 1/Roof 1

| Location | Access | Asset | Manufacturer | Risk Rating (GYOR) | Comment |
|---|---|---|---|---|---|
| Building 1 Roof area 1 | Hatch | Gutter | N/A | Red | Exceeds guardrail boundary, no fall protection beyond boundary, SOW Required. |
| Building 1 Roof area 1 | Hatch | Lightning protection | N/A | Red | Exceeds guardrail boundary, no fall protection beyond boundary, SOW Required. |
| Building 1 Roof area 1 | Hatch | Plant | N/A | Red | Exceeds guardrail boundary, no fall protection beyond boundary, SOW Required. |

<table><tr> <th>Tasks</th><th>Comments</th></tr><tr> <td>Gutter Maintenance</td><td>Gutters located both outside and inside of the confines of the collective protection, should maintenance be required outside of the guardrail then an SSOW will be required.</td></tr><tr> <td>Lightning Protection Maintenance</td><td>Lightening protection is located both inside and outside of the collective protection, should maintenance be required outside of the guardrail then an SSOW will be required.</td></tr><tr> <td>Plant Maintenance</td><td>Plant work exceeds the boundaries of the collective protection therefore an SSOW is required.</td></tr></table>

There is existing Guardrail installed although this does not cover all aspects and requirements on this roof in some cases there are more practical forms of fall protection available which would be more suited for these areas, due to this more often than not the end user will be required to work outside of these perimeters with the use of correct PPE and adequate training, please note there are certain assets that currently cannot be accessed without additional equipment/specialist access methods.

| <p>We suggest that anyone going to the roof areas should always work in pairs in case of an emergency, in most cases we would advise that additional Horizontal cable systems are installed to aid the safe movement around these roof areas in an aim to keep the end user away from any potential fall hazard, currently the access methods fall down to the end user and their competency/training, there is excess potential for human error involved that could potentially be mitigated by the installation of additional equipment.</p> |

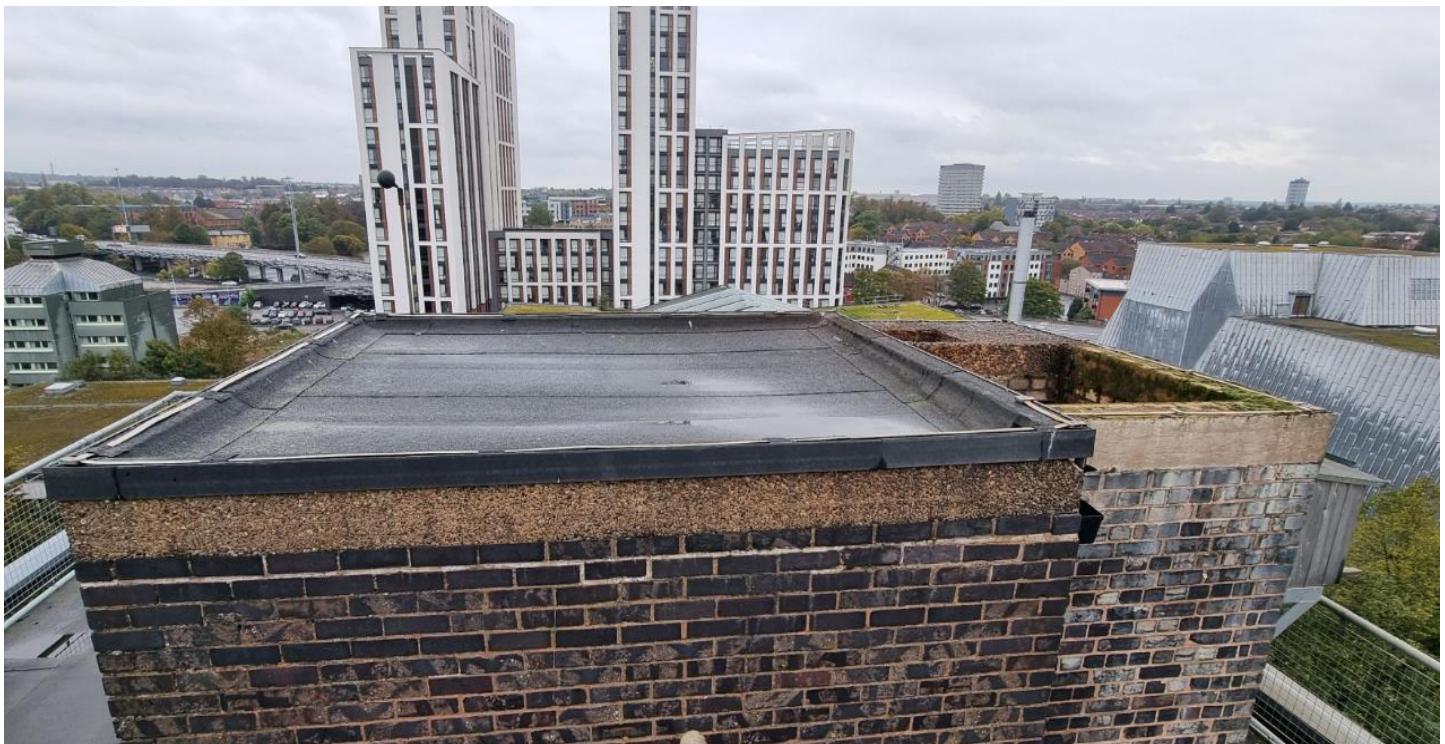
Building 1/ Roof 2

| Roof area accessed by temp ladder; no fall protection present therefore a SSOW is required. | | | | | | |
| Lightning Protection Maintenance | There is no fall protection present on this roof area, no fixed access therefore an SSOW is required. | | | | | |

A permit to work system could help control who goes on the roof area to ensure they understand the risk associated with this area and the procedures in place also to identify that the engineers/contractors are trained and competent and that their RAMS are identified and suitable for the works required of them regarding access methods/Rescue.

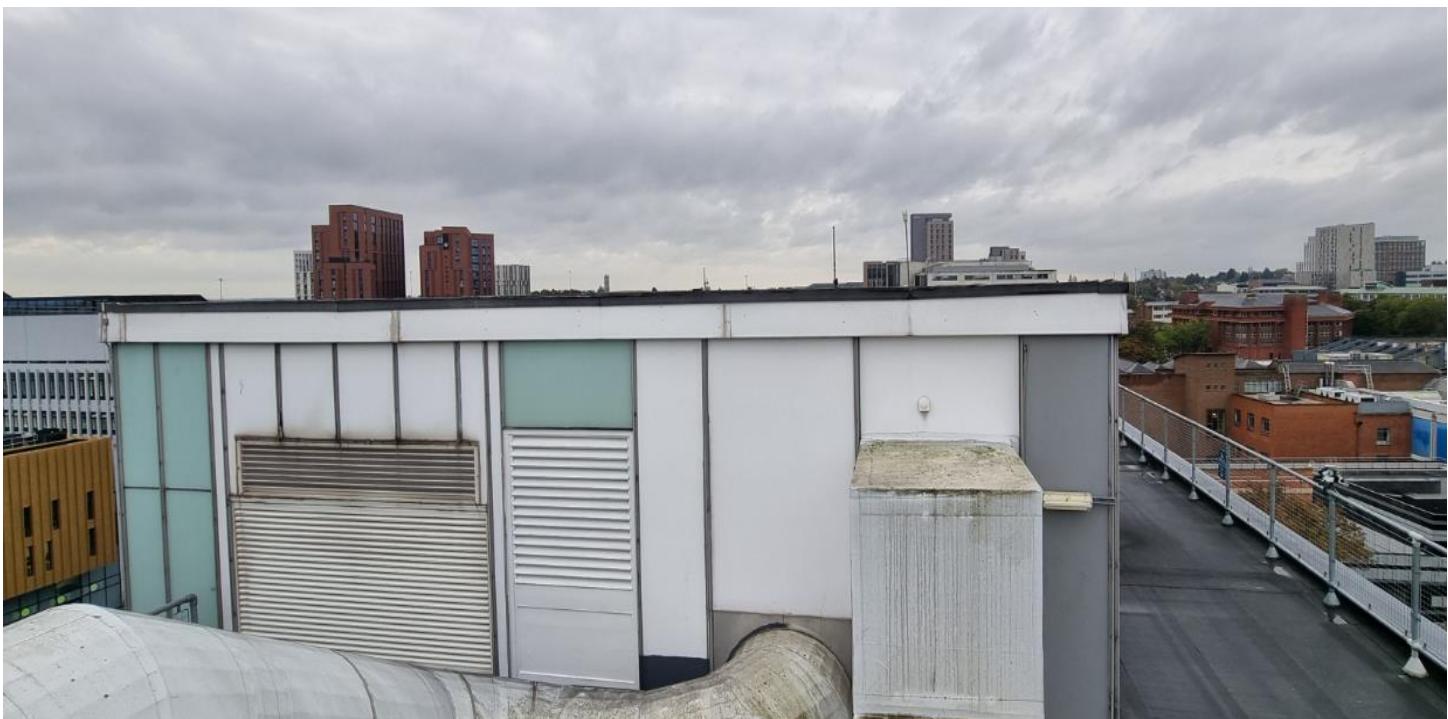
Building 1/ Roof 2

| <p>The roof areas are accessed on a case-by-case basis by site maintenance staff and contractors</p> <p>Roof area accessed by temp ladder; no fall protection present therefore a SSOW is required.</p> | | | | | |
| Lightning Protection Maintenance | There is no fall protection present on this roof area, no fixed access therefore an SSOW is required. | | | | |
| Chimney Flue Maintenance | There is no fall protection present on this roof area, no fixed access therefore an SSOW is required. | | | | |

| <p>A permit to work system could help control who goes on the roof area to ensure they understand the risk associated with this area and the procedures in place also to identify that the engineers/contractors are trained and competent and that their RAMS are identified and suitable for the works required of them regarding access methods/Rescue.</p> |
