Height Safety Asset Management Report

Site Assessment & Report

Coventry University – Health Design Institute and Innovation Centre, Puma Way, CV1 2TX

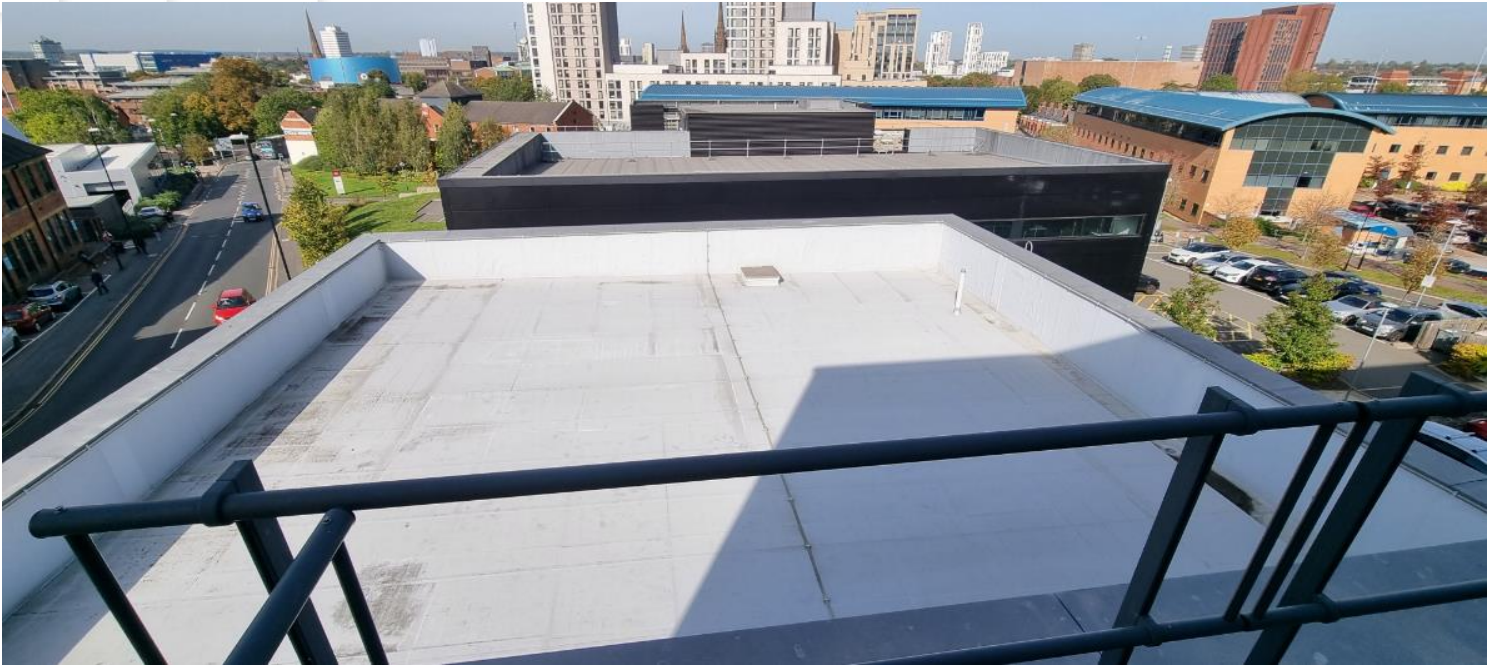
Photos – Building 1/ Roof 1

Area	Building 1/ Roof 1			Roof height	Approx 15m	
Access	Hatch	Door	Fixed Ladder	Temp Ladder	MEWP	Other
	x					
Access Comments						
The roof areas are accessed on a case-by-case basis by site maintenance staff and contractors. This roof is covered by collective protection in the form of a parapet.						
Hatch access						
We advise no lone working on this roof due to the specialized access methods.						
Tasks		Comments				
Chimney Flue Maintenance		Chimney flues can be maintained from within the confines of the collective protection.				
Hatch Maintenance		The hatch can be maintained from within the confines of the collective protection. Although we advise that the hatch is kept shut to eliminate any fall hazard whilst working on the hatch/Roof area.				
Lightning Protection Maintenance		Lightning protection can be maintained from within the confines of the collective protection.				
Access Suggestions

A permit to work system could help control who goes on the roof area to ensure they understand the risk associated with this area and the procedures in place also to identify that the engineers/contractors are trained and competent and that their RAMS are identified and suitable for the works required of them regarding access methods/Rescue.

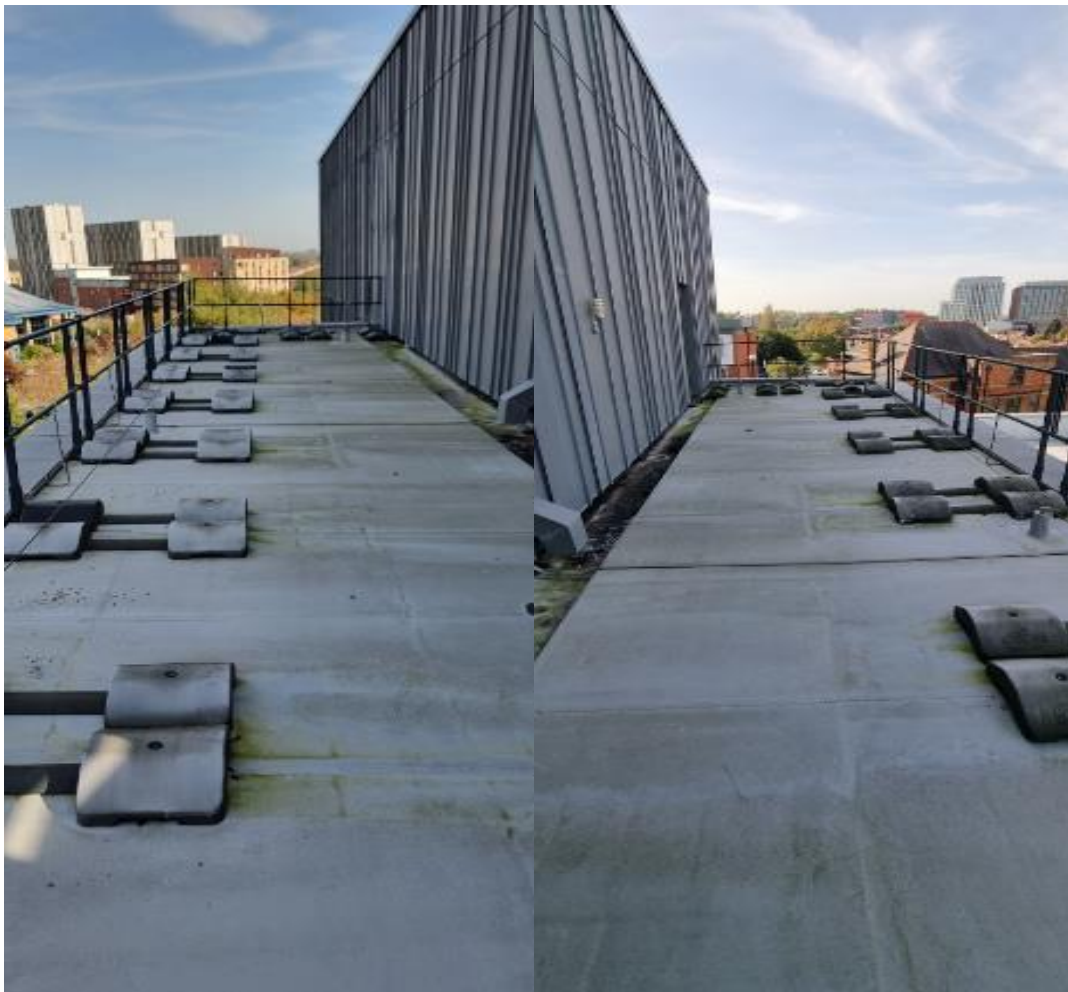
Area	Building 1/ Roof 2			Roof height	Approx 20m	
Access	Hatch	Door	Fixed Ladder	Temp Ladder	MEWP	Other
		x				
Access Comments						
<p>The roof areas are accessed on a case-by-case basis by site maintenance staff and contractors. This roof is covered by collective protection in the form of guardrail, there is also a mansafe system present in this area both of which are not in compliance although the mansafe system is somewhat redundant due to collective protection being in place.</p>						
Door access						
We advise no lone working on this roof due to the specialized access methods.						
Tasks		Comments				
Gutter Cleaning/Maintenance		Gutters can be maintained from within the confines of the collective protection.				
Maintenance of Plant Work		Plant work can be maintained from within the confines of the collective protection.				
Lightning Protection Maintenance		Lightning protection can be maintained from within the confines of the collective protection.

Access Suggestions						
<p>A permit to work system could help control who goes on the roof area to ensure they understand the risk associated with this area and the procedures in place also to identify that the engineers/contractors are trained and competent and that their RAMS are identified and suitable for the works required of them regarding access methods/Rescue.</p> <p>Should the system be required for use then additional basic work at height/rescue training will be required.</p>

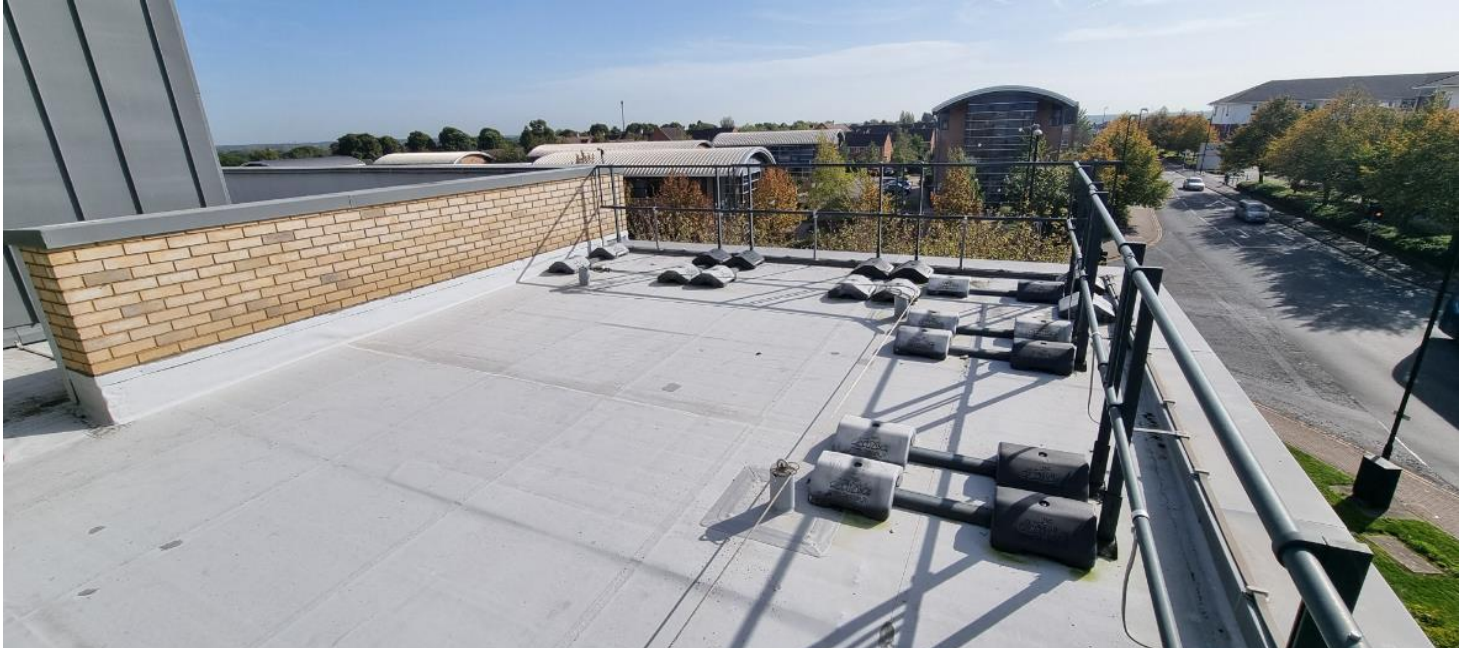
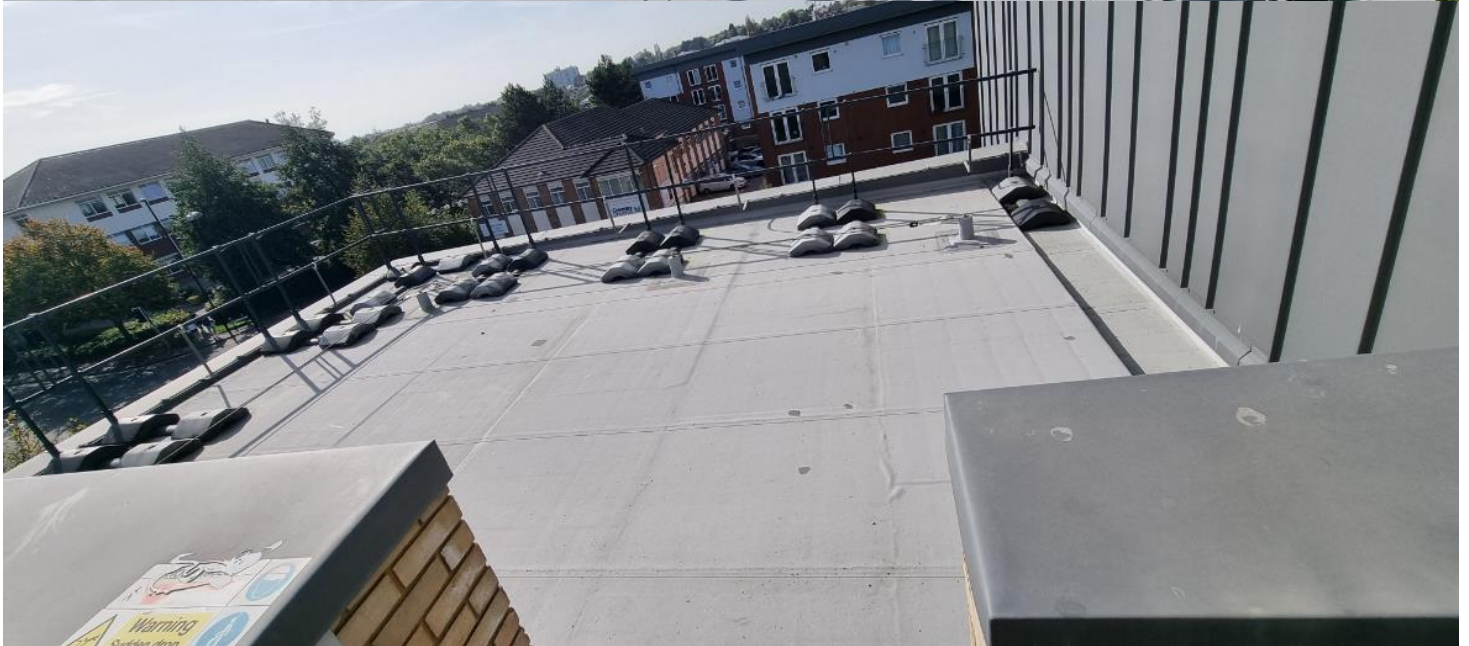
Area	Building 1/ Roof 4			Roof height	Approx 20m	
Access	Hatch	Door	Fixed Ladder	Temp Ladder	MEWP	Other
		x				
Access Comments						
<p>The roof areas are accessed on a case-by-case basis by site maintenance staff and contractors. This roof is covered by collective protection in the form of guardrail, there is also a mansafe system present in this area both of which are not in compliance although the mansafe system is somewhat redundant due to collective protection being in place.</p>						
Door access						
<p>We advise no lone working on this roof due to the specialized access methods.</p>						
Tasks		Comments				
Gutter Cleaning/Maintenance		Gutters can be maintained from within the confines of the collective protection.				
Chimney Flue Maintenance		Chimney flues can be maintained from within the confines of the collective protection.				
Lightning Protection Maintenance		Lightning protection can be maintained from within the confines of the collective protection.

Access Suggestions						
<p>A permit to work system could help control who goes on the roof area to ensure they understand the risk associated with this area and the procedures in place also to identify that the engineers/contractors are trained and competent and that their RAMS are identified and suitable for the works required of them regarding access methods/Rescue.</p> <p>Should the system be required for use then additional basic work at height/rescue training will be required.</p>
