Height Safety Asset Management Report

Site Assessment & Report

Coventry University – National Transport Design Centre, Swift Road off Puma Way, Coventry, CV1 2TT

Surveyed on behalf of Coventry University

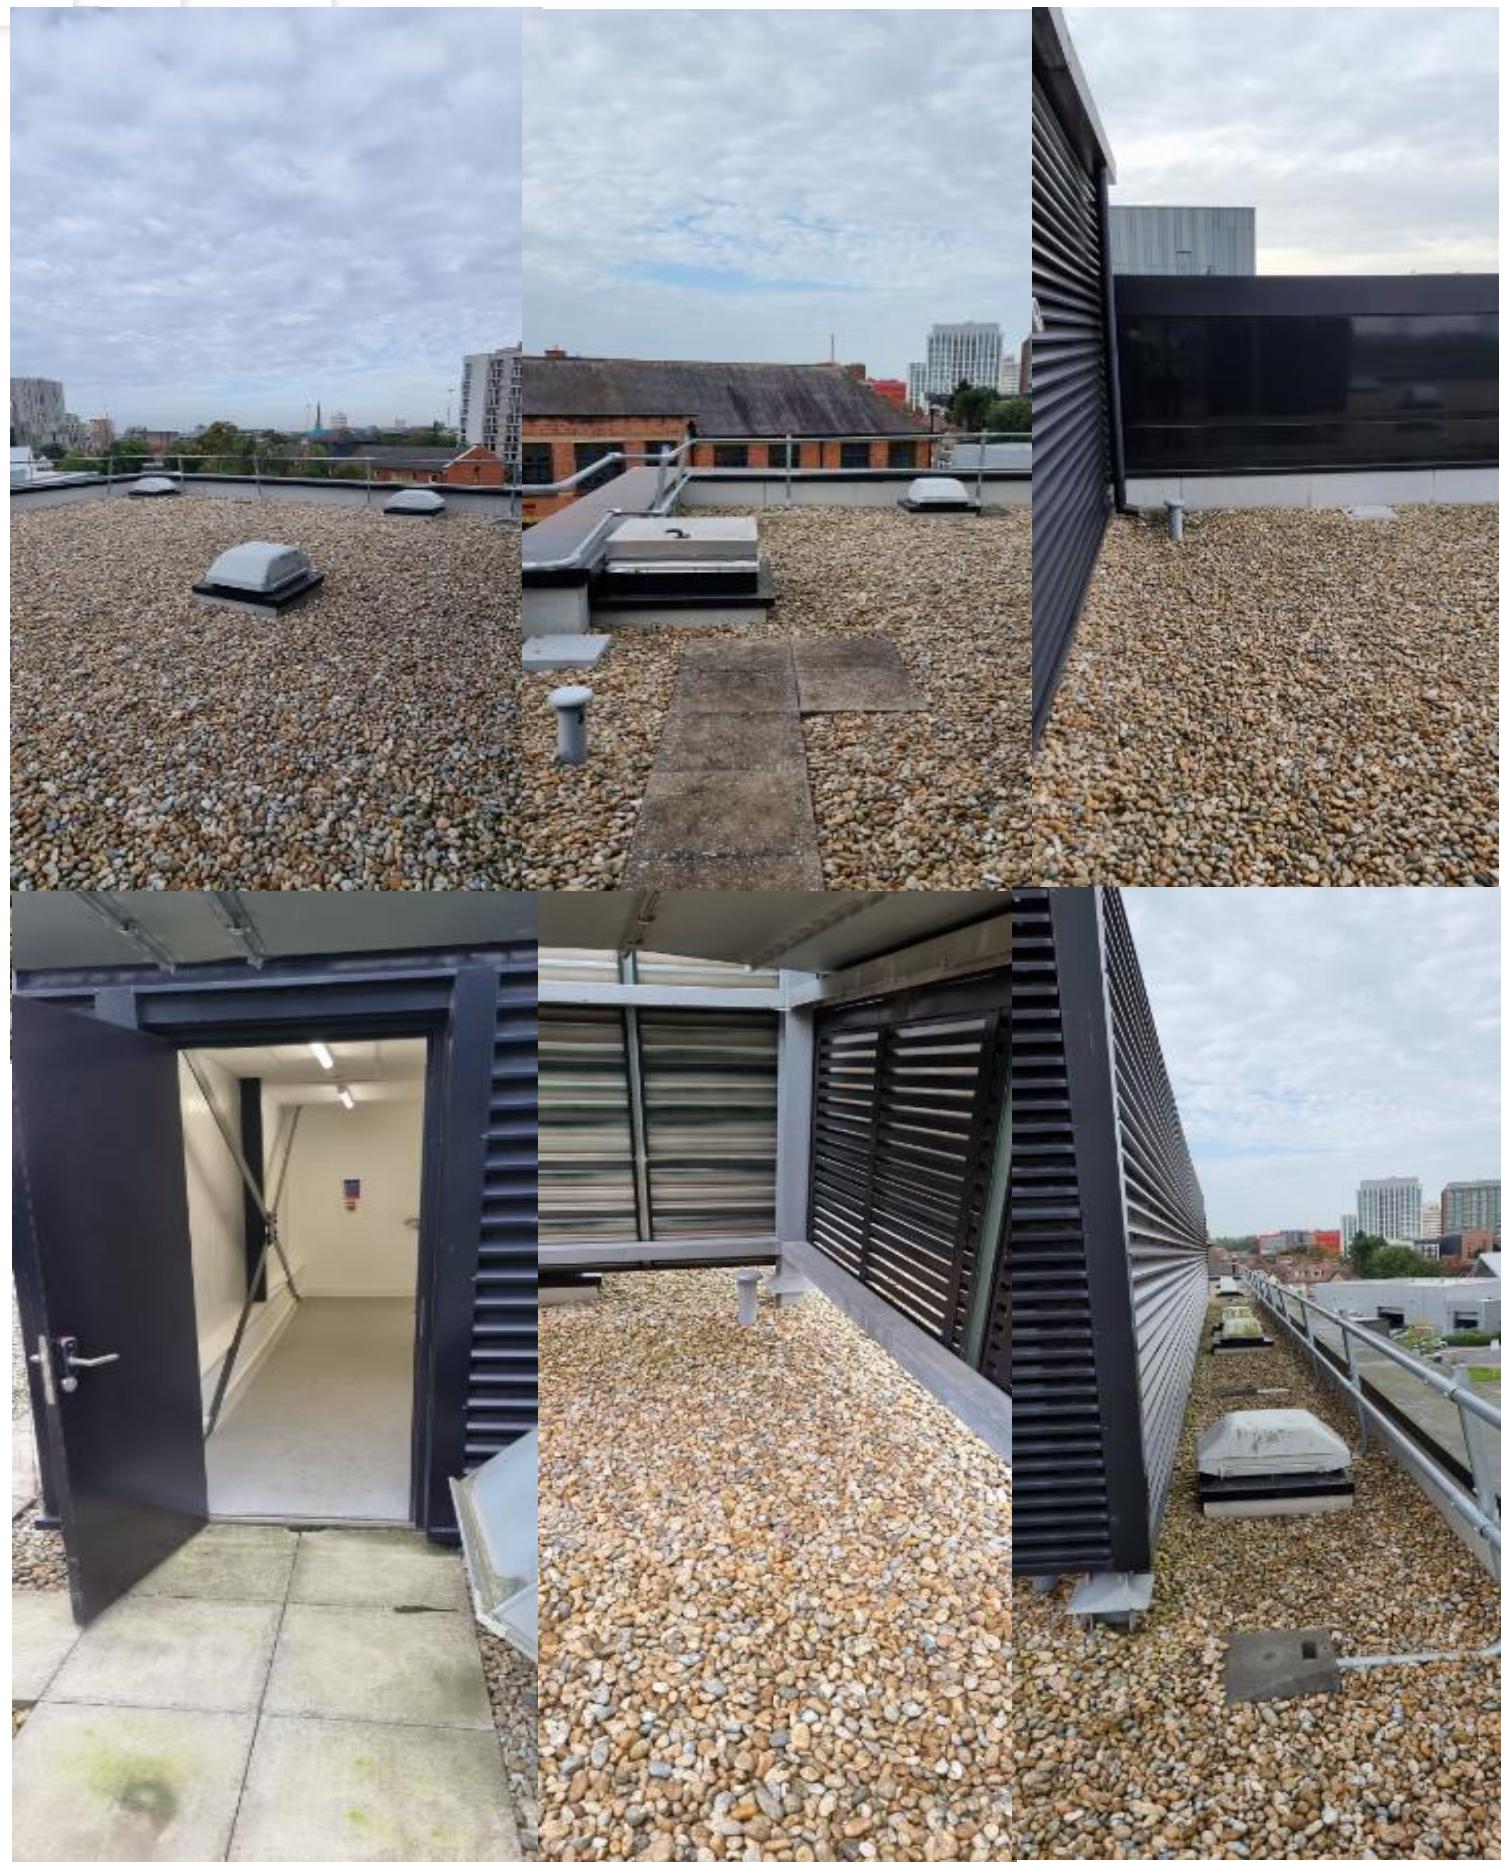
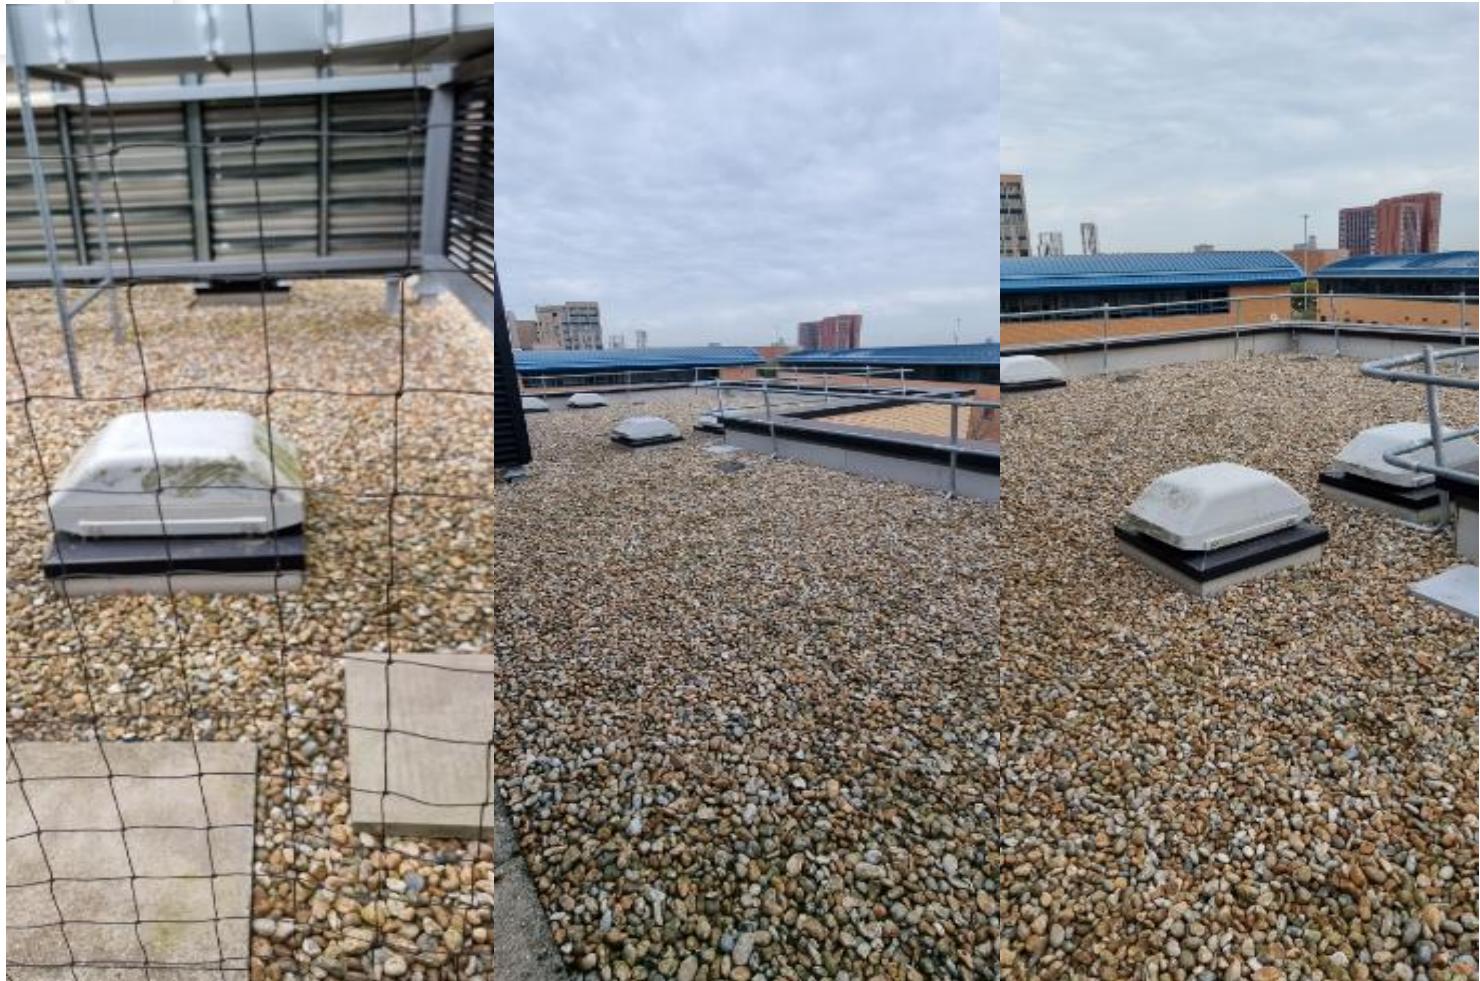
Photos – Building 1/Roof 1

Area	Building 1/Roof area 1		Roof height	Approx 15m								
Access	Hatch	Door	Fixed Ladder	Temp Ladder	MEWP	Other						
Access Comments												
The roof areas are accessed on a case-by-case basis by site maintenance staff and contractors, this roof area is covered by collective protection in the form of guardrail.												
Guardrail is within compliance.												
Roof area accessed by Door												
We advise no lone working on this roof.												
Tasks	Comments											
Lightning Protection Maintenance	Collective protection present, Mandatory PPE required to be specified by Coventry University.											
Chimney Flue Maintenance	Collective protection present, Mandatory PPE required to be specified by Coventry University.											
Smoke Vent Maintenance	Collective protection present, Mandatory PPE required to be specified by Coventry University.											
Plant Maintenance	Collective protection present, Mandatory PPE required to be specified by Coventry University.

Access Suggestions												
A permit to work system could help control who goes on the roof area to ensure they understand the risk associated with this area and the procedures in place also to identify that the engineers/contractors are trained and competent and that their RAMS are identified and suitable for the works required of them regarding access methods/Rescue.												
We suggest that anyone going to the roof areas should always work in pairs in case of an emergency, this roof area is covered by collective protection, mandatory PPE required.

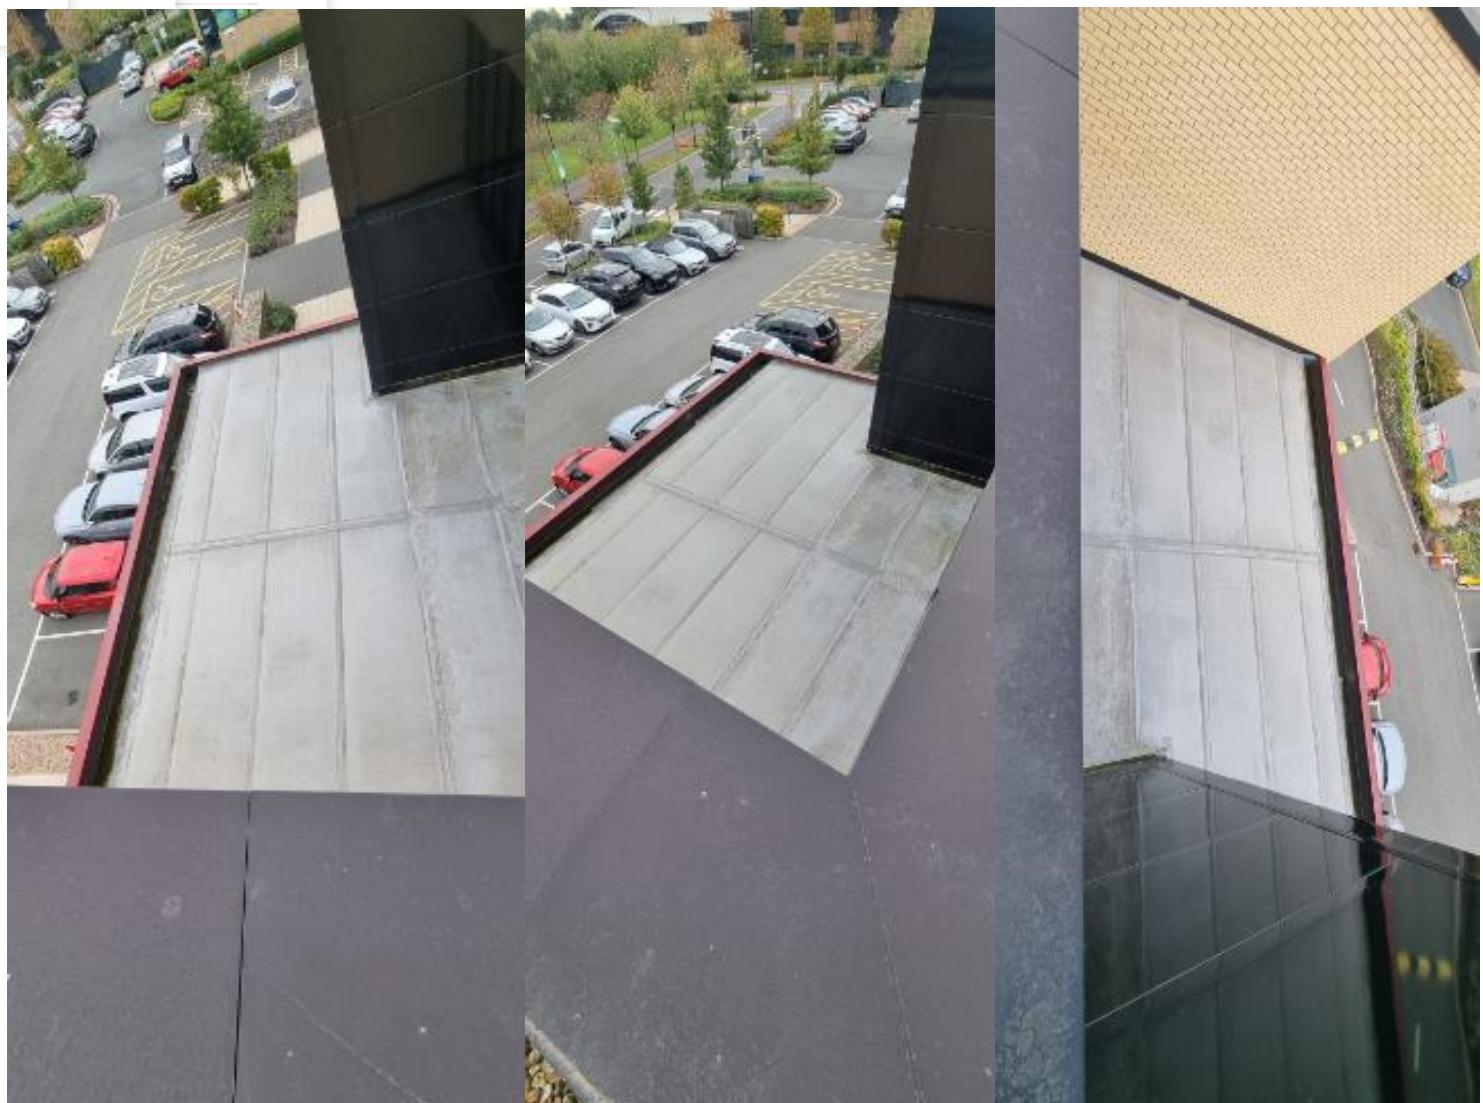
Building 1/Roof 2

Building 1/ Roof area 2		Roof height	Approx 10m		
Hatch	Door	Fixed Ladder	Temp Ladder	MEWP	Other
				X	
Access Comments					
<p>The roof areas are accessed on a case-by-case basis by site maintenance staff and contractors</p> <p>Roof area is not covered by any means of fall protection equipment. No fixed access, we advise a MEWP is the only suitable access for this roof area.</p>					
We advise no lone working on this roof.					
Tasks	Comments				
Lightning Protection Maintenance	No fixed access, no fall protection, SSOW/MEWP required.				
Gutter Cleaning/Maintenance	No fixed access, no fall protection, SSOW/MEWP required.				
Window Cleaning	No fixed access, no fall protection, SSOW/MEWP required.

Roof 2 has maintainable assets although can only be reached via way of MEWP.

A permit to work system could help control who goes on the roof area to ensure they understand the risk associated with this area and the procedures in place also to identify that the engineers/contractors are trained and competent and that their RAMS are identified and suitable for the works required of them regarding access methods/Rescue.

A MEWP is required for access onto this roof area therefore suitable training, PPE and SSOW must be in place.

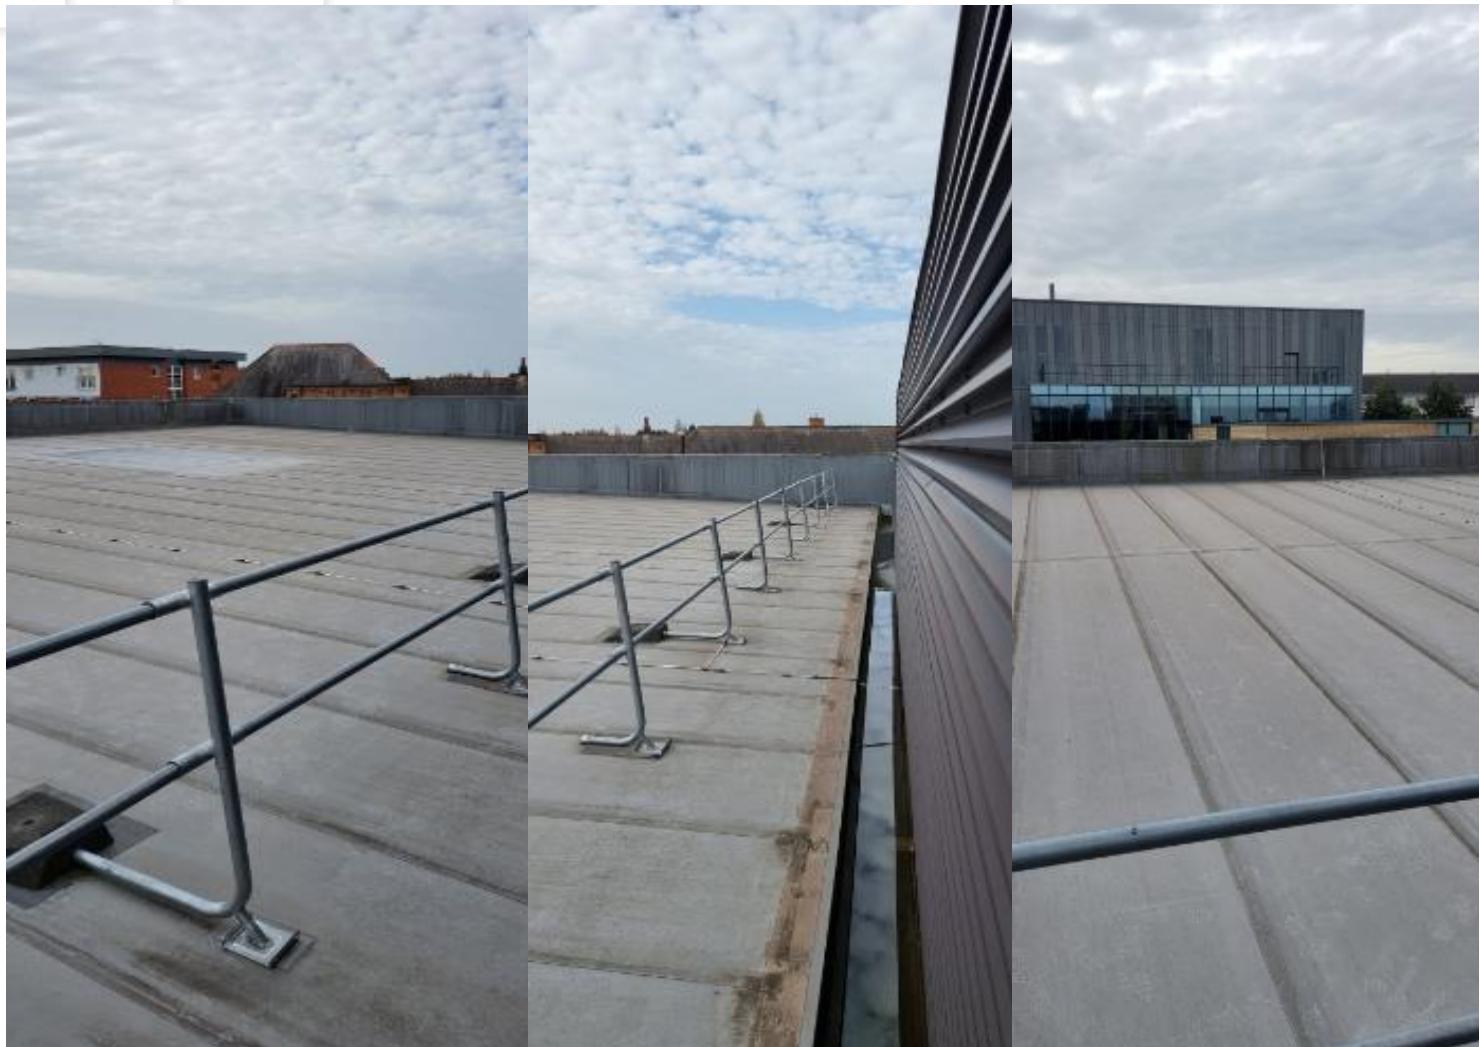
Building 1/Roof 3

Area	Building 1/Roof area 3		Roof height	Approx 15m		
Access	Hatch	Door	Fixed Ladder	Temp Ladder	MEWP	Other
Access Comments						
The roof areas are accessed on a case-by-case basis by site maintenance staff and contractors, this roof area is covered by collective protection in the form of guardrail.						
Guardrail is not within compliance.						
Roof area accessed by Door						
We advise no lone working on this roof.						
Tasks		Comments				
Lightning Protection Maintenance		Lightning protection is located outside the confines of the collective protection therefore an SSOW is required.

Access Suggestions
A permit to work system could help control who goes on the roof area to ensure they understand the risk associated with this area and the procedures in place also to identify that the engineers/contractors are trained and competent and that their RAMS are identified and suitable for the works required of them regarding access methods/Rescue.
We suggest that anyone going to the roof areas should always work in pairs in case of an emergency, this roof area is covered by collective protection.
Additional considerations are to be made when accessing lightening protection, with additional advanced training access can be made using work positioning equipment.

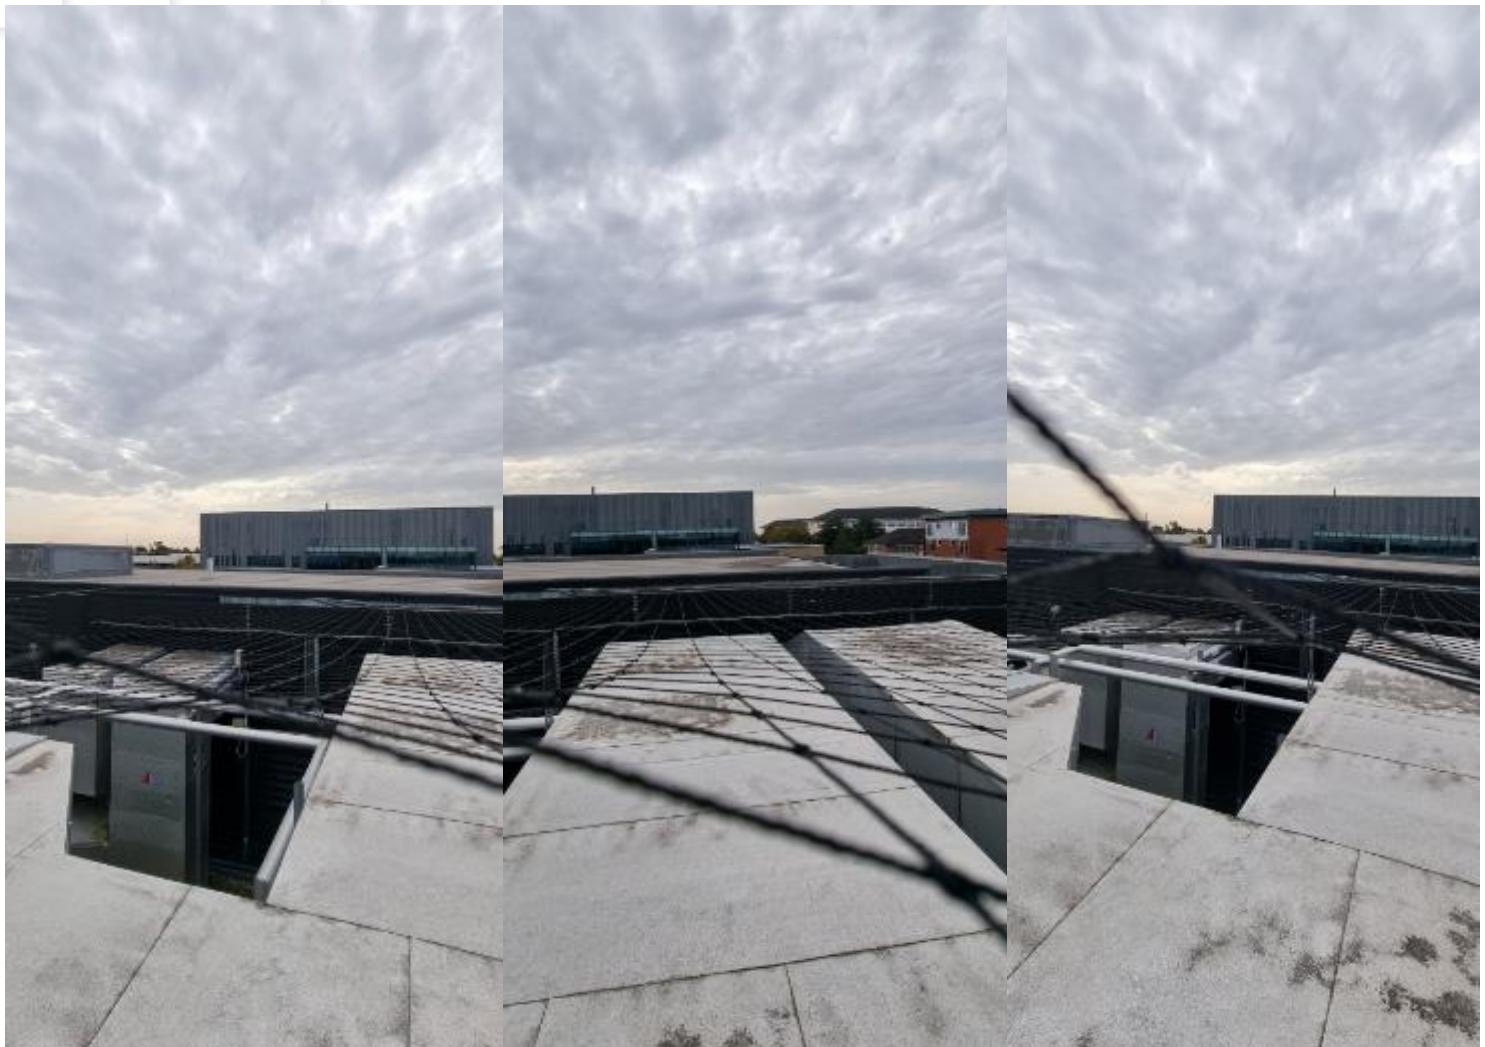
Building 1/roof 4

Area	Building 1/Roof area 4			Roof height	Approx 5m	
Access	Hatch	Door	Fixed Ladder	Temp Ladder	MEWP	Other
Access Comments						
The roof areas are accessed on a case-by-case basis by site maintenance staff and contractors, this roof has no fixed access or permanent fall protection equipment.						
	Roof area accessed by Temporary ladder.					
	We advise no lone working on this roof.					
Tasks	Comments					
No Assets present.	No requirement to access this roof area, no assets present.

Roof 4 Does not appear to have any maintainable assets along with no fixed/permanent means of access. Any access to this roof area will require an SSOW.

Access Suggestions
A permit to work system could help control who goes on the roof area to ensure they understand the risk associated with this area and the procedures in place also to identify that the engineers/contractors are trained and competent and that their RAMS are identified and suitable for the works required of them regarding access methods/Rescue.
We suggest that anyone going to the roof areas should always work in pairs in case of an emergency, this roof area had no fixed access or permanent fall protection. Although there appears that there are no maintainable assets present therefore no obvious reason for access.
