Height Safety Asset Management Report

Coventry University – The Priory Building, Coventry, West midlands, CV1 5FJ

Surveyed on behalf of Coventry University

Date: 20/10/2023

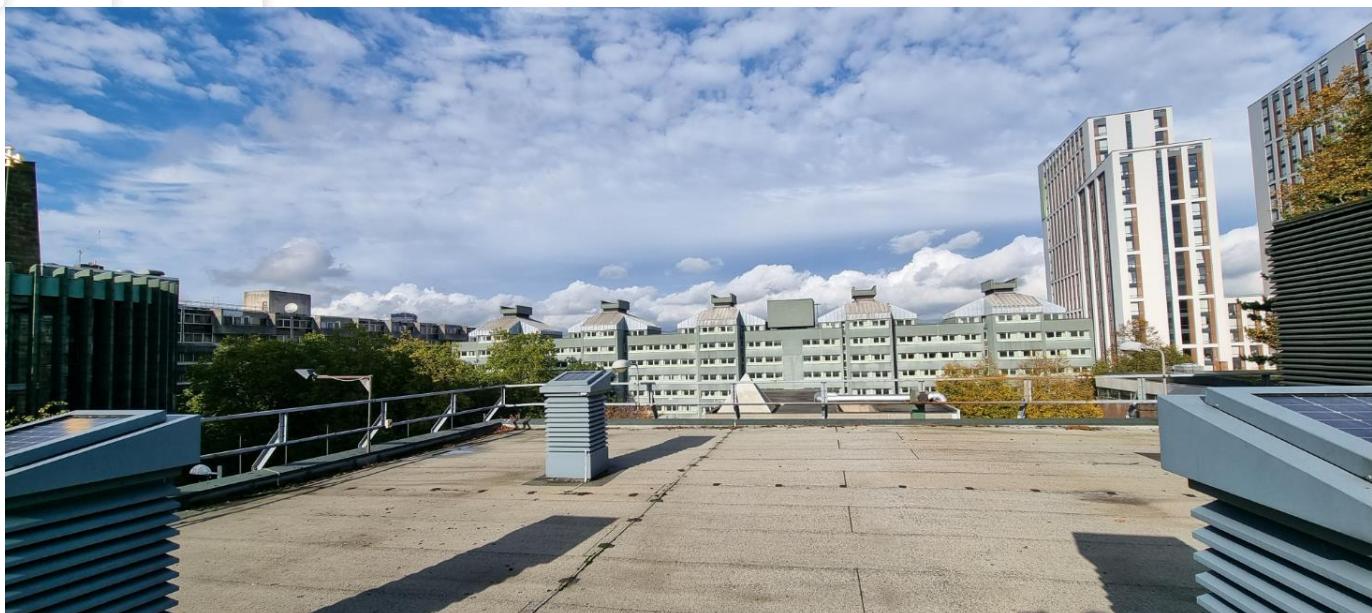
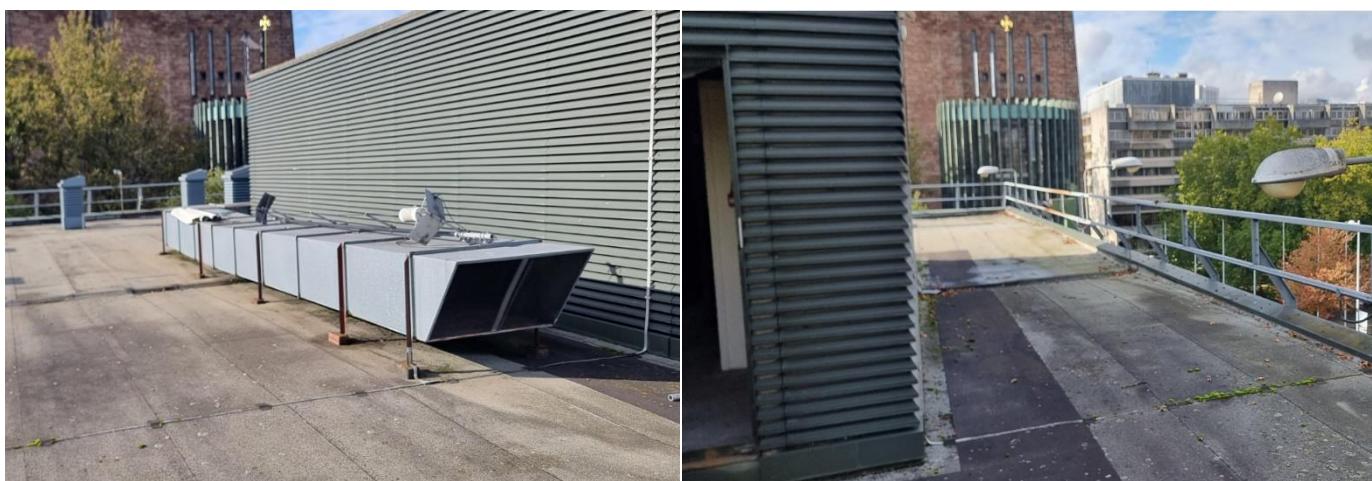
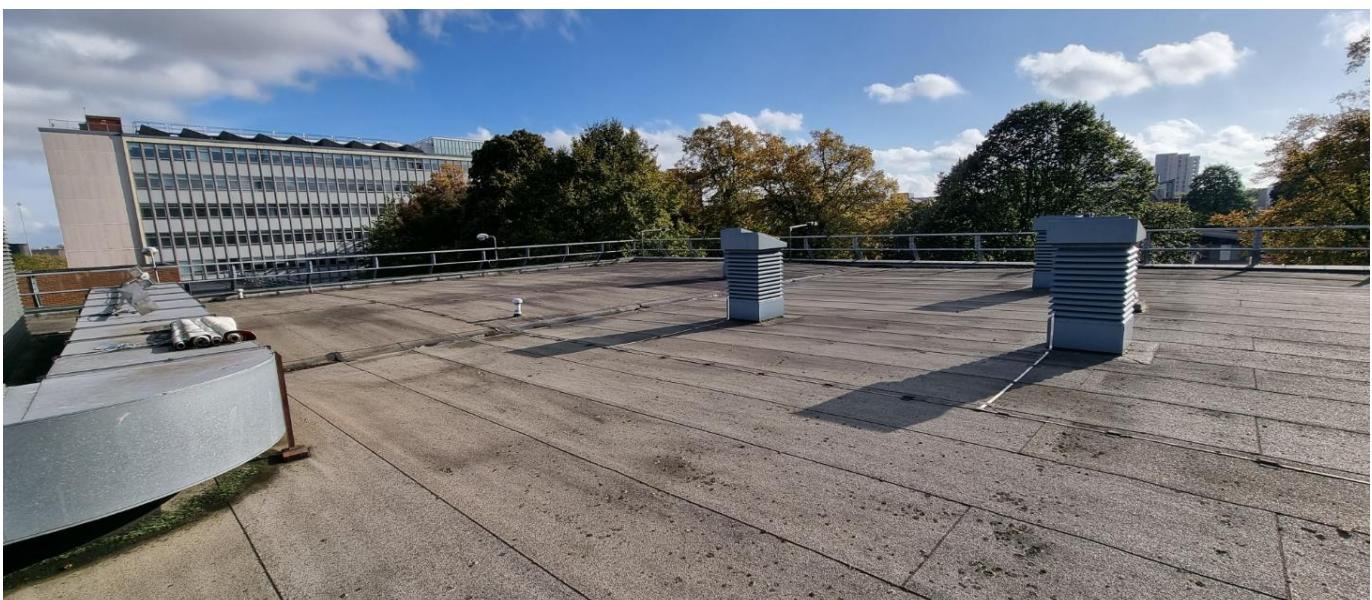
Photos – Roof 1

Area	Roof area 1		Roof height	Approx 14m								
Access	Hatch	Door	Fixed Ladder	Temp Ladder	MEWP	Other						
Access Comments												
The roof areas are accessed on a case-by-case basis by site maintenance staff and contractors												
Roof area accessed by fixed ladder/door												
We advise no lone working on this roof.												
Tasks	Comments											
Gutter Maintenance	There are gutters located to the perimeter of the building, these are to be cleaned/maintained whilst staying in the confines of the collective protection.											
Air Vent Maintenance	There are Air vents located within the confines of the collective protection, these are to be maintained whilst staying in the confines of the collective protection.											
Lightning Protection Maintenance	Lightening protection located within the confines of the collective protection, these are to be maintained whilst staying in the confines of the collective protection.

Chimney Flue Maintenance	Chimney Flues located within the confines of the collective protection, these are to be maintained whilst staying in the confines of the collective protection.											
Access Suggestions												
A permit to work system could help control who goes on the roof area to ensure they understand the risk associated with this area and the procedures in place also to identify that the engineers/contractors are trained and competent and that their RAMS are identified and suitable for the works required of them regarding access methods/Rescue.												
We suggest that anyone going to the roof areas should always work in pairs in case of an emergency, this roof area is covered by collective protection although the access is via fixed ladder, therefore we could advise that additional ladder training would benefit the end user, also the inclusion of suitable PPE, in this case Mandatory site PPE as specified by Coventry University.

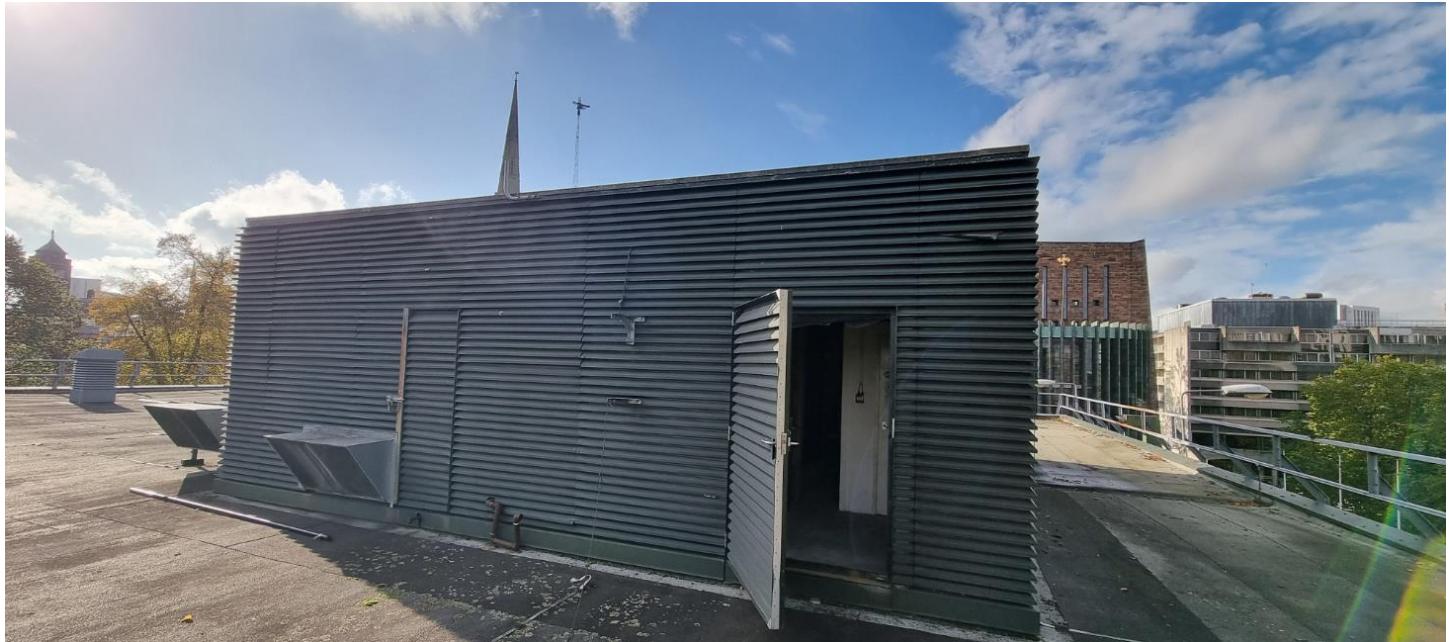
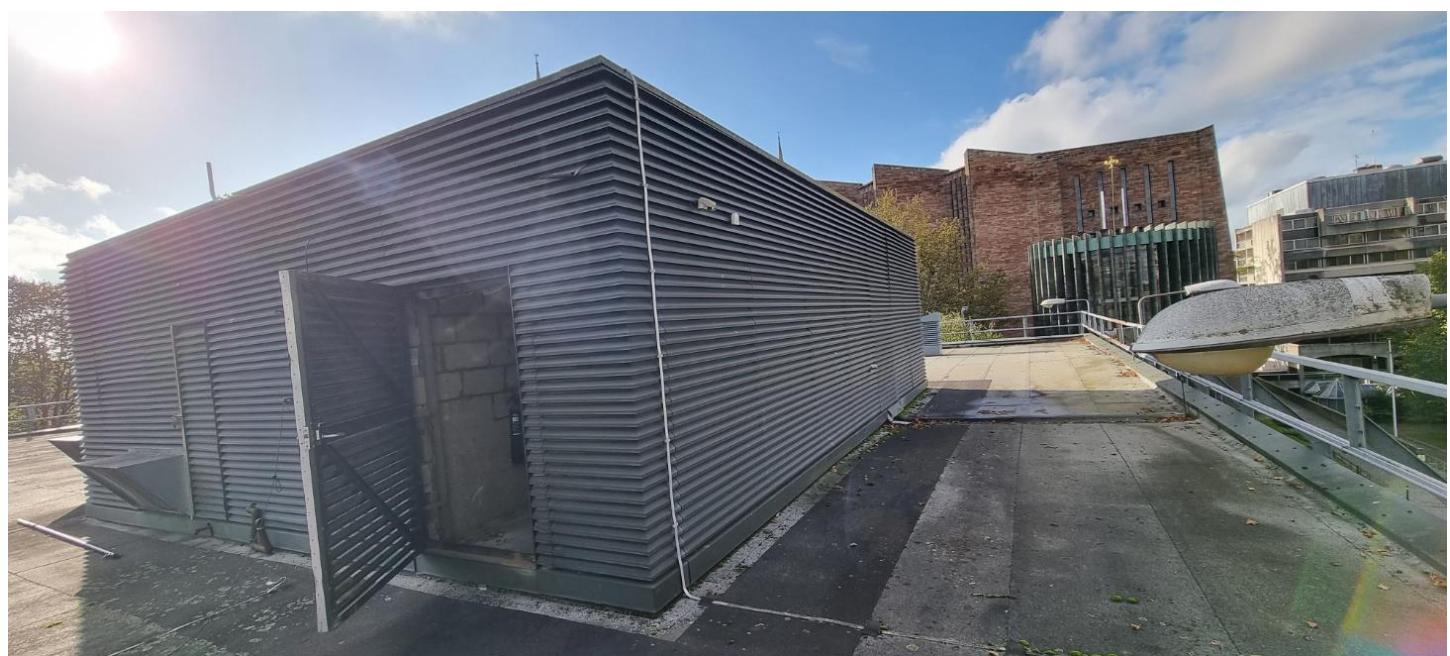
Roof 2

Roof area 2		Roof height	Approx 4m		
Hatch	Door	Fixed Ladder	Temp Ladder	MEWP	Other
			x		
Access Comments					
<p>The roof areas are accessed on a case-by-case basis by site maintenance staff and contractors</p> <p>Roof area accessed by temp ladder, no fall protection/assets present on the roof area therefore no current requirement to access.</p>					
<p>We advise no lone working on this roof.</p>					
Tasks		Comments			
N/A		No Assets present.

Access Suggestions
<p>A permit to work system could help control who goes on the roof area to ensure they understand the risk associated with this area and the procedures in place also to identify that the engineers/contractors are trained and competent and that their RAMS are identified and suitable for the works required of them regarding access methods/Rescue.</p>
<p>We suggest that anyone going to the roof areas should always work in pairs in case of an emergency, this roof area is not covered by any fall protection although there are no serviceable assets located on this upper section, no cause for access.</p>
