Height Safety Asset Management Report

Site Assessment & Report

Coventry University – Priory Hall Block J, Priory Street, Coventry, CV1 5FB

Date: 20/10/2023

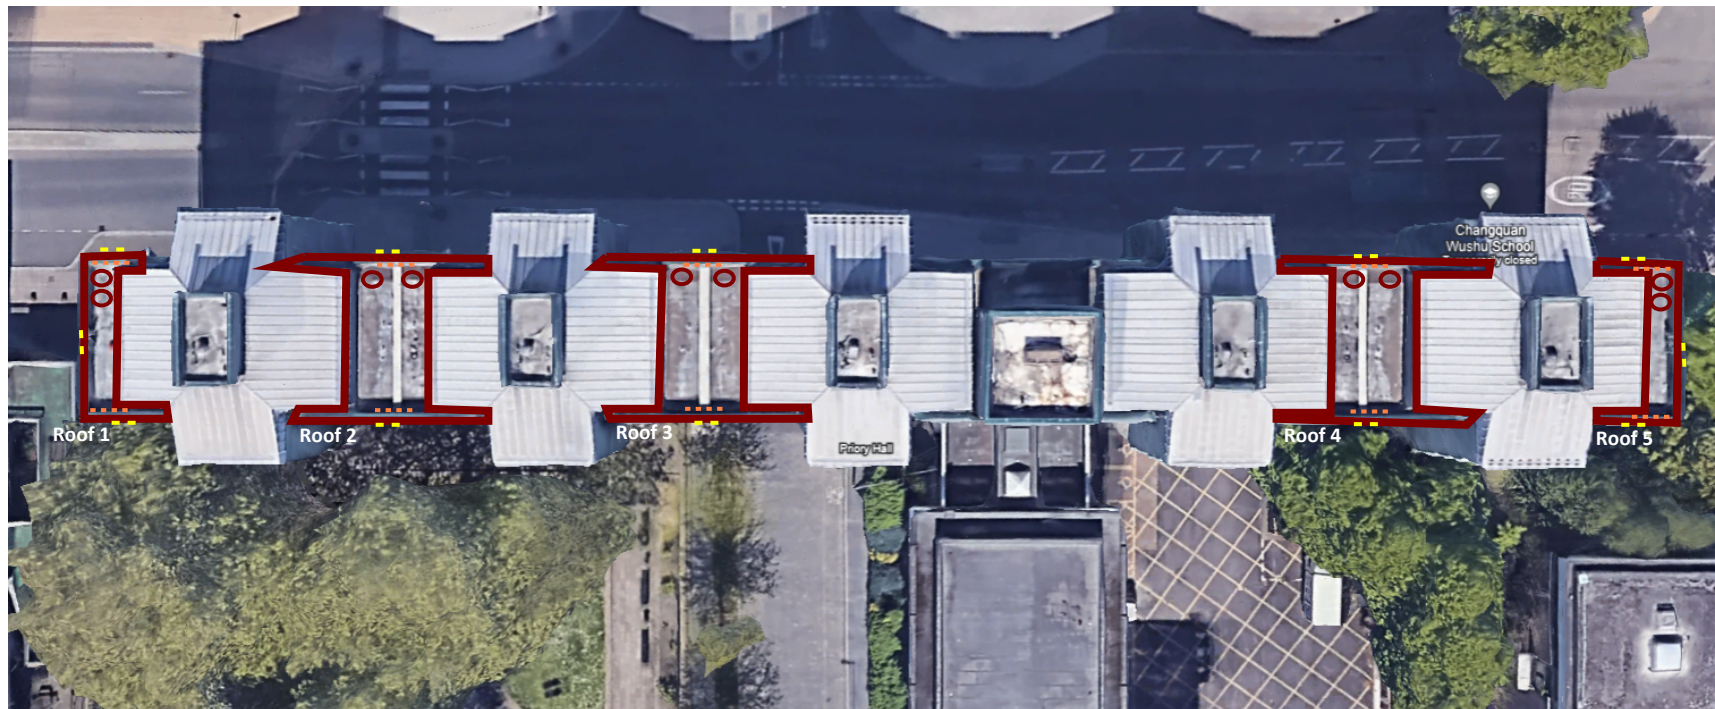
Main Roof - Areas 1 - 5

The roof areas are accessed on a case-by-case basis by site maintenance staff and contractors, this roof area is covered by Collective protection in the form of a parapet. Mandatory PPE is required on this roof only.

Advise all assets/tasks can be completed from within the collective protection.

All assets can be maintained from within the collective protection.

A permit to work system could help control who goes on the roof area to ensure they understand the risk associated with this area and the procedures in place also to identify that the engineers/contractors are trained and competent and that their RAMS are identified and suitable for the works required of them regarding access methods/Rescue.

We suggest that anyone going to the roof areas should always work in pairs in case of an emergency, this roof area is covered by collective protection.
