Height Safety Asset Management Report

Site Assessment & Report

Coventry University – Sir John Laing, Much park street, Coventry, CV1 2LT

Date: 20/10/2023

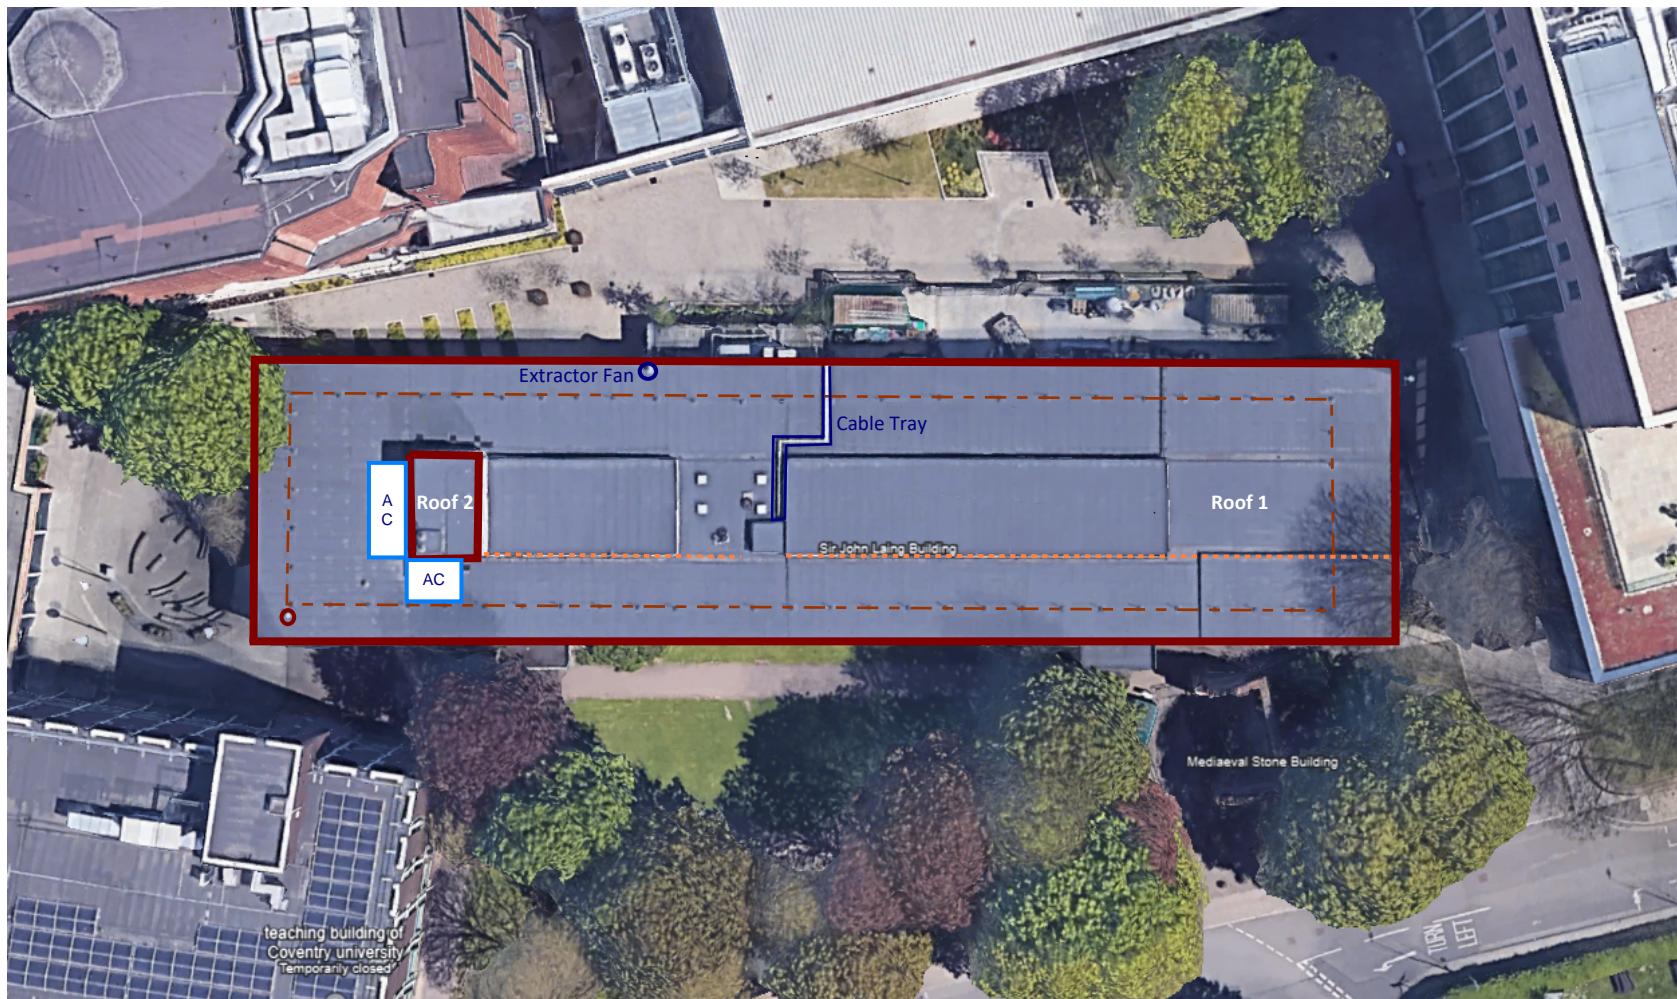
Main Roof - Areas 1 - 2

Area	Building 1/Roof 1		Roof height	Approx 15m		
Access	Hatch	Door	Fixed Ladder	Temp Ladder	MEWP	Other
Access Comments						
The roof areas are accessed on a case-by-case basis by site maintenance staff and contractors						
Roof area accessed via fixed ladder; additional considerations should be made in regard to rescue.						
We advise no lone working on this roof.						
Tasks	Comments					
Gutter Maintenance	Located within D-marc boundary, this must be always adhered to and should be detailed within SSOW.					
Air Conditioning Unit Maintenance	Located within D-marc boundary, this must be always adhered to and should be detailed within SSOW.					
Extraction Fans Maintenance	Located within D-marc boundary, this must be always adhered to and should be detailed within SSOW. Some of these are located outside of the boundaries of the D-marc SSOW also required.					
Chimney Flue Maintenance	Located within D-marc boundary, this must be always adhered to and should be detailed within SSOW.

Cable Tray Maintenance	Located within D-marc boundary, this must be always adhered to and should be detailed within SSOW. Some of these are located outside of the boundaries of the D-marc SSOW also required.

There is existing D-marc installed although this does not cover all aspects and requirements on this roof in some cases there are more practical forms of fall protection available which would be more suited for these areas, due to this more often than not the end user will be required to work outside of these perimeters with the use of correct PPE and adequate training, please note there are certain assets that currently cannot be accessed without additional equipment/specialist access methods.

Area	Building 1/Roof 2		Roof height	Approx 6m		
Access	Hatch	Door	Fixed Ladder	Temp Ladder	MEWP	Other
Access Comments						
The roof areas are accessed on a case-by-case basis by site maintenance staff and contractors						
Roof area accessed by temp ladder; no fall protection present therefore a SSOW is required.						
We advise no lone working on this roof.						
Tasks	Comments					
N/A	No assets visible/present on this raised roof area, no requirement for access.

Access Suggestions
A permit to work system could help control who goes on the roof area to ensure they understand the risk associated with this area and the procedures in place also to identify that the engineers/contractors are trained and competent and that their RAMS are identified and suitable for the works required of them regarding access methods/Rescue.
We suggest that anyone going to the roof areas should always work in pairs in case of an emergency, in most cases we would advise that additional Horizontal cable systems are installed to aid the safe movement around these roof areas in an aim to keep the end user away from any potential fall hazard, currently the access methods fall down to the end user and their competency/training, there is excess potential for human error involved that could potentially be mitigated by the installation of additional equipment.
