Height Safety Asset Management Report

Site Assessment & Report

Coventry University – The Enterprise Centre, Coventry, West midlands, CV1 2TX

Surveyed on behalf of Coventry University

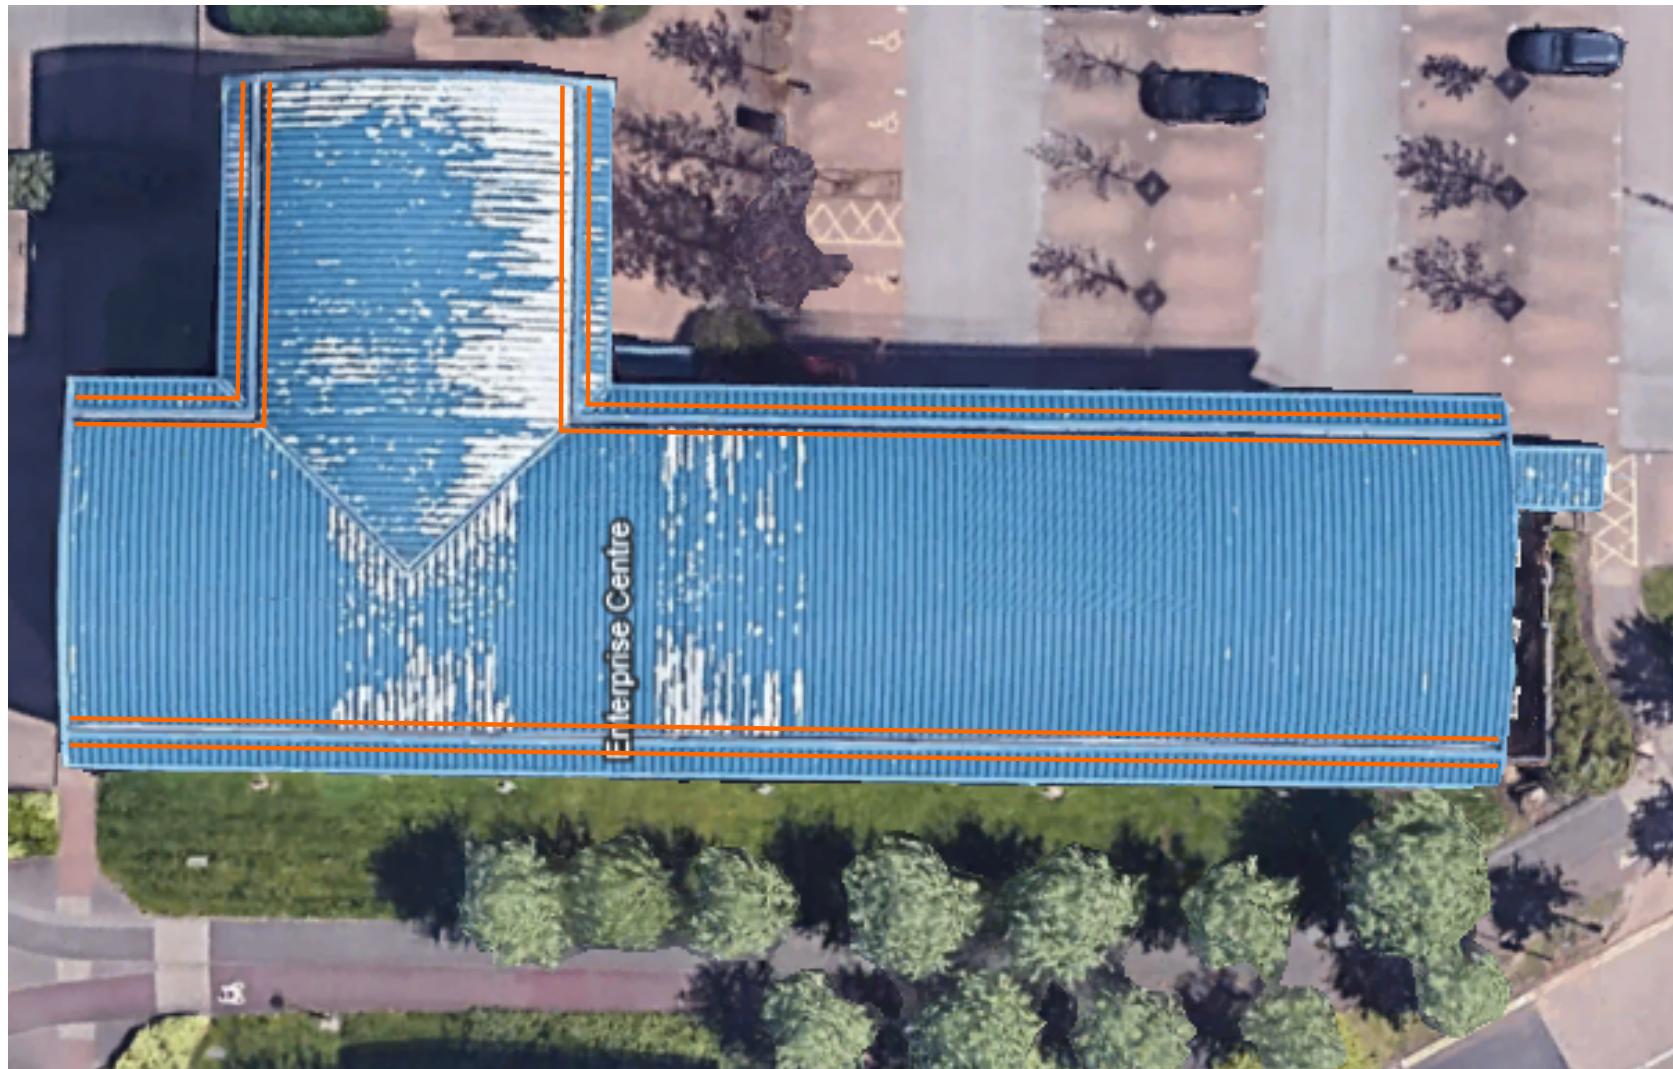
Building 1 - Main Roof

Area	Main Roof		Roof height	Approx 20m		
Access	Hatch	Door	Fixed Ladder	Temp Ladder	MEWP	Other
Access Comments						
The roof areas are accessed on a case-by-case basis by site maintenance staff and contractors						
No Current Fixed access, MEWP required.						
We advise no lone working on this roof due to the specialized access methods, MEWP required in order to access.						
Tasks	Comments					
Gutter Maintenance	There are gutters located to the perimeter of the building, These are to be cleaned/maintained from MEWP. MEWP specific PPE required.

Other Comments
There is existing Height safety equipment installed although this does not cover all aspects and requirements on this roof in some cases there a more practical forms of fall protection available which would be more suited for these areas, due this more often than not the end user will be required to work outside of these perimeter with the use of correct PPE and adequate training, please note there are certain assets that currently cannot be accessed without additional equipment/specialist access methods. Please see asset list where these will be highlighted.

This roof area is largely inaccessible due to having no fixed access/access hatch, there are gutters present that can be seen from ground level. Adequate space surrounds the building to allow for MEWP, advise any works be undertook via MEWP.

Access Suggestions
A permit to work system could help control who goes on the roof area to ensure they understand the risk associated with this area and the procedures in place also to identify that the engineers/contractors are trained and competent and that their RAMS are identified and suitable for the works required of them regarding access methods/Rescue.
We suggest that anyone going to the roof areas should always work in pairs in case of an emergency, especially with the specialist access/traversal methods required on this roof by way of work positioning and the minimal fall protection installed, in most cases we would advise that additional Horizontal cable systems are installed to aid the safe movement around these roof areas in an aim to keep the end user away from any potential fall hazard, currently the access methods fall down to the end user and their competency/training, there is excess potential for human error involved that could potentially be mitigated by the installation of additional equipment.
