## **Height Safety Asset Management Report**

### **Site Assessment & Report**

Coventry University – The Print Shop (Resource Centre), 3 Whitefriars Street, Coventry, CV1 2DS

### **Surveyed on behalf of Coventry University**

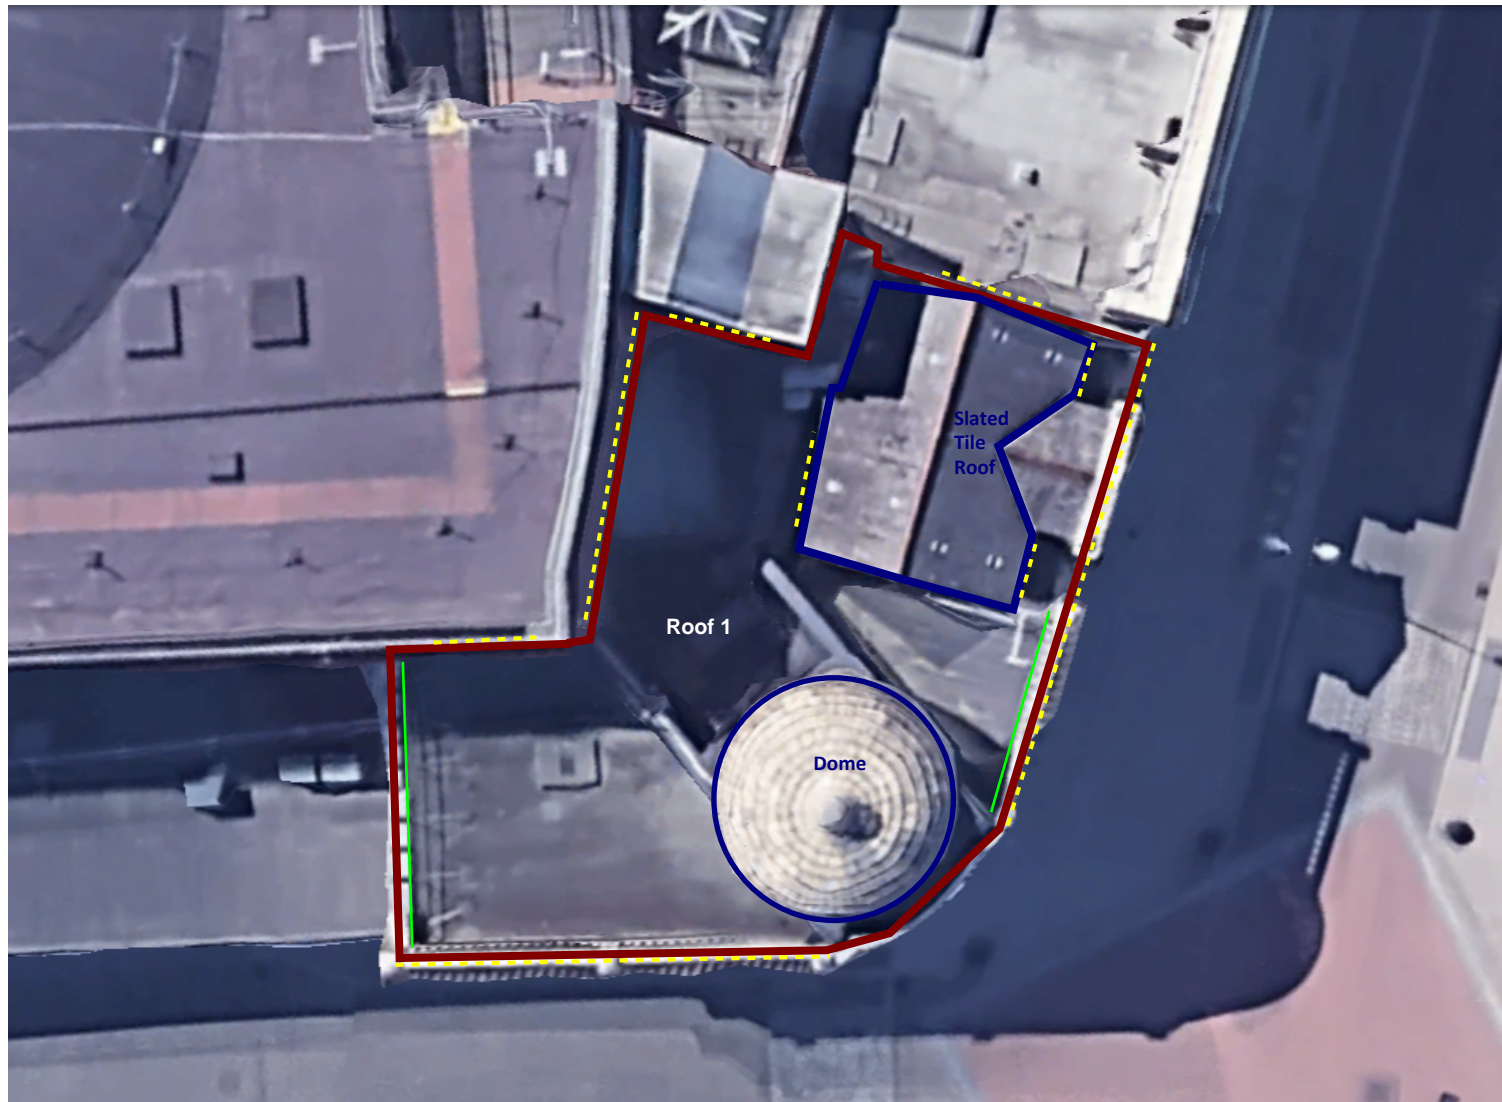
## Main Roof

The roof areas are accessed on a case-by-case basis by site maintenance staff and contractors, this roof area is covered by collective Fall protection in the form of guardrail/parapet. This equipment is within compliance.

Tasks	Comments
Lightning Protection Maintenance	Lightning protection is located both within the confines of the collective protection and outside, lightening protection located outside on the roof dome had no current safe means of access/fall protection. Therefore, and SSOW is required.
Gutter Maintenance	Collective protection present, Mandatory PPE required to be specified by Coventry University.

Additional considerations are to be made when accessing lightening protection that falls outside of the confines of the collective protection, SSOW required.
