## Height Safety Asset Management Report

### Site Assessment & Report

Coventry University – Whitefriars Building, Coventry, West midlands, CV1 2DS

**Surveyed on behalf of Coventry University**

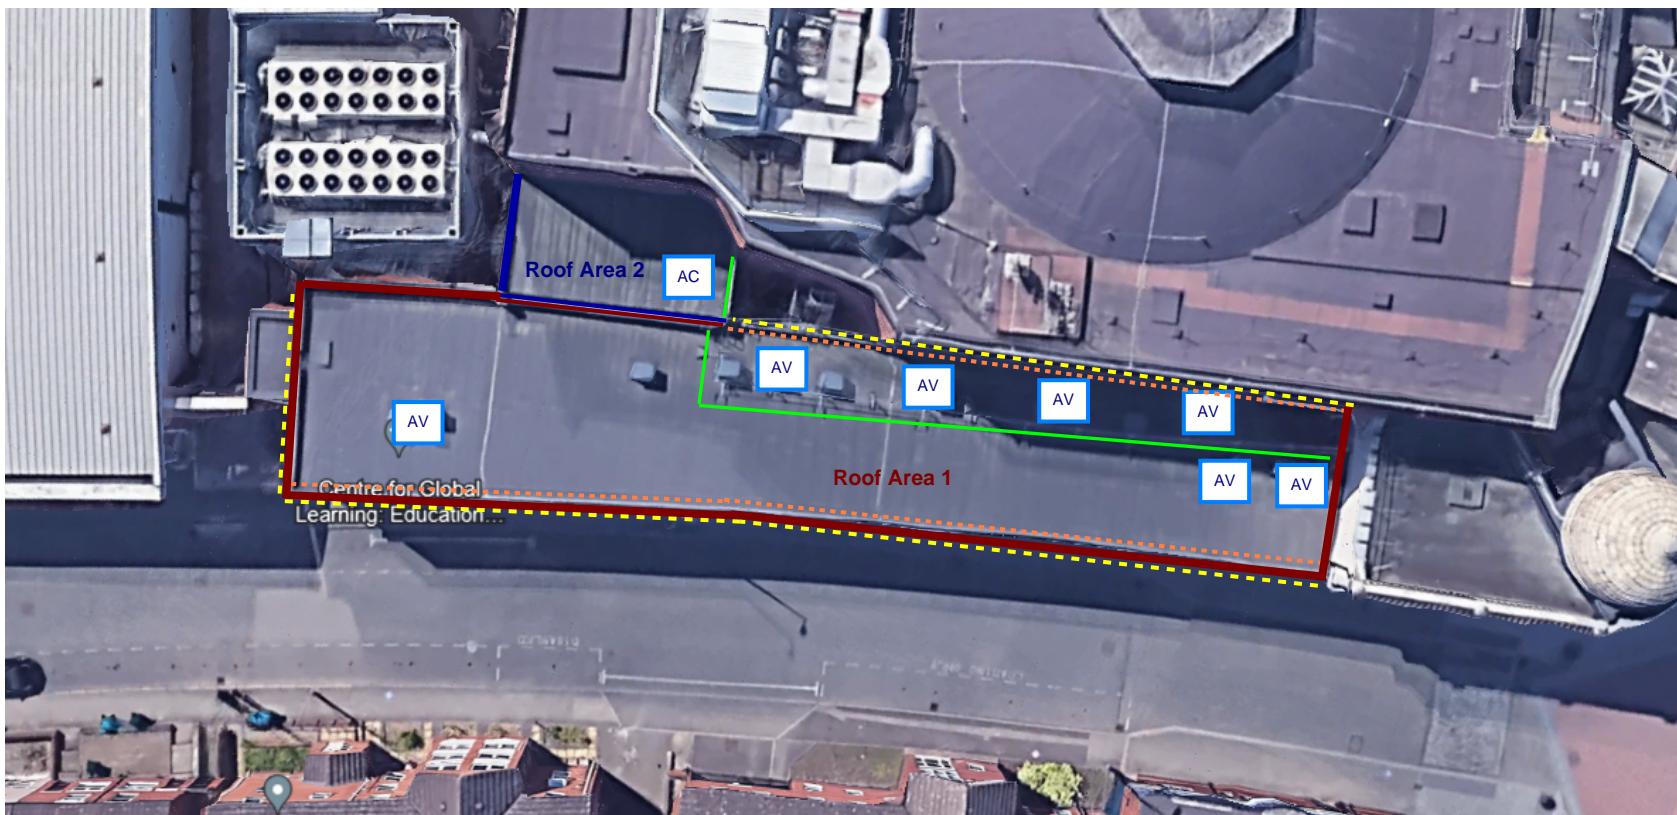
## Whitefriars Building 1 - Main Roof - Areas 1 & 2

Area	Roof area 1		Roof height	Approx 15m		
Access	Hatch	Door	Fixed Ladder	Temp Ladder	MEWP	Other
<b>Access Comments</b>						
The roof areas are accessed on a case-by-case basis by site maintenance staff and contractors, this roof area is covered by collective protection and is within compliance. Although certain assets on this roof are located outside the confines of the collective protection, In this case SSOW is required.						
Roof area accessed by fixed ladder/door						
We advise no lone working on this roof.						
Tasks	<b>Comments</b>					
Gutter Maintenance	<p>Gutters are located within the confines of the collective protection, these are to be maintained whilst staying in the confines of the collective protection.</p> <p>Gutters are also located outside of the confines of the collective protection therefore additional training/PPE and SSOW will be required.</p>					
Air Vent Maintenance	<p>There are Air Vents located within the confines of the collective protection, these are to be maintained whilst staying in the confines of the collective protection.</p> <p>Air vents are also located outside of the confines of the collective protection therefore additional training/PPE and SSOW will be required.</p>

Lightning Protection Maintenance	<p>Lightning Protection is located within the confines of the collective protection, this to be maintained whilst staying in the confines of the collective protection.</p> <p>Lightning Protection is also located outside of the confines of the collective protection therefore additional training/PPE and SSOW will be required.</p>

The roof areas are accessed on a case-by-case basis by site maintenance staff and contractors, this roof area is covered by collective protection and is within compliance. Although certain assets on this roof are located outside the confines of the collective protection, In this case SSOW is required.

Tasks	Comments
Air Conditioning Unit Maintenance	Air conditioning units are located within the confines of the of the collective protection, this to be maintained whilst staying in the confines of the collective protection.
Lightning Protection Maintenance	Lightning protection is located within the confines of the of the collective protection, this to be maintained whilst staying in the confines of the collective protection. Lightening protection is also located outside of the confines of the collective protection by an exposed roof edge therefore additional training/PPE and SSOW will be required.

A permit to work system could help control who goes on the roof area to ensure they understand the risk associated with this area and the procedures in place also to identify that the engineers/contractors are trained and competent and that their RAMS are identified and suitable for the works required of them regarding access methods/Rescue.

We suggest that anyone going to the roof areas should always work in pairs in case of an emergency, this roof area is covered by collective protection although the access is via fixed ladder, therefore we could advise that additional ladder training would benefit the end user, also the inclusion of suitable PPE, in this case Mandatory site PPE as specified by Coventry University.

Also, there are some assets that venture outside the confines of the collective protection and therefore will require additional training/equipment and SSOW.
