Height Safety Asset Management Report

Site Assessment & Report

Coventry University – Armstrong Siddeley Building, Coventry, West Midlands, CV1 5PY.

Surveyed on behalf of Coventry University

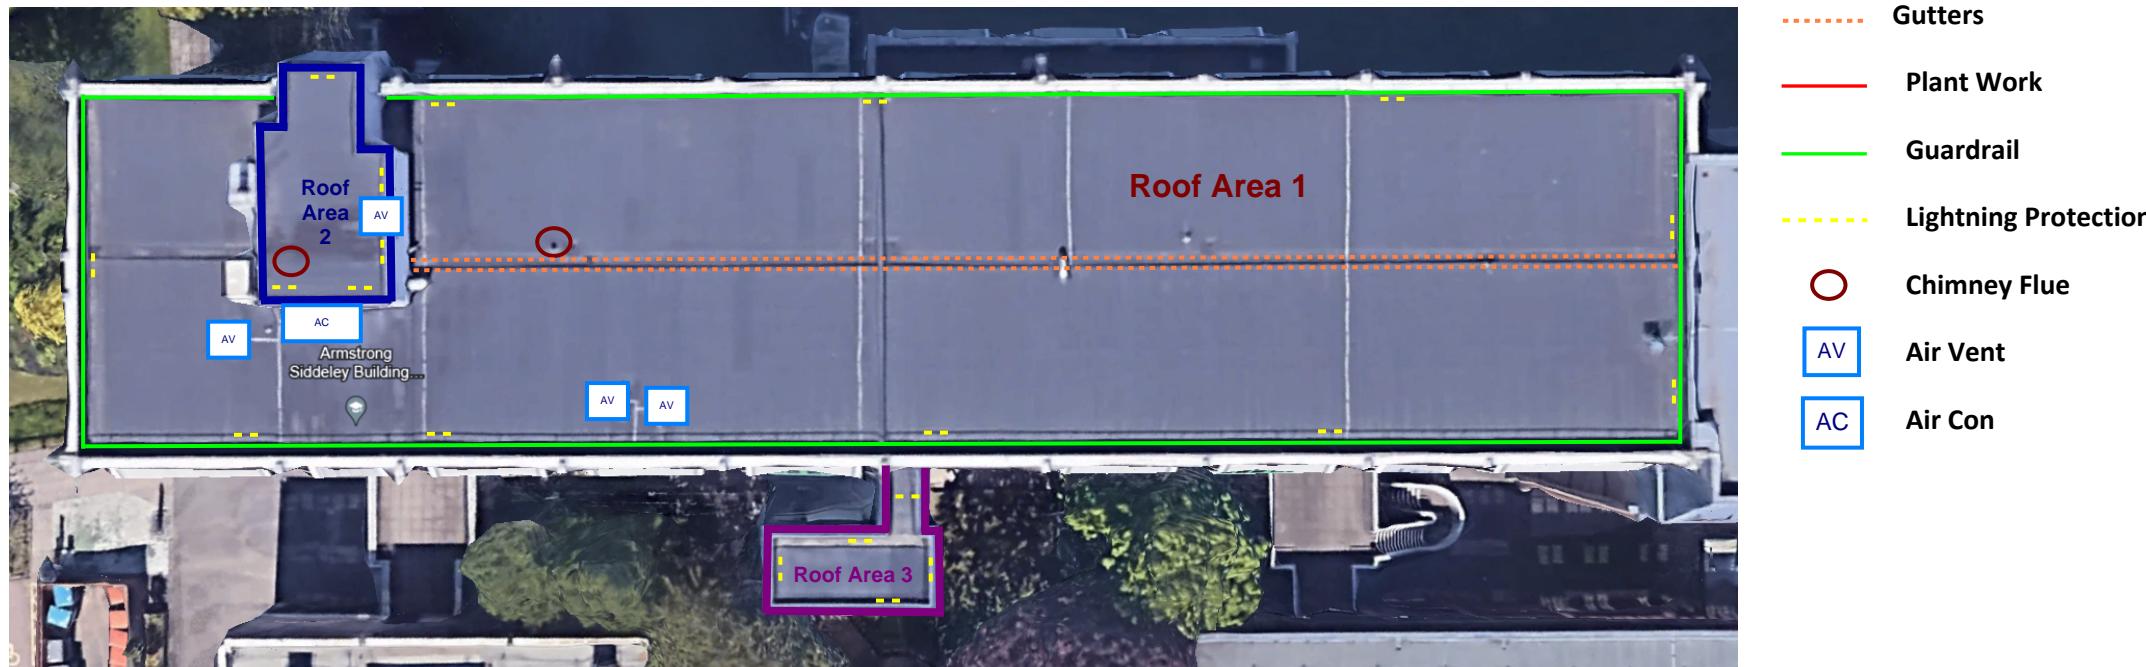
Building 1 - Main Roof - Areas 1, 2 and 3

Area	Roof Area 1		Roof height	Approx 40m								
Access	Hatch	Door	Fixed Ladder	Temp Ladder	MEWP	Other						
Access Comments												
The roof areas are accessed on a case-by-case basis by site maintenance staff and contractors, this roof area is covered by collective protection and is within compliance.												
Roof area accessed by fixed ladder.												
We advise no lone working on this roof.												
Tasks	Comments											
Gutter maintenance	There are gutters located to the perimeter of the building, these are to be cleaned/maintained whilst staying in the confines of the collective protection.											
Air Vents	There are air vents located within the confines of the collective protection, these are to be maintained whilst staying in the confines of the collective protection.											
Lightning Protection	Lightning Protection located within the confines of the collective protection, these are to be maintained whilst staying in the confines of the collective protection.

Chimney Flue	Chimney Flue located within the confines of the collective protection, these are to be maintained whilst staying in the confines of the collective protection.											
Access Suggestions												
A permit to work system could help control who goes on the roof area to ensure they understand the risk associated with this area and the procedures in place also to identify that the engineers/contractors are trained and competent and that their RAMS are identified and suitable for the works required of them regarding access methods/Rescue.												
We suggest that anyone going to the roof areas should always work in pairs in case of an emergency, this roof area is covered by collective protection although the access is via fixed ladder, therefore we could advise that additional ladder training would benefit the end user, also the inclusion of suitable PPE, in this case Mandatory site PPE as specified by Coventry University.
