Height Safety Asset Management Report

Site Assessment & Report

Coventry University – Beatrice shilling building, Coventry, West midlands, CV1 5JH

Surveyed on behalf of Coventry University

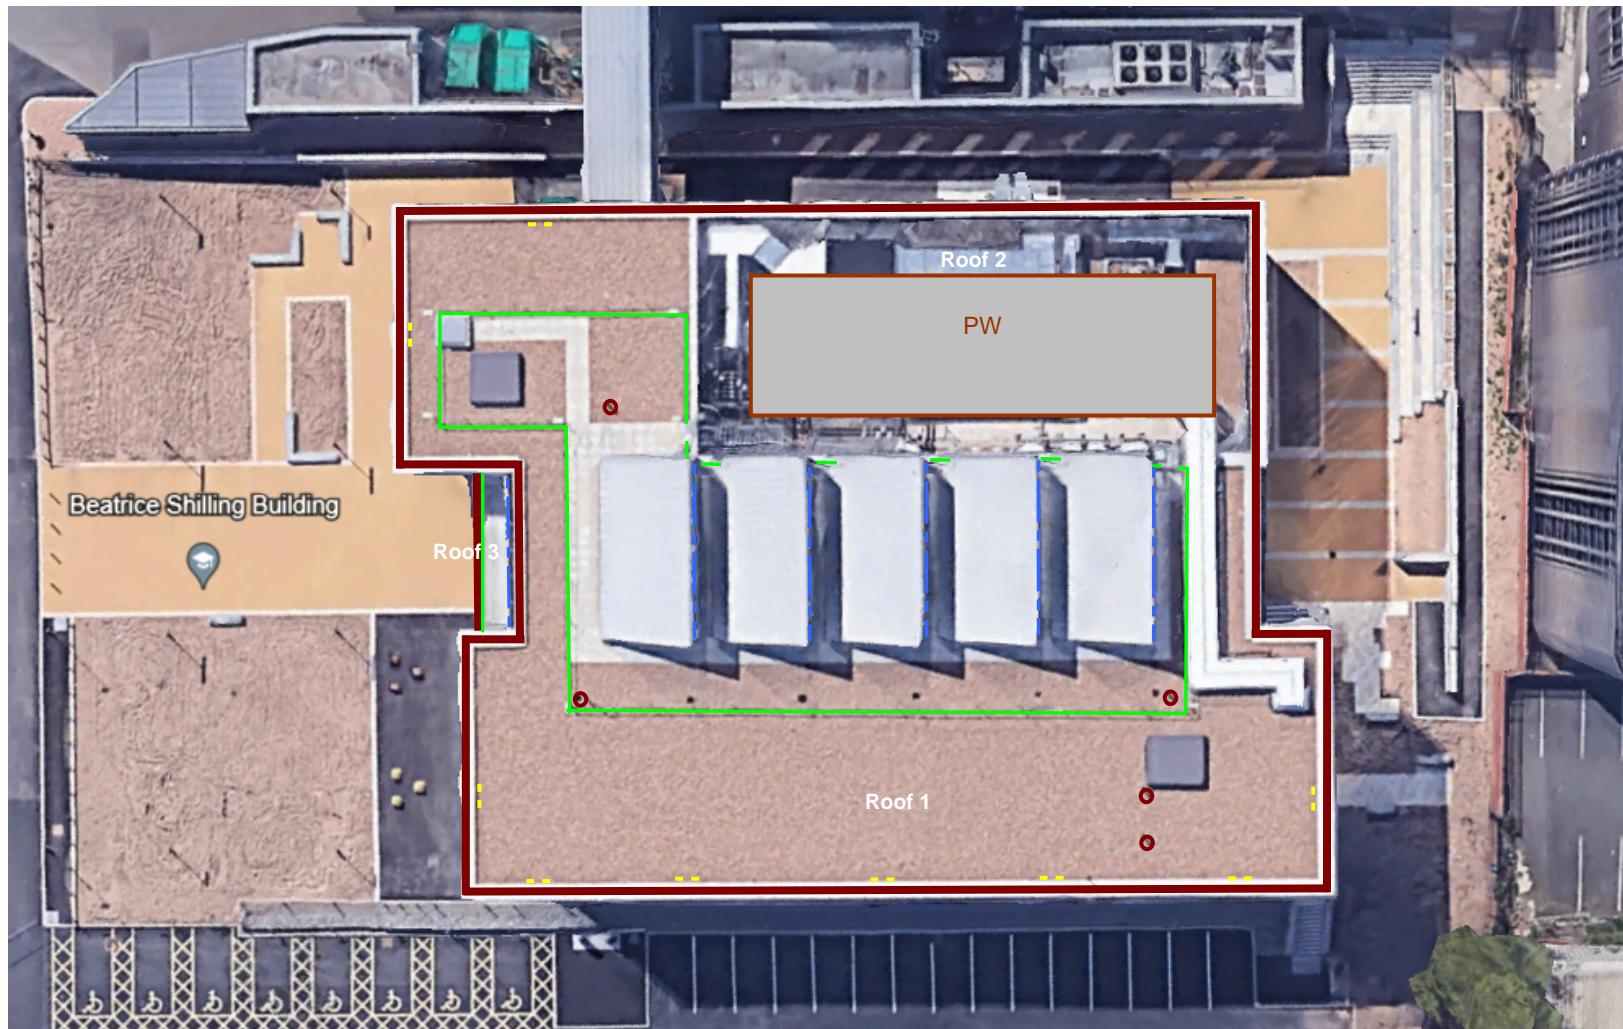
Main Roof - Areas 1 - 3

Area	Building 1/Roof 1		Roof height	Approx 25m		
Access	Hatch	Door	Fixed Ladder	Temp Ladder	MEWP	Other
Access Comments						
The roof areas are accessed on a case-by-case basis by site maintenance staff and contractors, this roof area is covered by collective protection and is certified and within compliance						
Roof area accessed via door.						
We advise no lone working on this roof with consideration towards evacuation.						
Tasks	Comments					
Window Maintenance	These are located within the confines of the collective protection, these are to be maintained whilst staying in the confines of the collective protection.					
Chimney Flue Maintenance	Chimney Flues are located both within the confines of the collective protection & outside it, should maintenance be required on those that are located outside the boundaries of the collective protection then an SSOW, training and additional equipment is required.

Lightning Protection Maintenance	Lightning Protection is both within the confines of the collective protection & outside it, should maintenance be required on those that are located outside the boundaries of the collective protection then an SSOW, training and additional equipment is required.					
Air Vent Maintenance	Air Vents are located both within the confines of the collective protection & outside it, should maintenance be required on those that are located outside the boundaries of the collective protection then an SSOW, training and additional equipment is required.

We suggest that anyone going to the roof areas should always work in pairs in case of an emergency, especially with the specialist access/traversal methods required on this roof by way of work positioning and the minimal fall protection installed, in most cases we would advise that additional Horizontal cable systems are installed to aid the safe movement around these roof areas in an aim to keep the end user away from any potential fall hazard, currently the access methods fall down to the end user and their competency/training, there is excess potential for human error involved that could potentially be mitigated by the installation of additional equipment.
