Height Safety Asset Management Report

Site Assessment & Report

Coventry University – Engineering and Computing building (Frank Whittle Building) – 3 Gulson Road,
Coventry, CV1 2JH

Surveyed on behalf of Coventry University

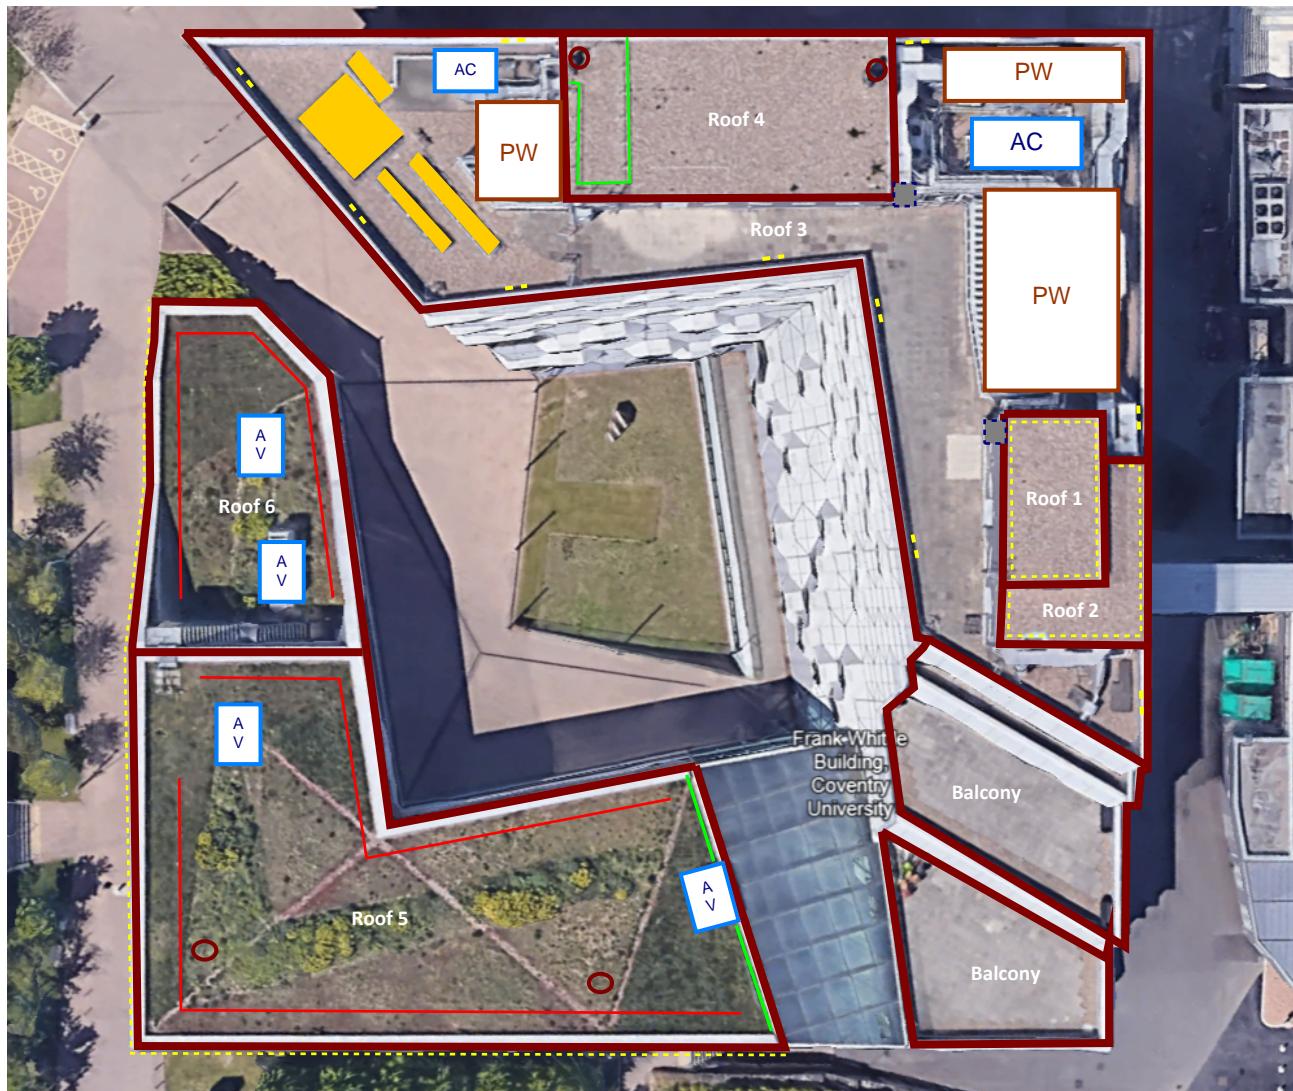
Main Roof - Areas 1 - 6

Area	Building 1/Roof area 1		Roof height	Approx 7m		
Access	Hatch	Door	Fixed Ladder	Temp Ladder	MEWP	Other
Access Comments						
<p>The roof areas are accessed on a case-by-case basis by site maintenance staff and contractors, this roof area has fixed access, but no fall protection is present.</p> <p>Roof area accessed by fixed ladder; additional considerations are to be taken in regard to rescue/evacuation.</p>						
We advise no lone working on this roof.						
Tasks	Comments					
Lightning Protection Maintenance	No Fall protection located on this roof area, bespoke SSOW is required.

Area	Building 1/Roof area 2			Roof height	Approx 6m	
Access	Hatch	Door	Fixed Ladder	Temp Ladder	MEWP	Other
Access Comments						
<p>The roof areas are accessed on a case-by-case basis by site maintenance staff and contractors, this roof area has fixed access, but no fall protection is present.</p> <p>Roof area accessed by fixed ladder; additional considerations are to be taken in regard to rescue/evacuation.</p> <p>We advise no lone working on this roof.</p>						
Tasks	Comments					
Lightning Protection Maintenance	No Fall protection located on this roof area, bespoke SSOW is required.

The roof areas are accessed on a case-by-case basis by site maintenance staff and contractors, this roof area is covered by collective protection via parapet/Guardrail, although there may be a requirement to venture outside of the confines of the collective protection to access certain assets.

This Guardrail is not withing compliance.

Access Suggestions
<p>A permit to work system could help control who goes on the roof area to ensure they understand the risk associated with this area and the procedures in place also to identify that the engineers/contractors are trained and competent and that their RAMS are identified and suitable for the works required of them regarding access methods/Rescue.</p>
<p>We suggest that anyone going to the roof areas should always work in pairs in case of an emergency, there is currently so safe means of access to onto this roof. The addition of fall protection equipment would benefit here.</p>

A permit to work system could help control who goes on the roof area to ensure they understand the risk associated with this area and the procedures in place also to identify that the engineers/contractors are trained and competent and that their RAMS are identified and suitable for the works required of them regarding access methods/Rescue.

We suggest that anyone going to the roof areas should always work in pairs in case of an emergency, this roof area is covered by a collective protection.
