Height Safety Asset Management Report

Site Assessment & Report

Coventry University – George Eliot, Priory street, CV1 5FB

Date: 20/10/2023

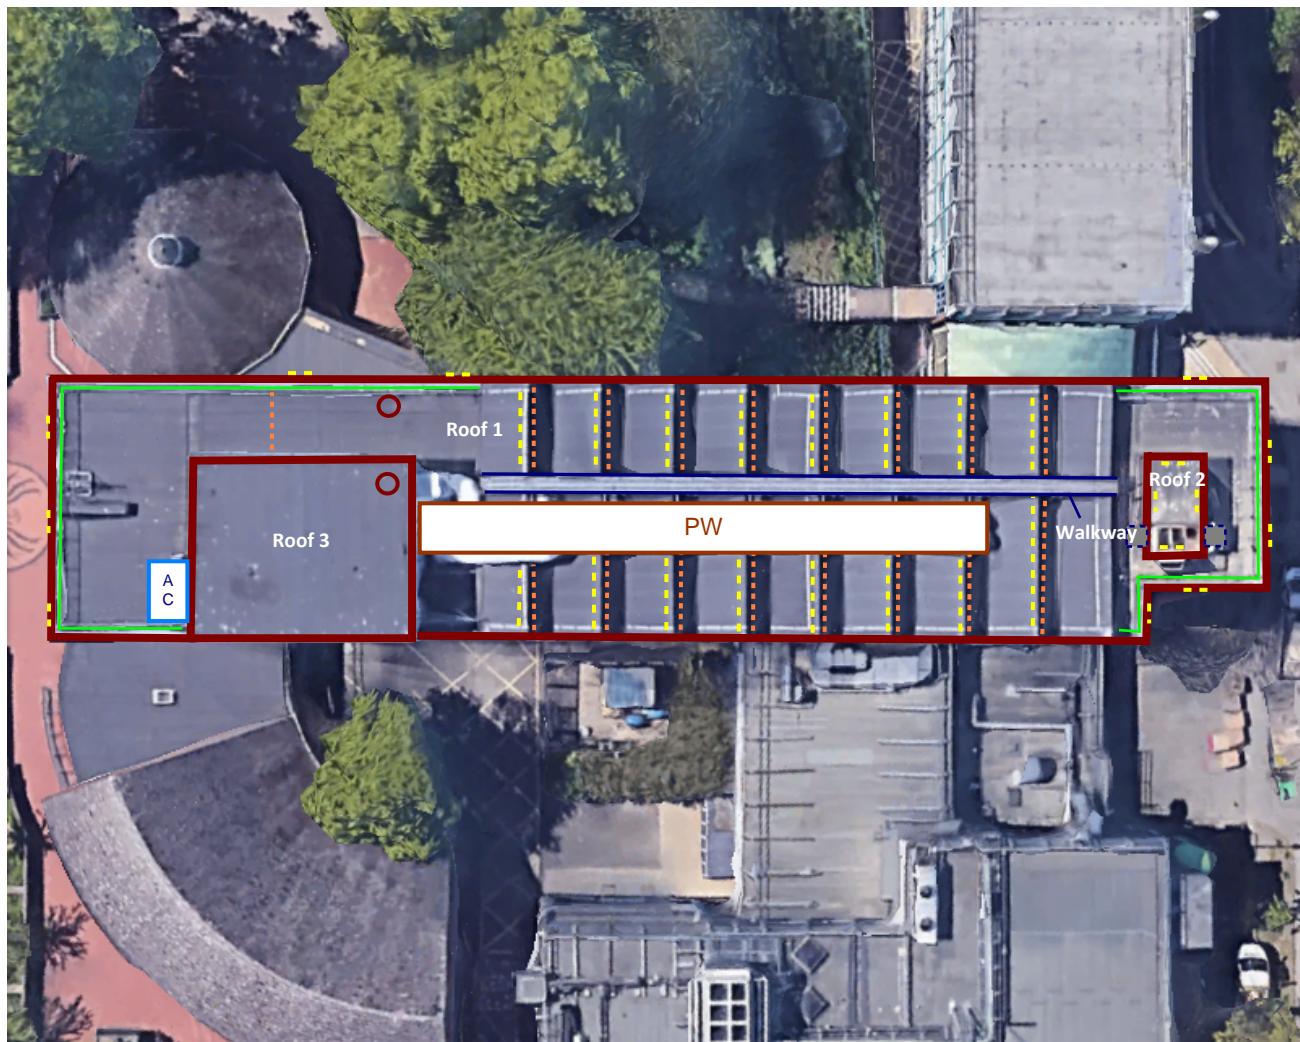
Main Roof - Areas 1 - 6

| Location | Access | Asset | Manufacturer | Risk Rating (GYOR) | Comment |
|---|---|---|---|---|---|
| Building 1 Roof area 1 | Hatch | Gutter | N/A | Red | Exceeds guardrail boundary, no fall protection beyond boundary, SOW Required. |
| Building 1 Roof area 1 | Hatch | Lightning protection | N/A | Red | Exceeds guardrail boundary, no fall protection beyond boundary, SOW Required. |
| Building 1 Roof area 1 | Hatch | Plant | N/A | Red | Exceeds guardrail boundary, no fall protection beyond boundary, SOW Required. |
| Building 1 Roof area 2 | Temp ladder | Lightning protection | N/A | Red | No fall protection, no fixed access, SOW Required. |
| Building 1 Roof area 3 | Temp ladder | Lightning protection | N/A | Red | No fall protection, no fixed access, SOW Required. |
| Building 1 Roof area 3 | Temp ladder | Chimney flue | N/A | Red | No fall protection, no fixed access, SOW Required. |

| <p>We suggest that anyone going to the roof areas should always work in pairs in case of an emergency, in most cases we would advise that additional Horizontal cable systems are installed to aid the safe movement around these roof areas in an aim to keep the end user away from any potential fall hazard, currently the access methods fall down to the end user and their competency/training, there is excess potential for human error involved that could potentially be mitigated by the installation of additional equipment.</p> |
