Height Safety Asset Management Report

Site Assessment & Report

Coventry University – Richard Crossman Building, Jordan WI, Coventry, CV1 5RW

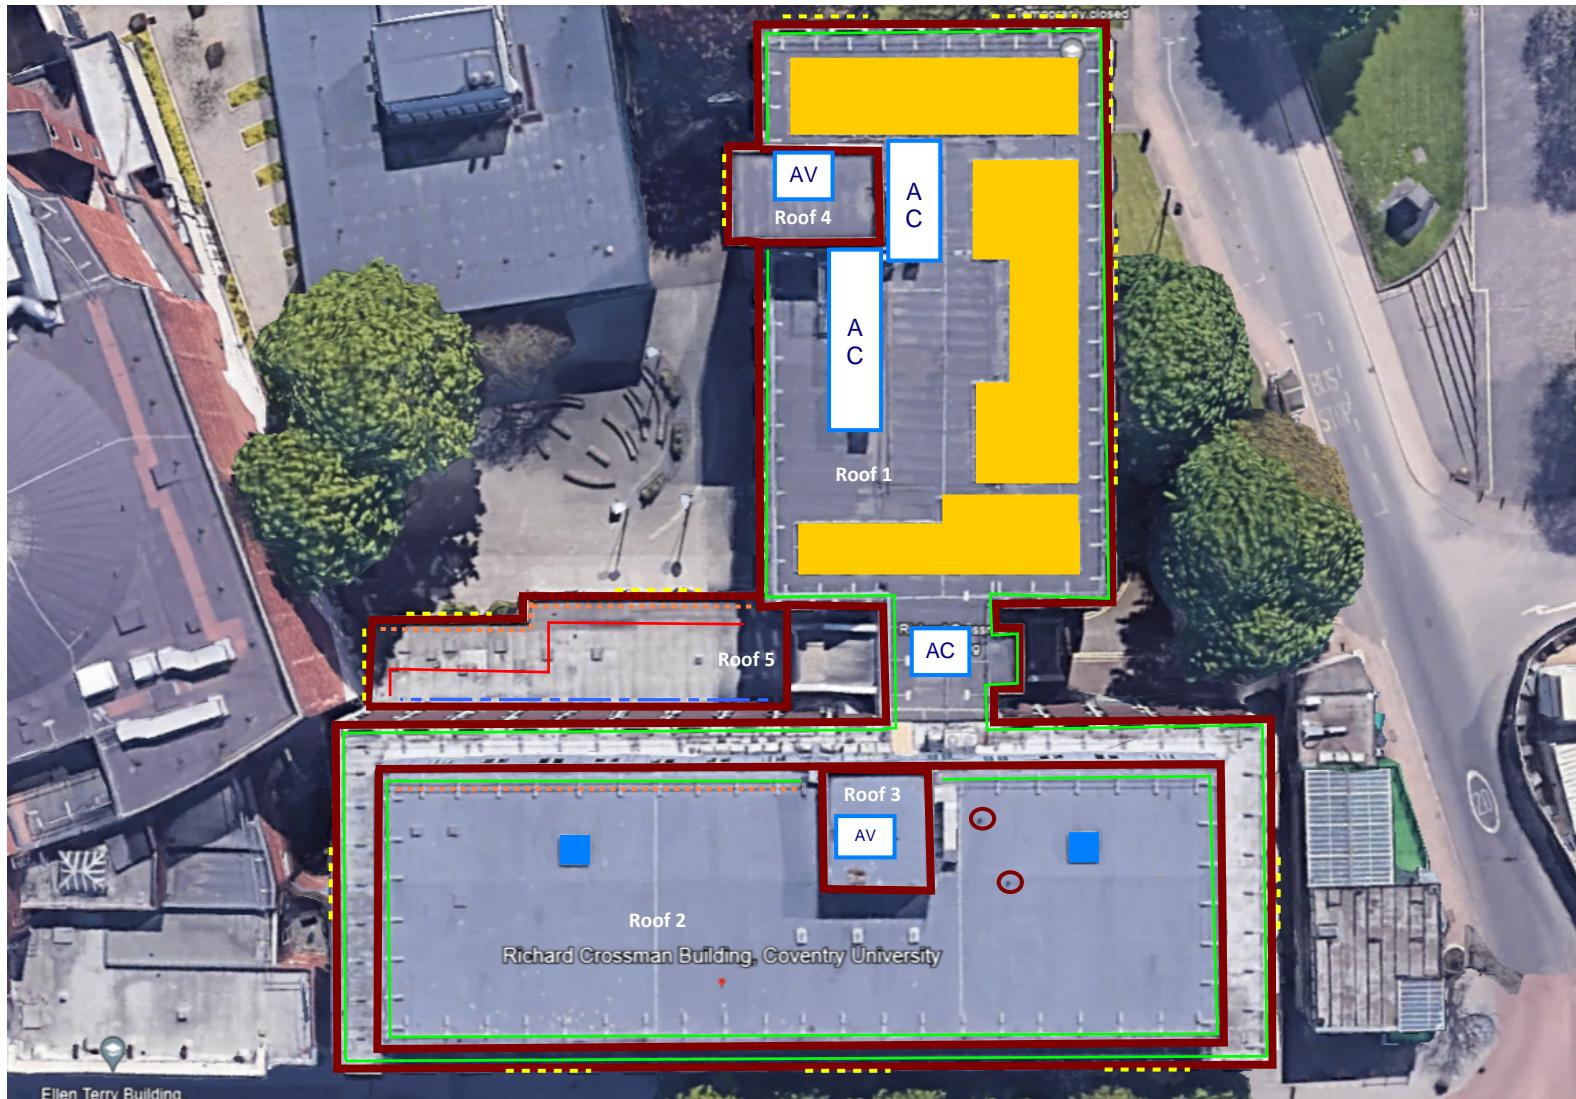
Main Roof - Areas 1 - 5

Area	Building 1/Roof area 1			Roof height	Approx 25m							
Access	Hatch	Door	Fixed Ladder	Temp Ladder	MEWP	Other						
Access Comments												
<p>The roof areas are accessed on a case-by-case basis by site maintenance staff and contractors, this roof area is covered by collective protection in the form of Guardrail.</p> <p>Guardrail GR01 is not within compliance.</p> <p>Guardrail GR02 is within compliance.</p>												
<p>Roof area accessed by Fixed ladder, additional considerations are to be made regarding access and egress/evacuation and rescue.</p>												
<p>We advise no lone working on this roof.</p>												
Tasks	Comments											
Lightning Protection Maintenance	Collective protection present, Mandatory PPE required to be specified by Coventry University.											
Chimney Flue Maintenance	Collective protection present, Mandatory PPE required to be specified by Coventry University.

Area	Building 1/Roof area 2			Roof height	Approx 25m	
Access	Hatch	Door	Fixed Ladder	Temp Ladder	MEWP	Other
Access Comments						
The roof areas are accessed on a case-by-case basis by site maintenance staff and contractors, this roof area is covered by collective protection in the form of Guardrail.						
This Guardrail is not within compliance.						
Roof area accessed by Fixed ladder, additional considerations are to be made regarding access and egress/evacuation and rescue.						
We advise no lone working on this roof.						
Tasks	Comments					
Lightning Protection Maintenance	Collective protection present, Mandatory PPE required to be specified by Coventry University.					
Chimney Flue Maintenance	Collective protection present, Mandatory PPE required to be specified by Coventry University.					
Skylight Maintenance	Collective protection present, Mandatory PPE required to be specified by Coventry University.

Area	Building 1/Roof area 3			Roof height	Approx 3m	
Access	Hatch	Door	Fixed Ladder	Temp Ladder	MEWP	Other
Access Comments						
The roof areas are accessed on a case-by-case basis by site maintenance staff and contractors, this roof area is not covered by any collective or permanent height safety equipment SSOW required.						
Roof area accessed by Temporary, additional considerations are to be made in regard to access and egress/evacuation and rescue.						
We advise no lone working on this roof.						
Tasks	Comments					
Lightning Protection Maintenance	SSOW Required - No collective or permanent height safety equipment installed					
Ventilation Unit Maintenance	SSOW Required - No collective or permanent height safety equipment installed

Area	Building 1/Roof area 4			Roof height	Approx 4m	
Access	Hatch	Door	Fixed Ladder	Temp Ladder	MEWP	Other
Access Comments						
The roof areas are accessed on a case-by-case basis by site maintenance staff and contractors, this roof area is not covered by any collective or permanent height safety equipment SSOW required.						
Roof area accessed by Temporary, additional considerations are to be made in regard to access and egress/evacuation and rescue.						
We advise no lone working on this roof.						
Tasks	Comments					
Lightning Protection Maintenance	SSOW Required - No collective or permanent height safety equipment installed					
Ventilation Unit Maintenance	SSOW Required - No collective or permanent height safety equipment installed

Area	Building 1/Roof area 5			Roof height	Approx 5m	
Access	Hatch	Door	Fixed Ladder	Temp Ladder	MEWP	Other
Access Comments						
<p>The roof areas are accessed on a case-by-case basis by site maintenance staff and contractors, this roof area is covered by Fall protection in the form of a mansafe system. This system is within compliance</p> <p>Roof area accessed by temporary ladder, additional considerations are to be made in regard to rescue and evacuation.</p>						
We advise no lone working on this roof.						
Tasks	Comments					
Lightning Protection Maintenance	Lightening protection is located away from the mansafe system and therefore advance work at height training and work positioning will be required to access.					
Gutter Cleaning/Maintenance	Gutters are located away from the mansafe system and therefore advance work at height training and work positioning will be required to access.

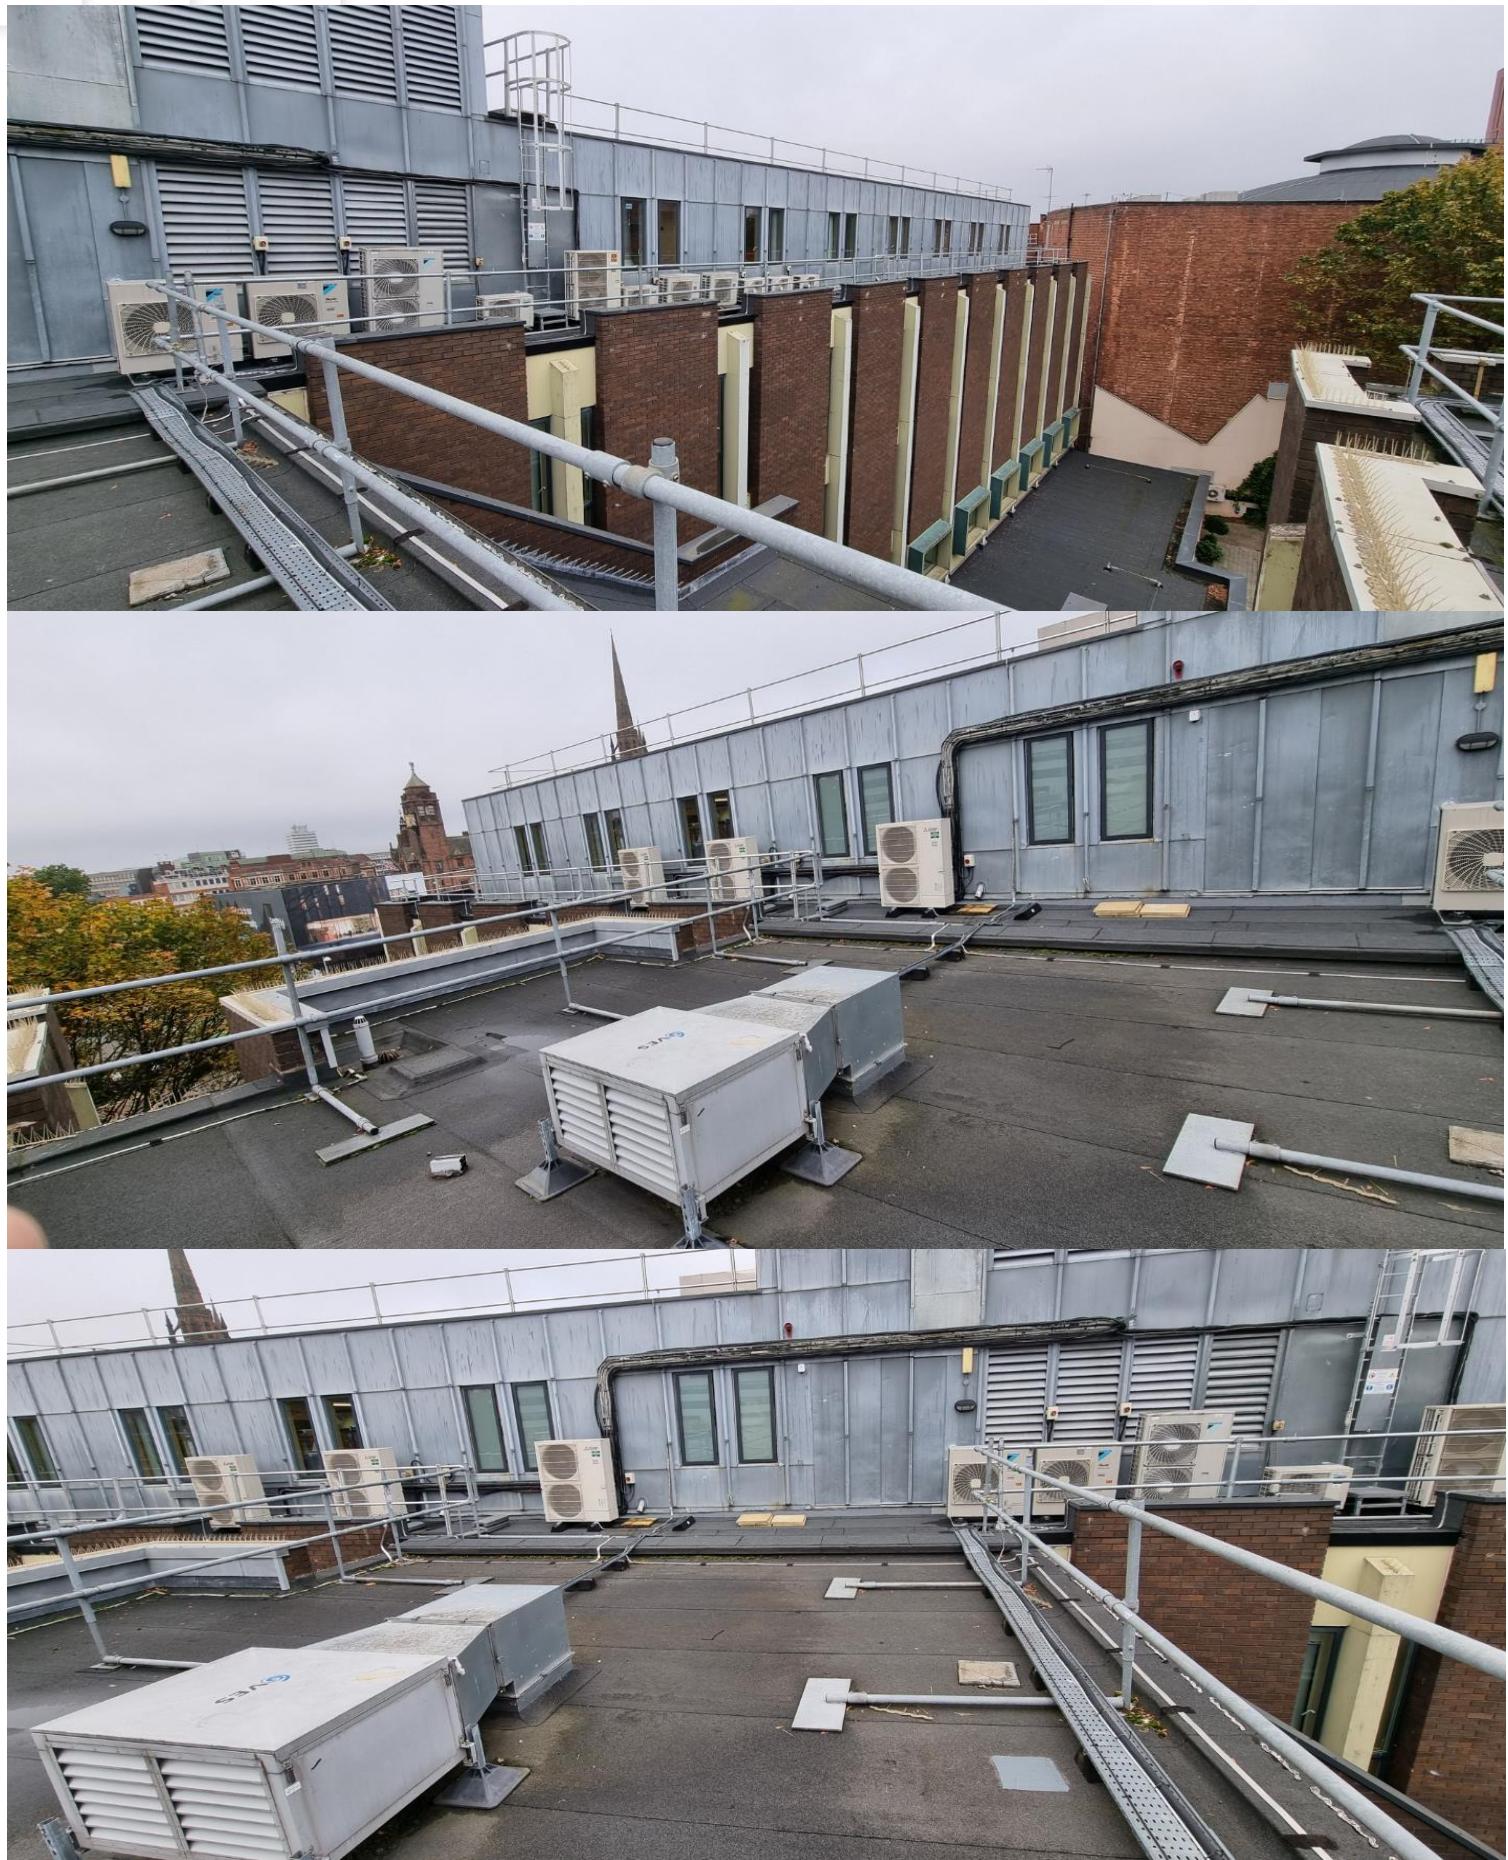
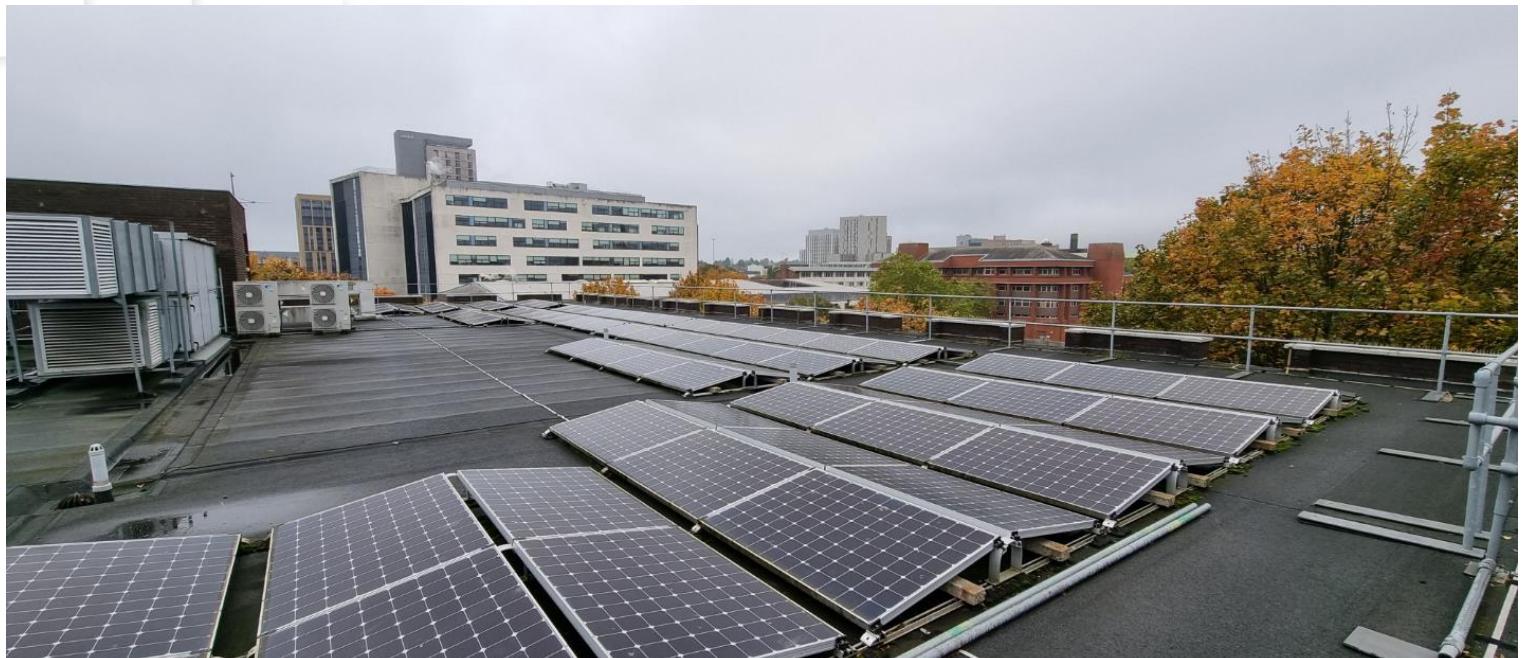
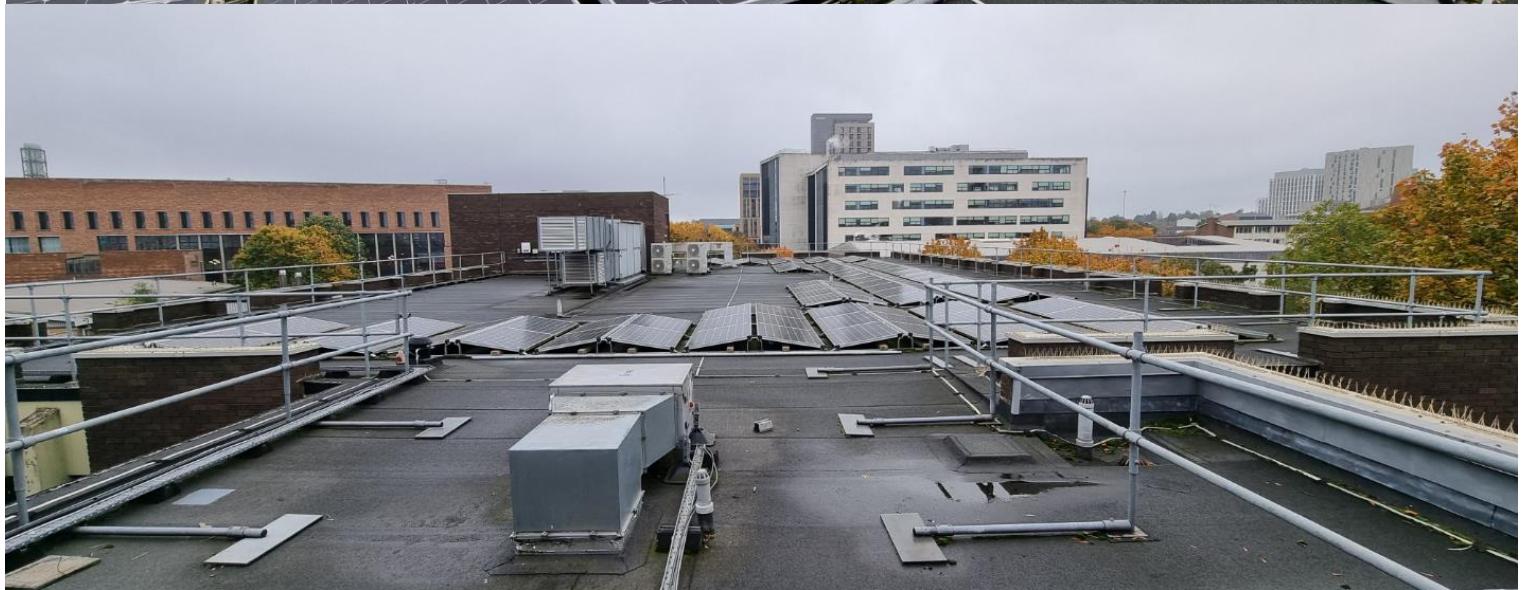
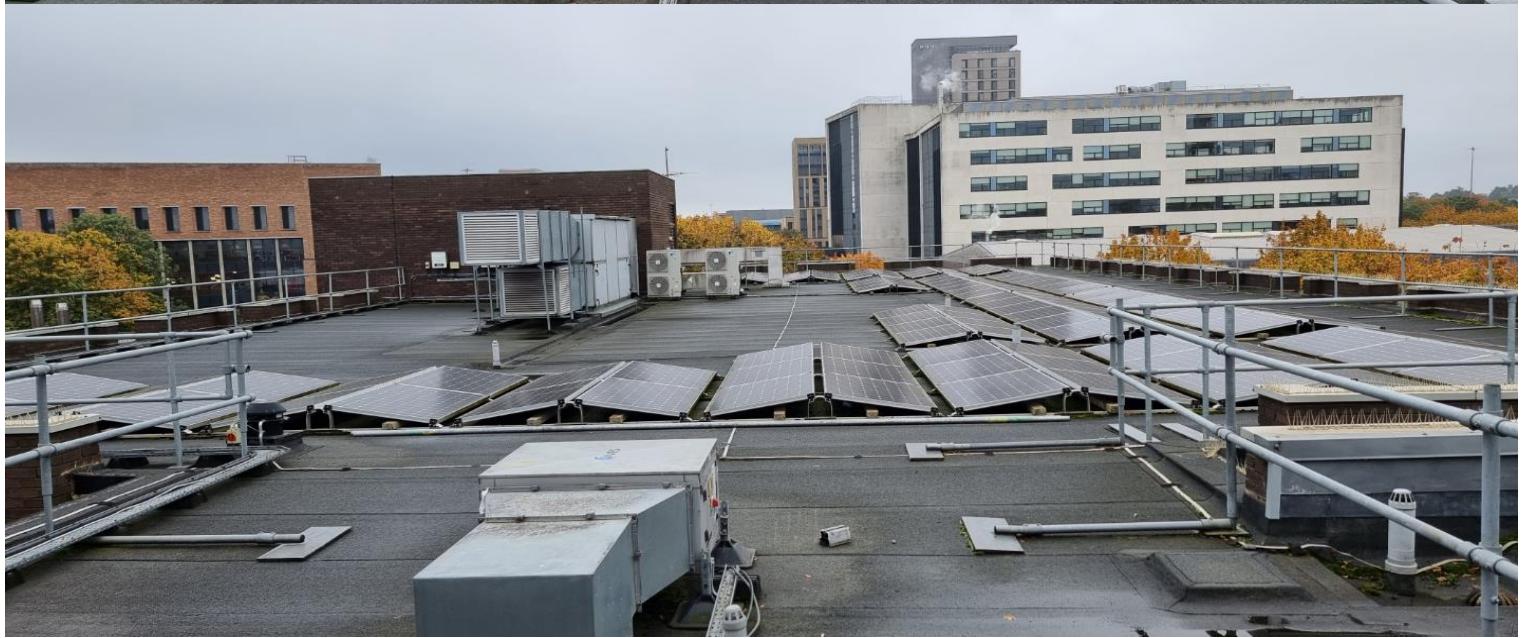
Photos – Building 1/Roof 1

Cable Maintenance	Collective protection present, Mandatory PPE required to be specified by Coventry University.											
Gutter Cleaning/Maintenance	Collective protection present, Mandatory PPE required to be specified by Coventry University.											
Air Conditioning Unit Maintenance	Collective protection present, Mandatory PPE required to be specified by Coventry University.											
Solar Panel Maintenance	Collective protection present, Mandatory PPE required to be specified by Coventry University.											
Access Suggestions												
<p>A permit to work system could help control who goes on the roof area to ensure they understand the risk associated with this area and the procedures in place also to identify that the engineers/contractors are trained and competent and that their RAMS are identified and suitable for the works required of them regarding access methods/Rescue.</p>

<p>We suggest that anyone going to the roof areas should always work in pairs in case of an emergency, this roof area is covered by collective protection and therefore requires minimal training/mandatory PPE to access.</p>

Excluding Roof area 3 and 4, all other roof areas on this building have fall protection equipment installed in the form of collective equipment and mansafe systems, most of these are in compliance except GR01, we would advise this is inspected and brought within compliance.

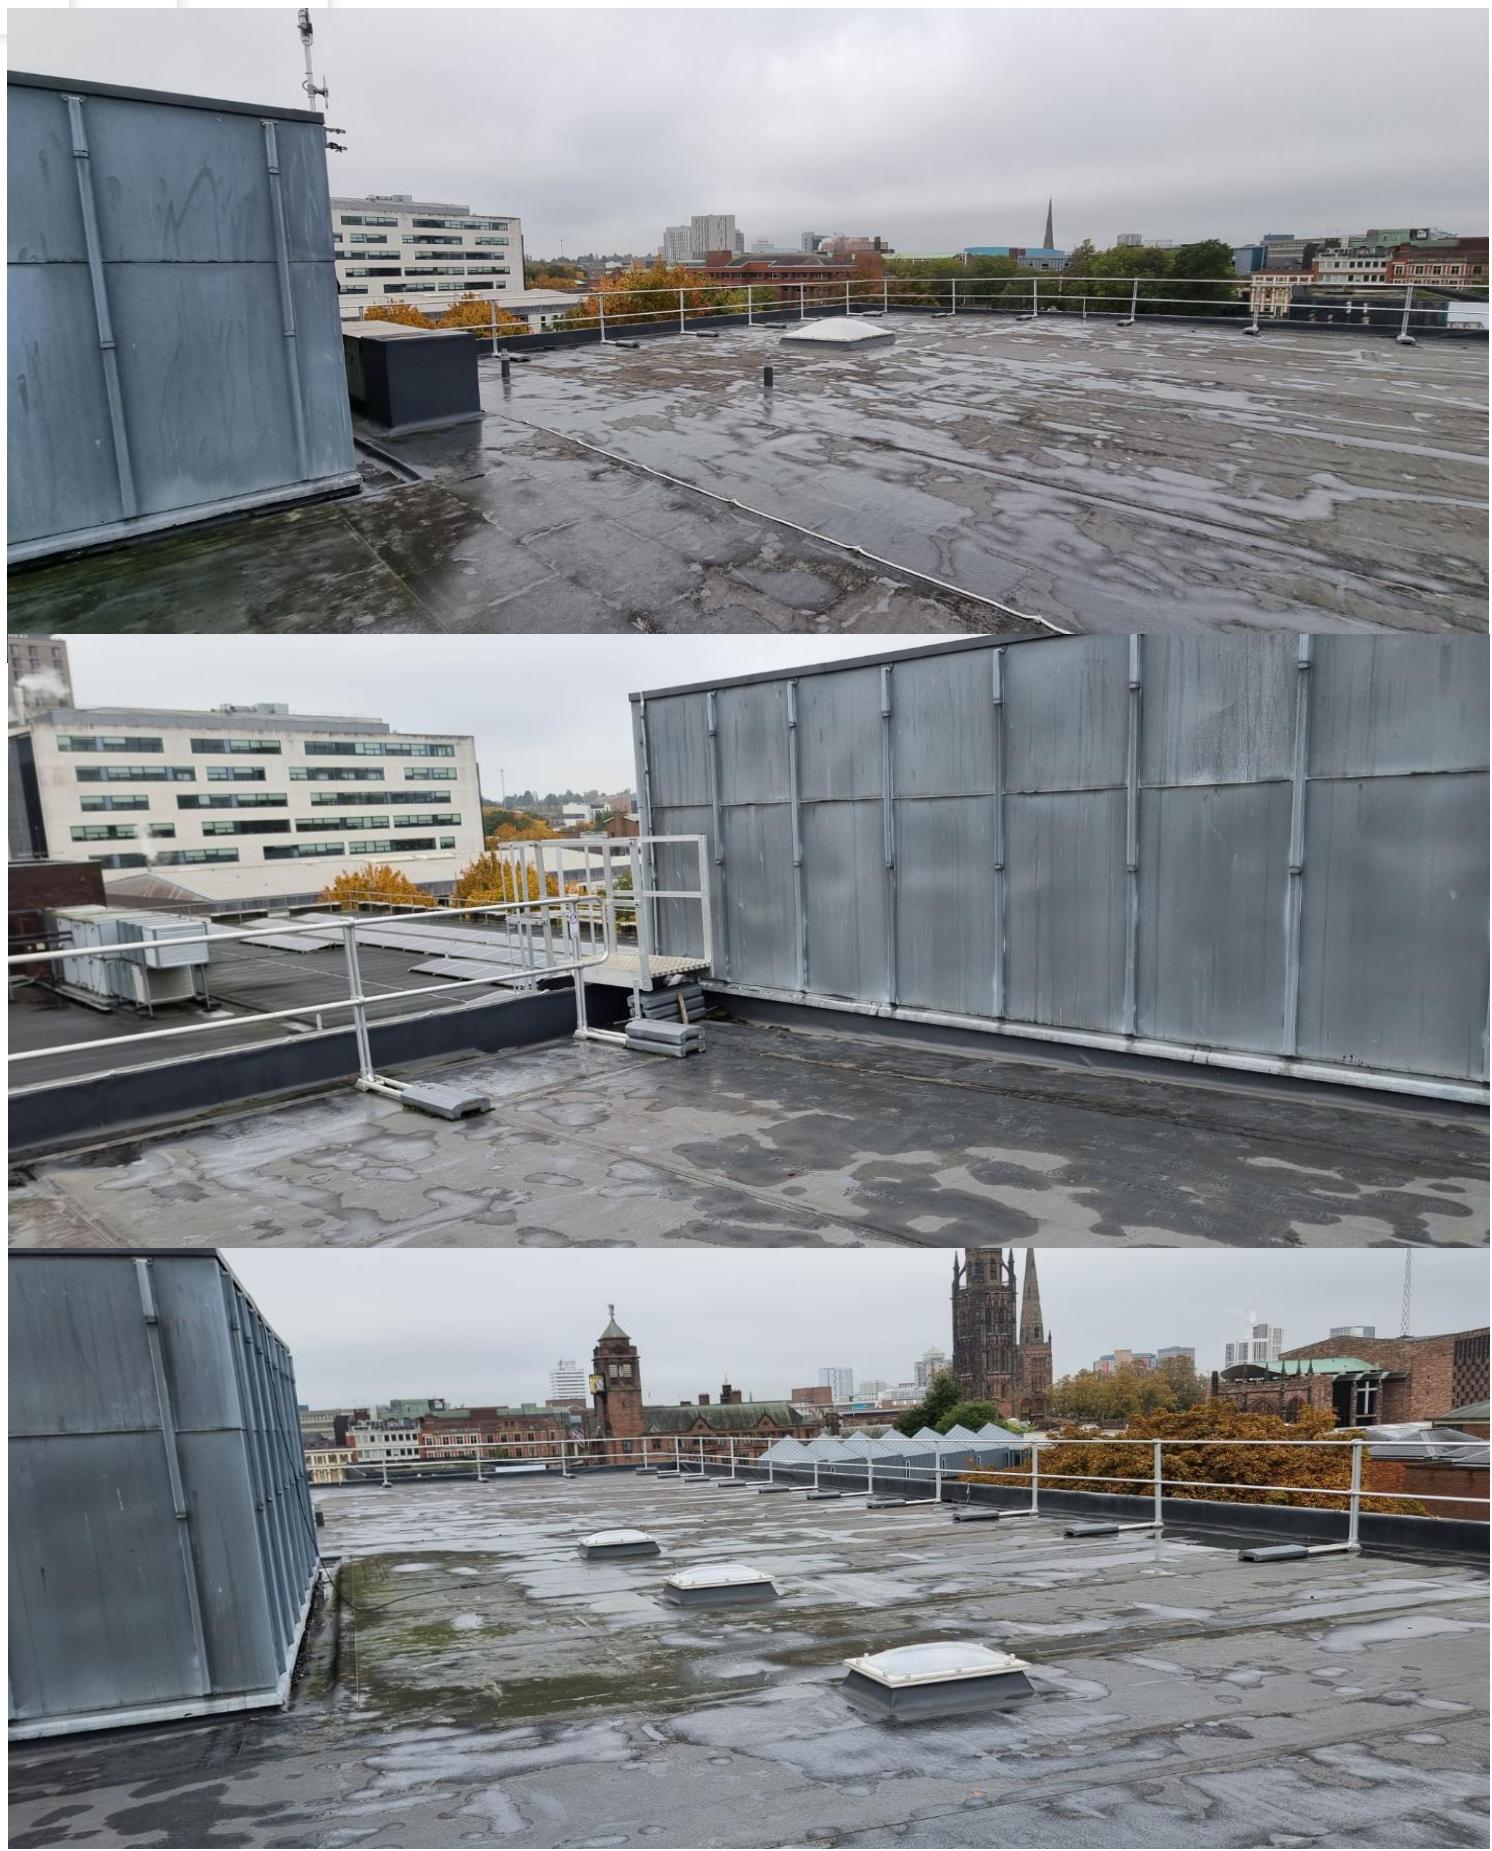
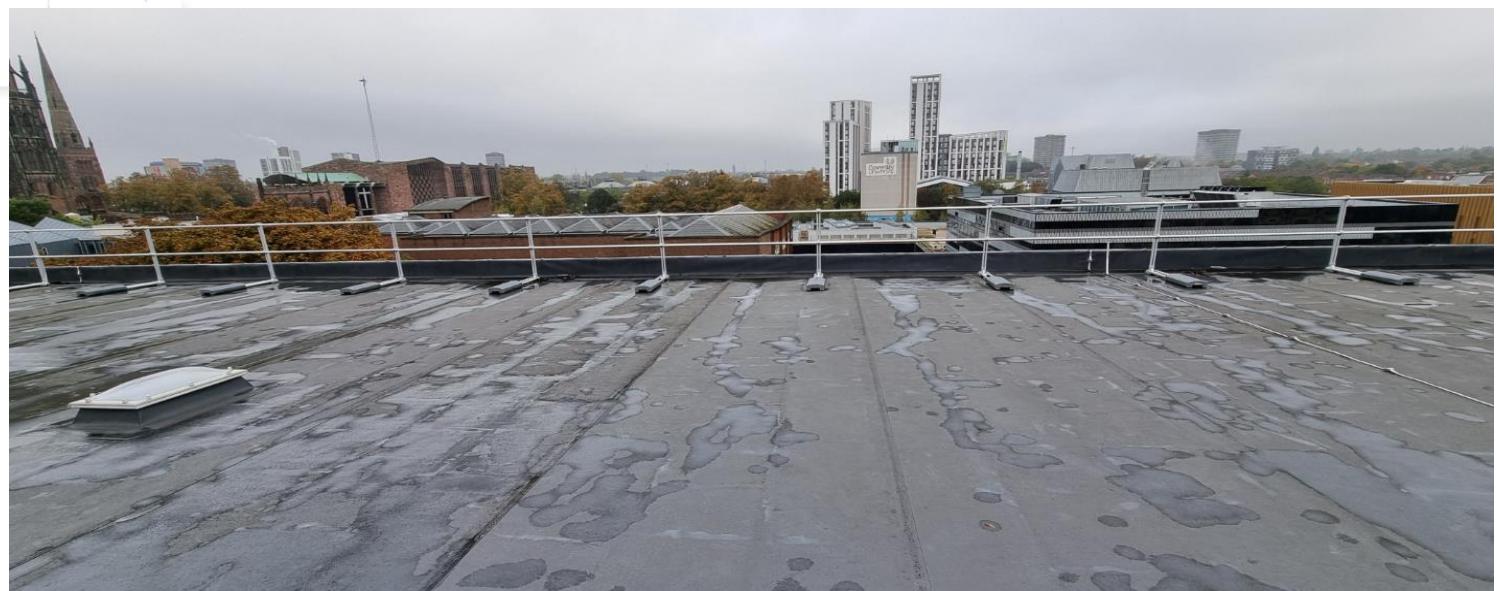
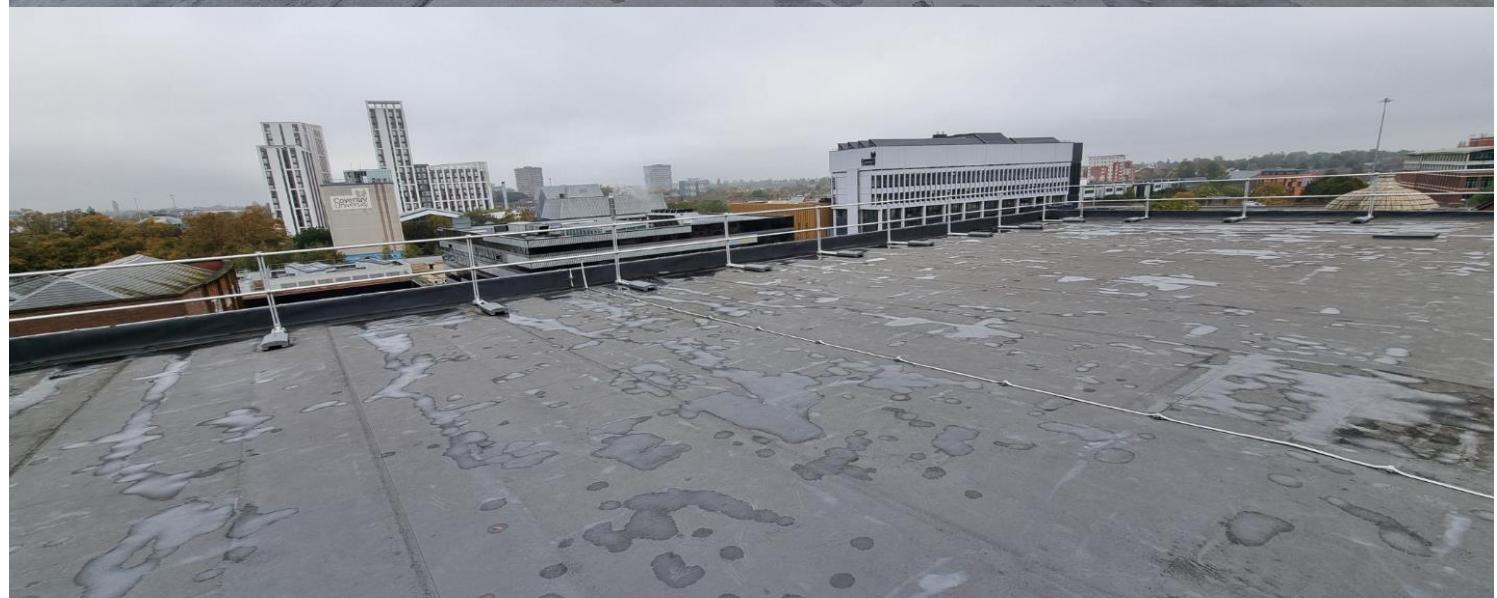
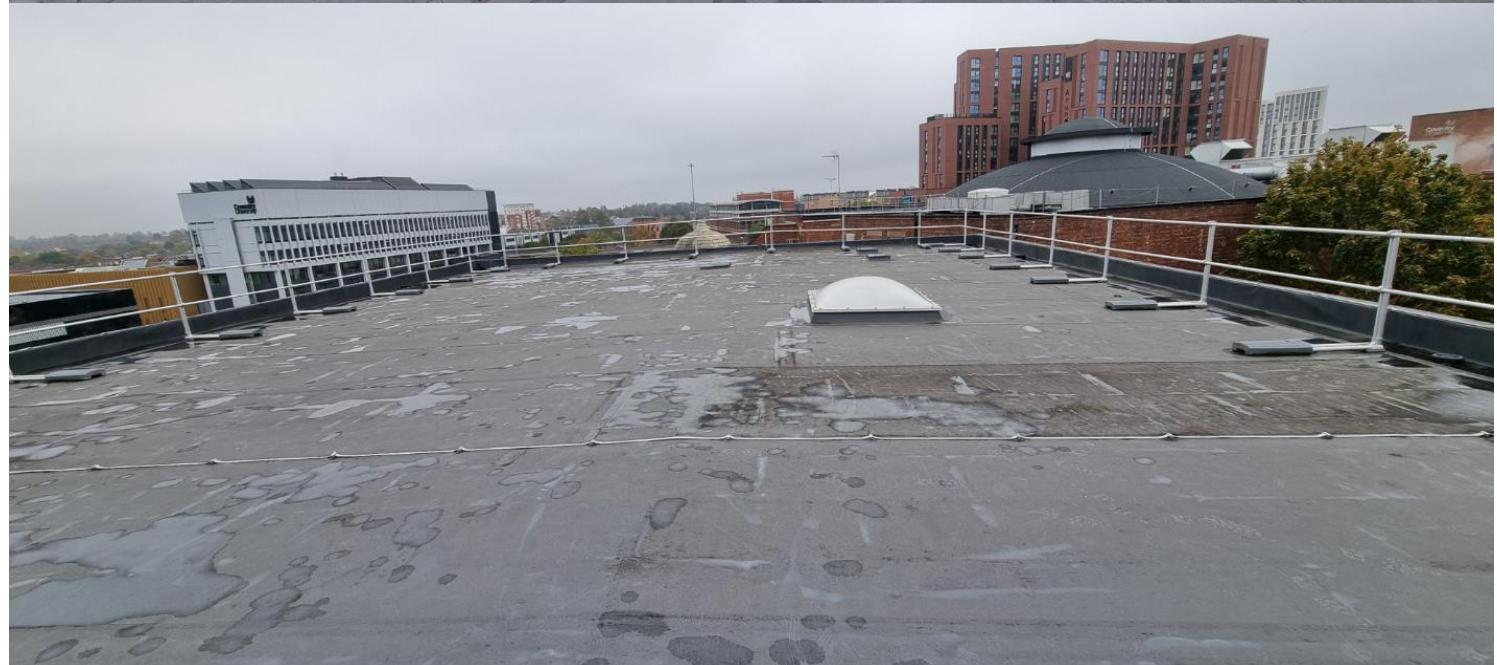
Building 1/Roof 2

Gutter Cleaning/Maintenance	Collective protection present, Mandatory PPE required to be specified by Coventry University.

A permit to work system could help control who goes on the roof area to ensure they understand the risk associated with this area and the procedures in place also to identify that the engineers/contractors are trained and competent and that their RAMS are identified and suitable for the works required of them regarding access methods/Rescue.

We suggest that anyone going to the roof areas should always work in pairs in case of an emergency, this roof area is covered by collective protection and therefore requires minimal training/mandatory PPE to access.

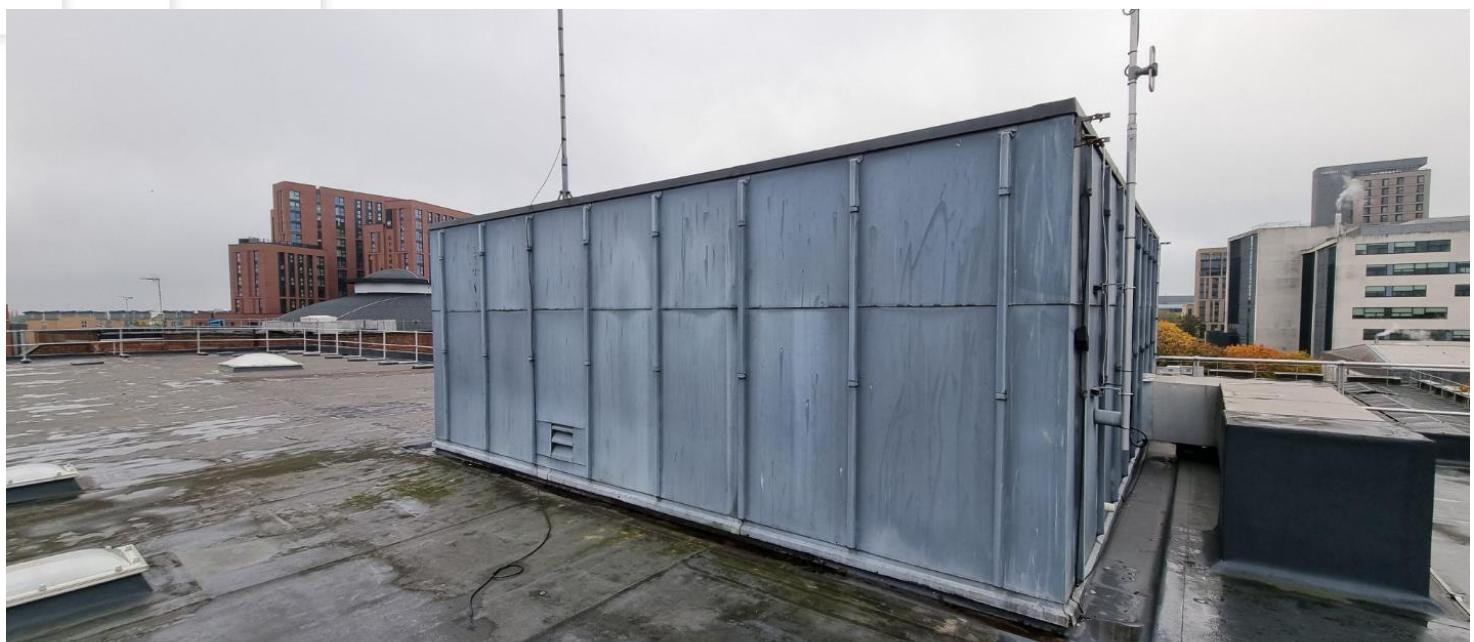
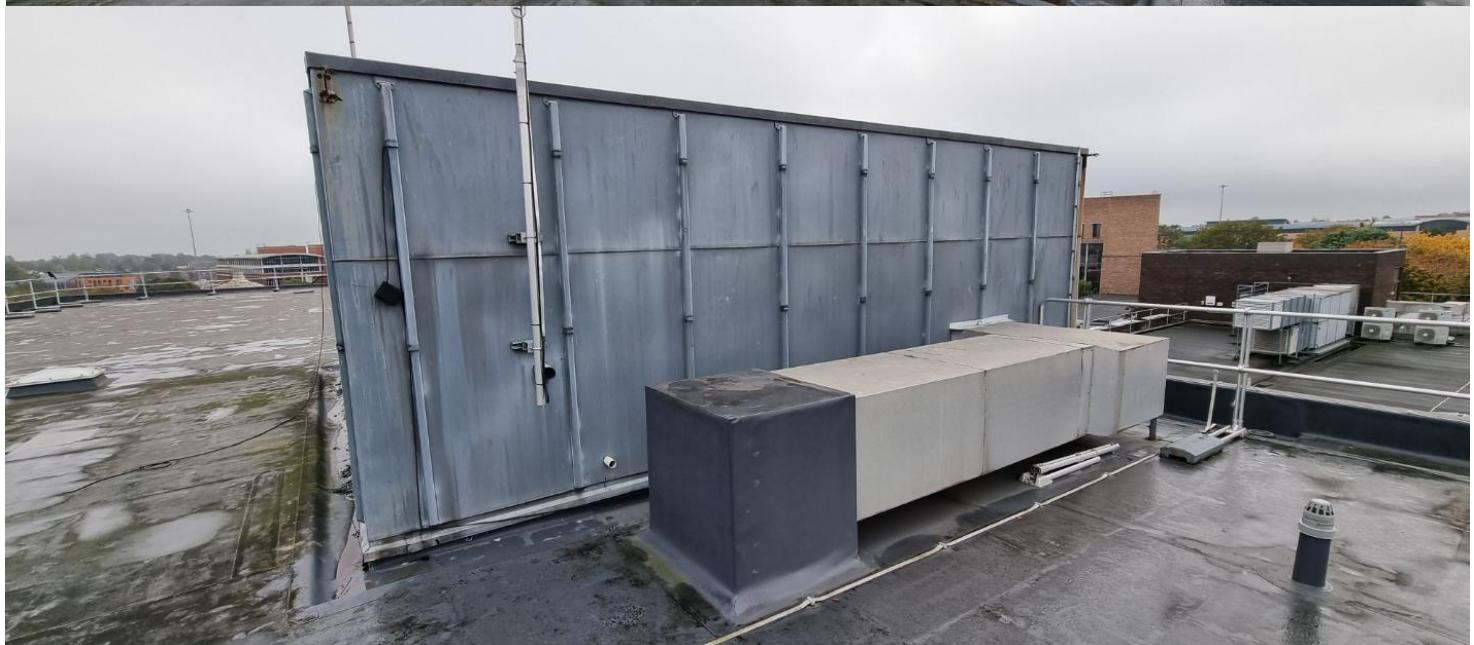
Building 1/Roof 3

Comments
SSOW Required - No collective or permanent height safety equipment installed

Access Suggestions
A permit to work system could help control who goes on the roof area to ensure they understand the risk associated with this area and the procedures in place also to identify that the engineers/contractors are trained and competent and that their RAMS are identified and suitable for the works required of them regarding access methods/Rescue.
We suggest that anyone going to the roof areas should always work in pairs in case of an emergency, this roof area is not covered by collective or permanent height safety equipment.
Roof area would benefit from additional install.

Roof areas 3 and 4 do not have any collective or permanent fall protection in place, these areas would benefit from additional install.

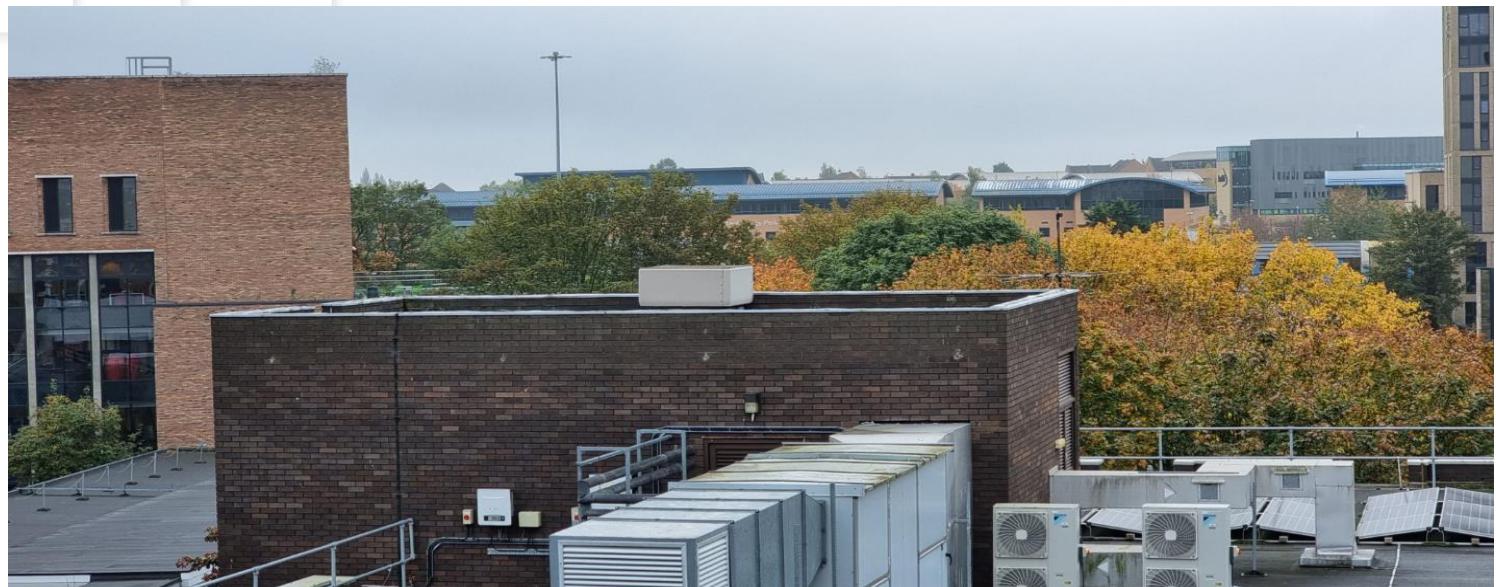
Building 1/roof 4

Comments
SSOW Required - No collective or permanent height safety equipment installed

Access Suggestions
A permit to work system could help control who goes on the roof area to ensure they understand the risk associated with this area and the procedures in place also to identify that the engineers/contractors are trained and competent and that their RAMS are identified and suitable for the works required of them regarding access methods/Rescue.
We suggest that anyone going to the roof areas should always work in pairs in case of an emergency, this roof area is not covered by collective or permanent height safety equipment.
Roof area would benefit from additional install.
