Height Safety Asset Management Report

Site Assessment & Report

Coventry University – Richard Crossman Building, Jordan WI, Coventry, CV1 5RW

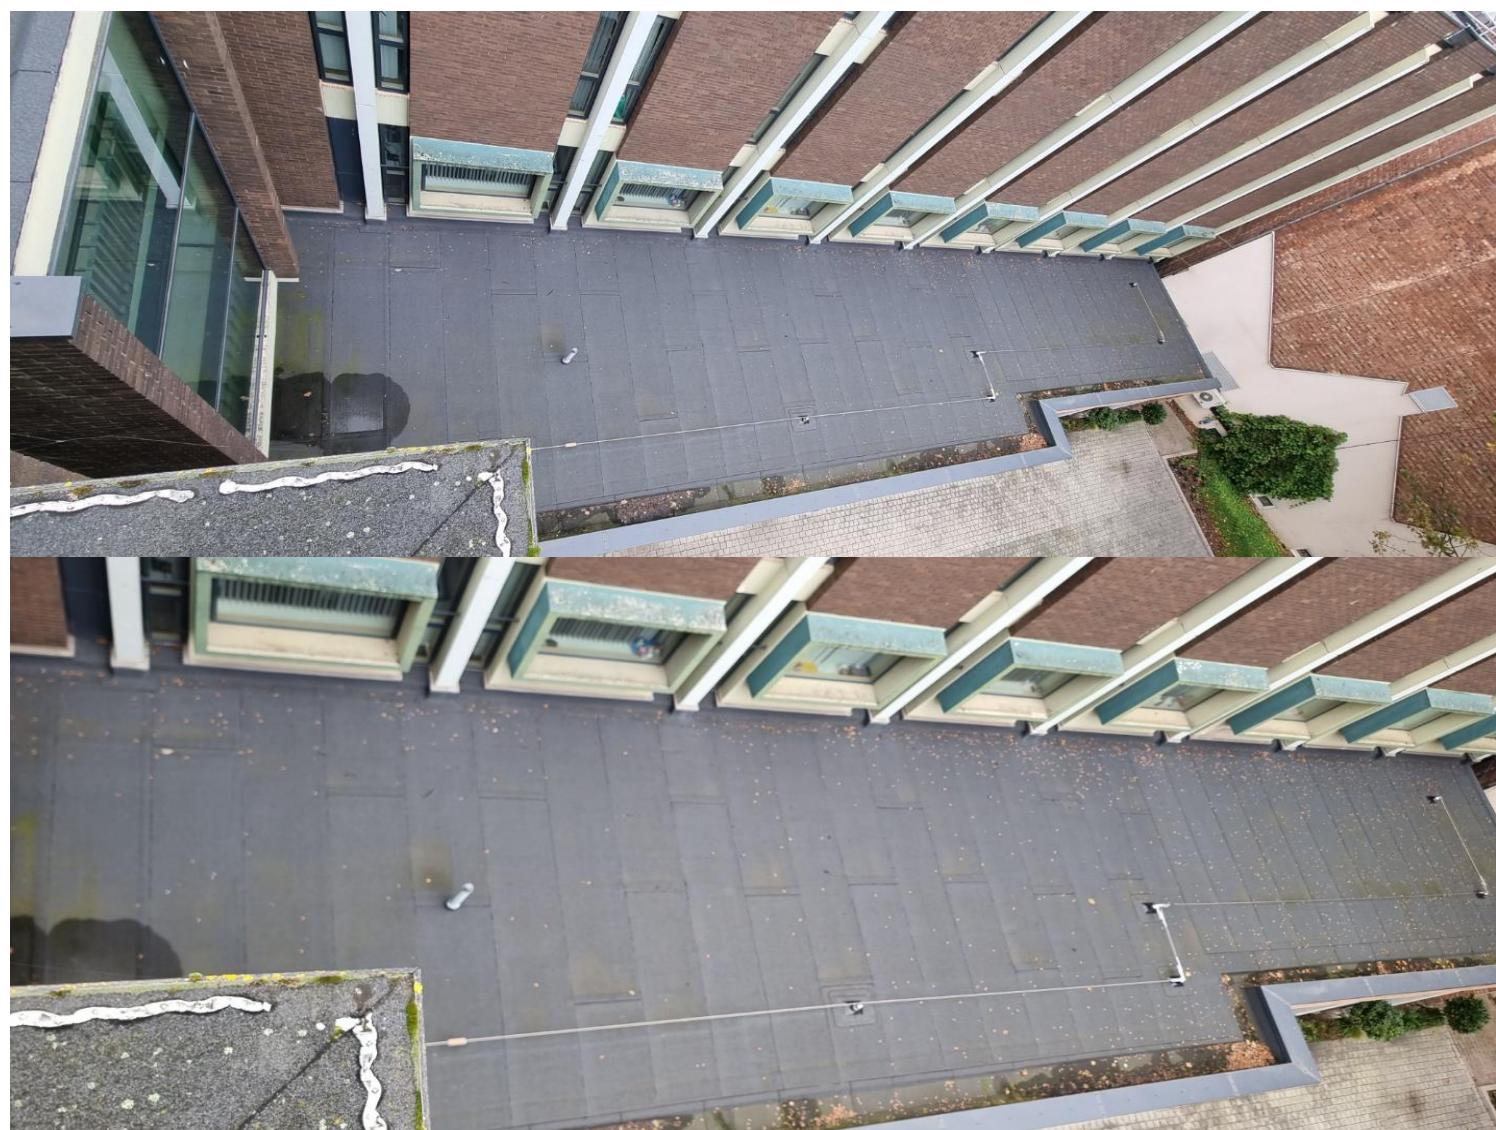
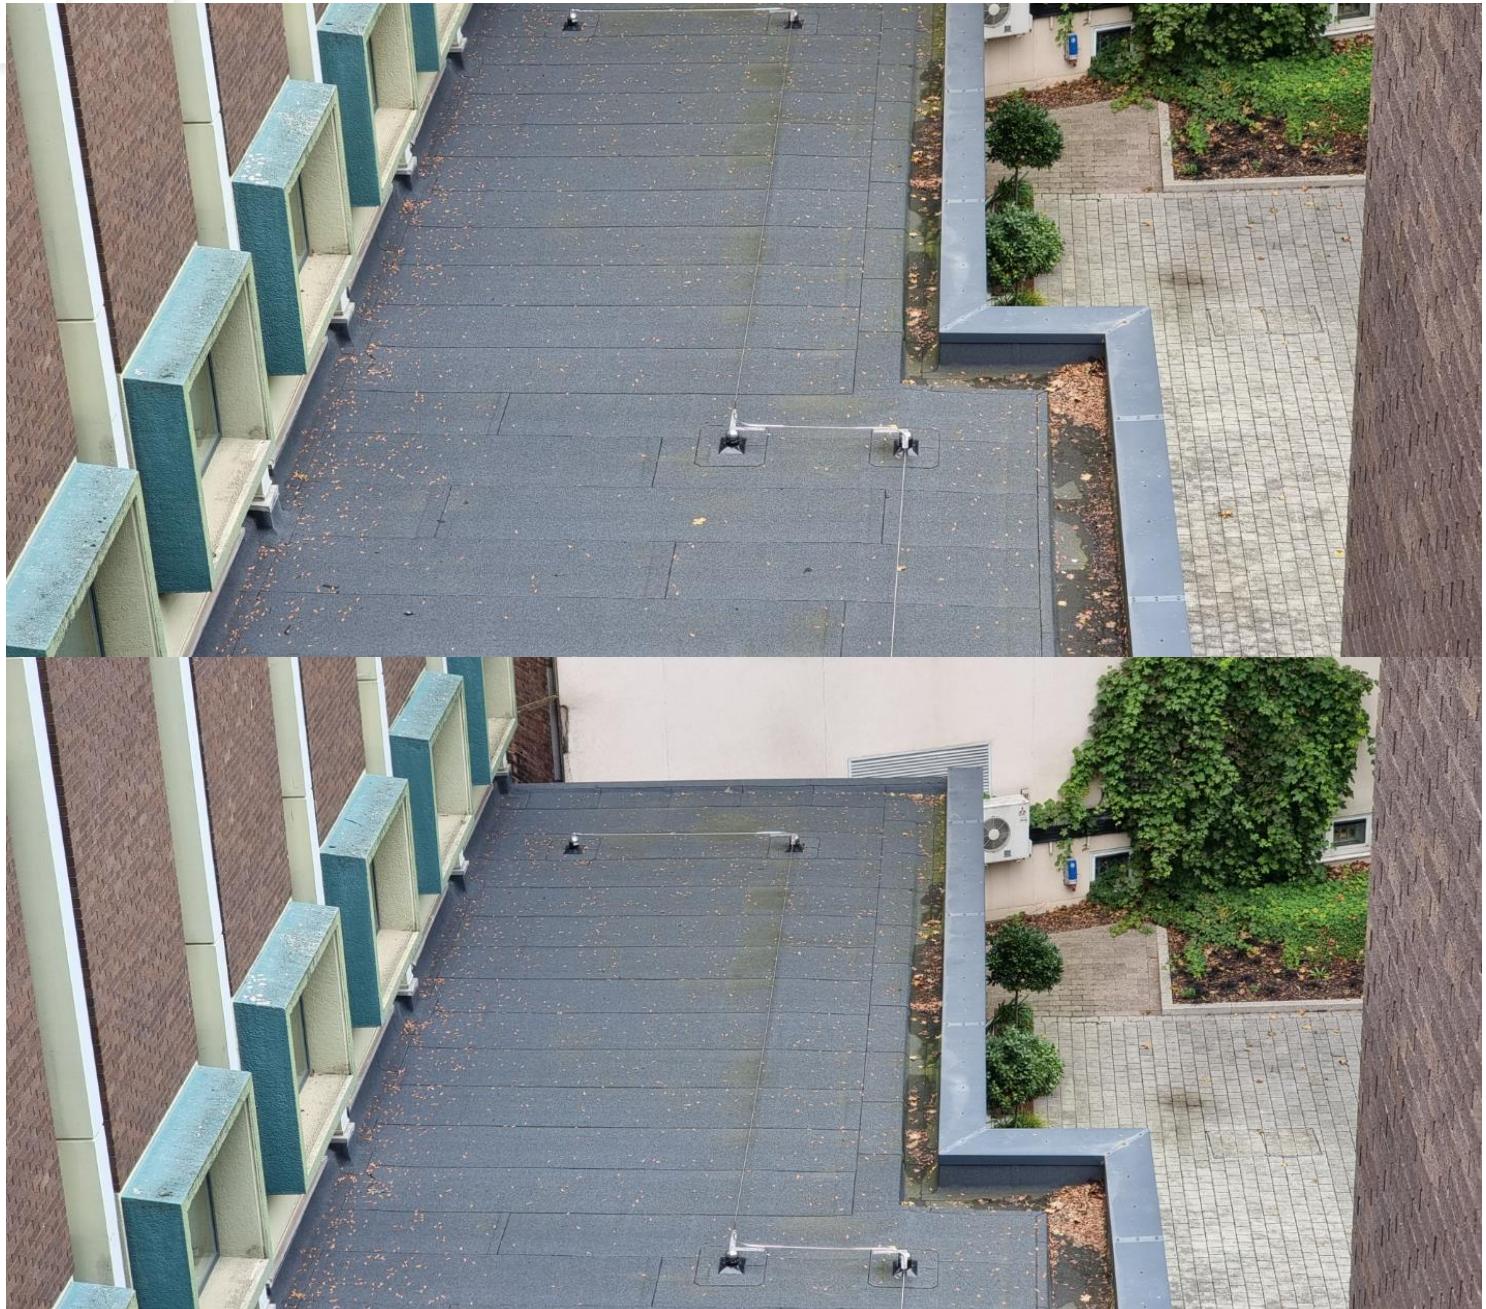
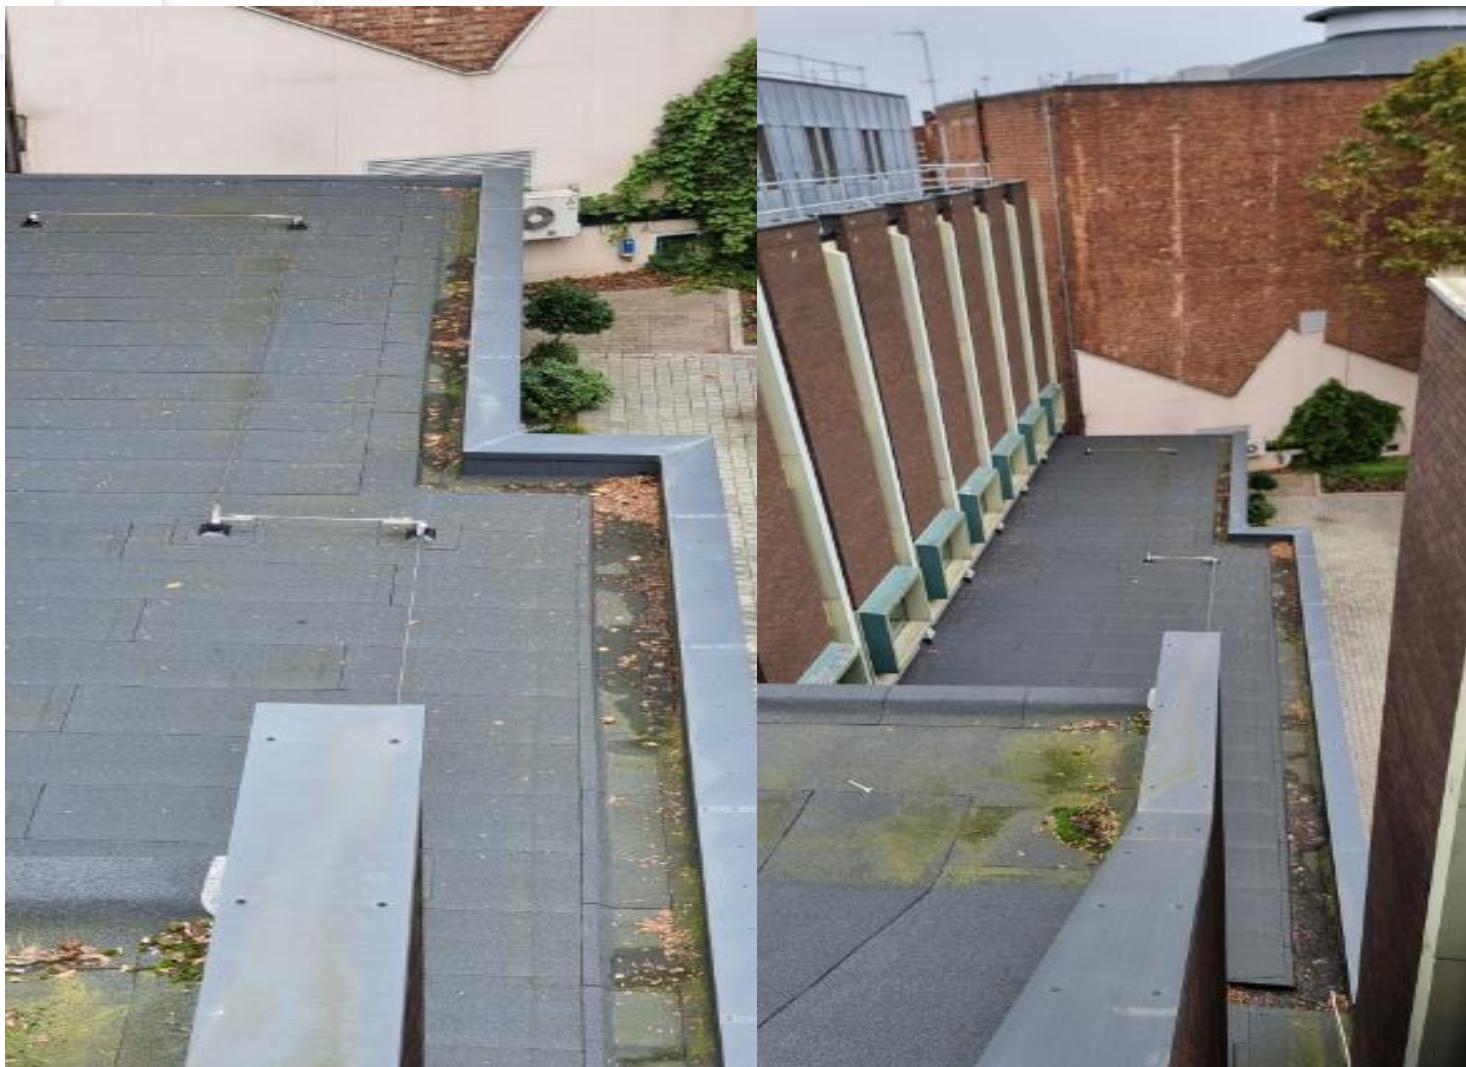
Building 1/roof 5

Area	Building 1/Roof area 5			Roof height	Approx 5m	
Access	Hatch	Door	Fixed Ladder	Temp Ladder	MEWP	Other
Access Comments						
<p>The roof areas are accessed on a case-by-case basis by site maintenance staff and contractors, this roof area is covered by Fall protection in the form of a mansafe system. This system is within compliance</p> <p>Roof area accessed by temporary ladder, additional considerations are to be made in regard to rescue and evacuation.</p>						
We advise no lone working on this roof.						
Tasks	Comments					
Lightning Protection Maintenance	Lightening protection is located away from the mansafe system and therefore advance work at height training and work positioning will be required to access.					
Gutter Cleaning/Maintenance	Gutters are located away from the mansafe system and therefore advance work at height training and work positioning will be required to access.

Window Cleaning/Maintenance	Windows are located away from the mansafe system and therefore advance work at height training and work positioning will be required to access.

Comments
Advanced work at height/rescue training required, 50m Ikar rescue kit is suitable on this roof area.

Access Suggestions
A permit to work system could help control who goes on the roof area to ensure they understand the risk associated with this area and the procedures in place also to identify that the engineers/contractors are trained and competent and that their RAMS are identified and suitable for the works required of them regarding access methods/Rescue.
We suggest that anyone going to the roof areas should always work in pairs in case of an emergency, this roof area is covered by a mansafe system therefore additional work at height training/rescue training will be required.
Additional considerations are to be made when accessing assets/tasks, with additional advanced training access can be made using work positioning equipment.
